Marulan South Limestone Mine

Boral Cement Limited

Annual Environmental Management Review

1 July 2021 to 30 June 2022

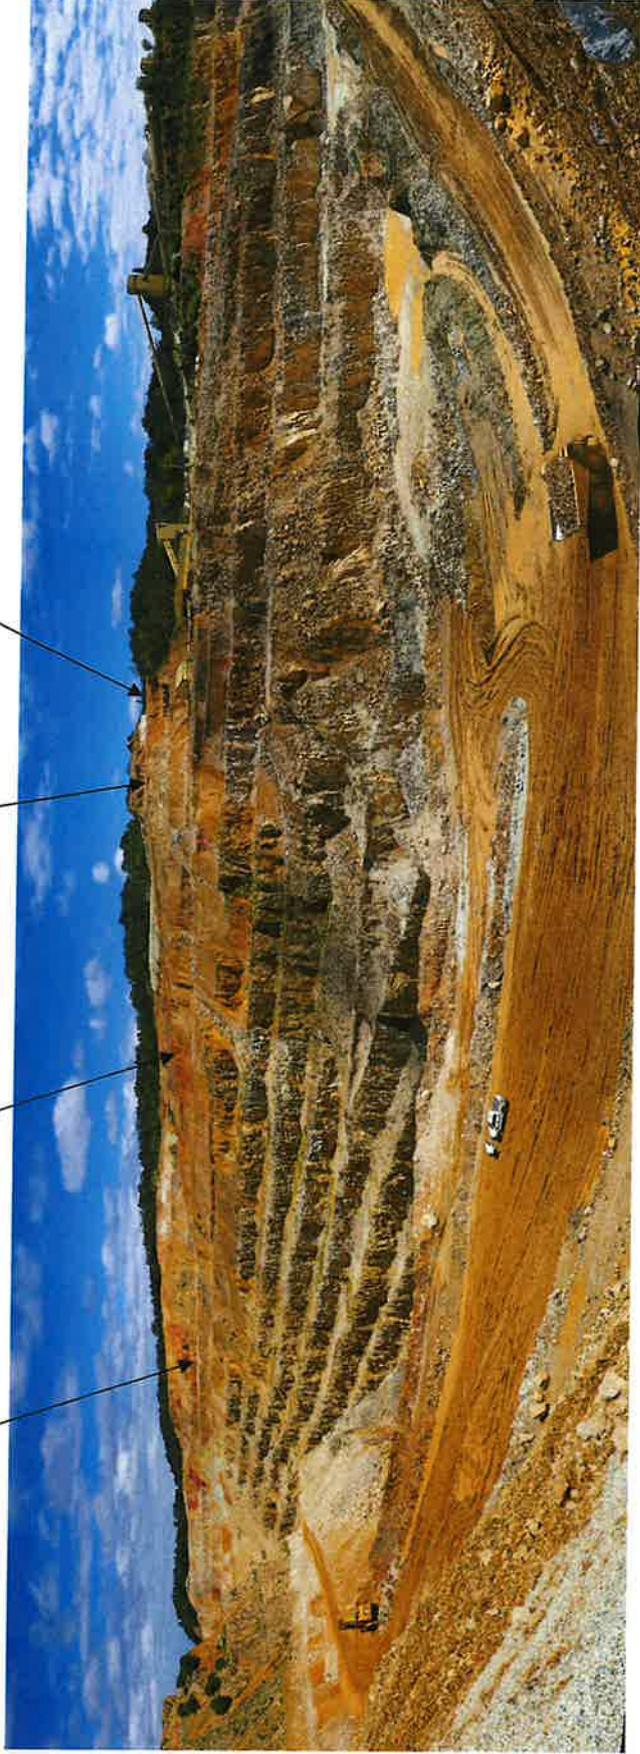
Photo 1: Overview of western wall in North pit and which has been largely inactive. Photo locations as appropriate annotated.

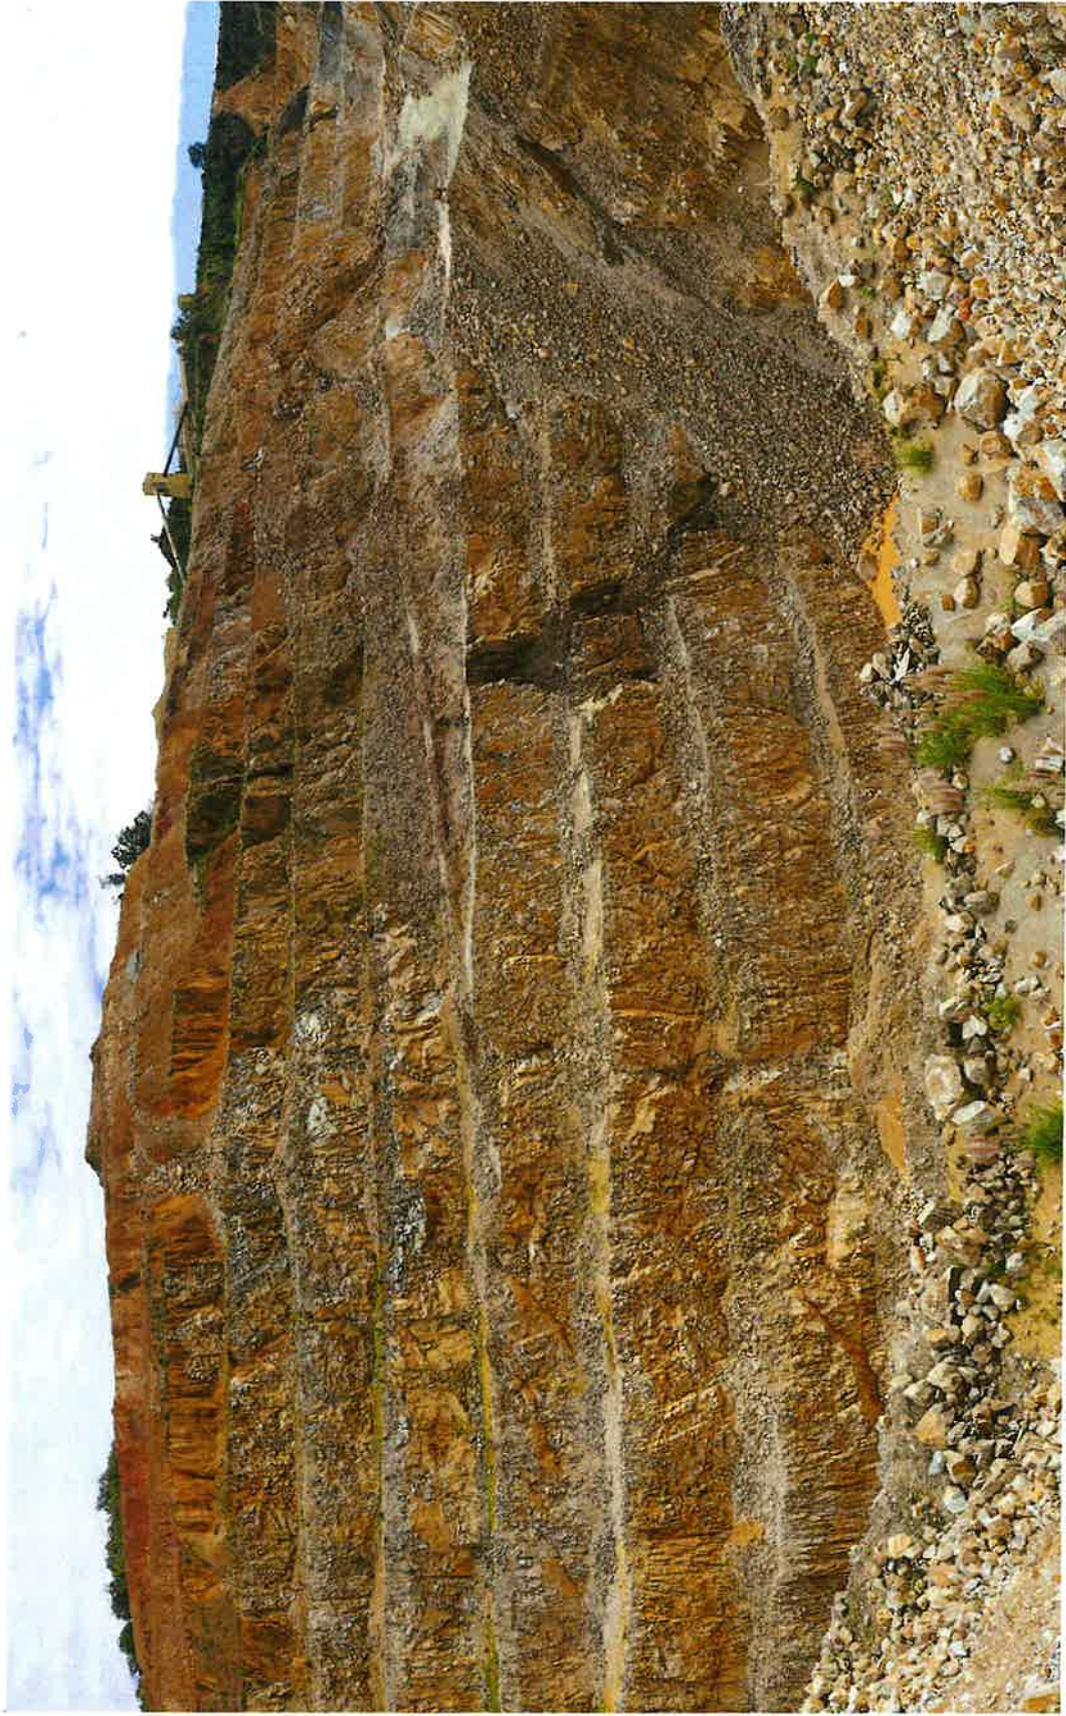
Photo 2: Overview of northern end of west wall in North pit.

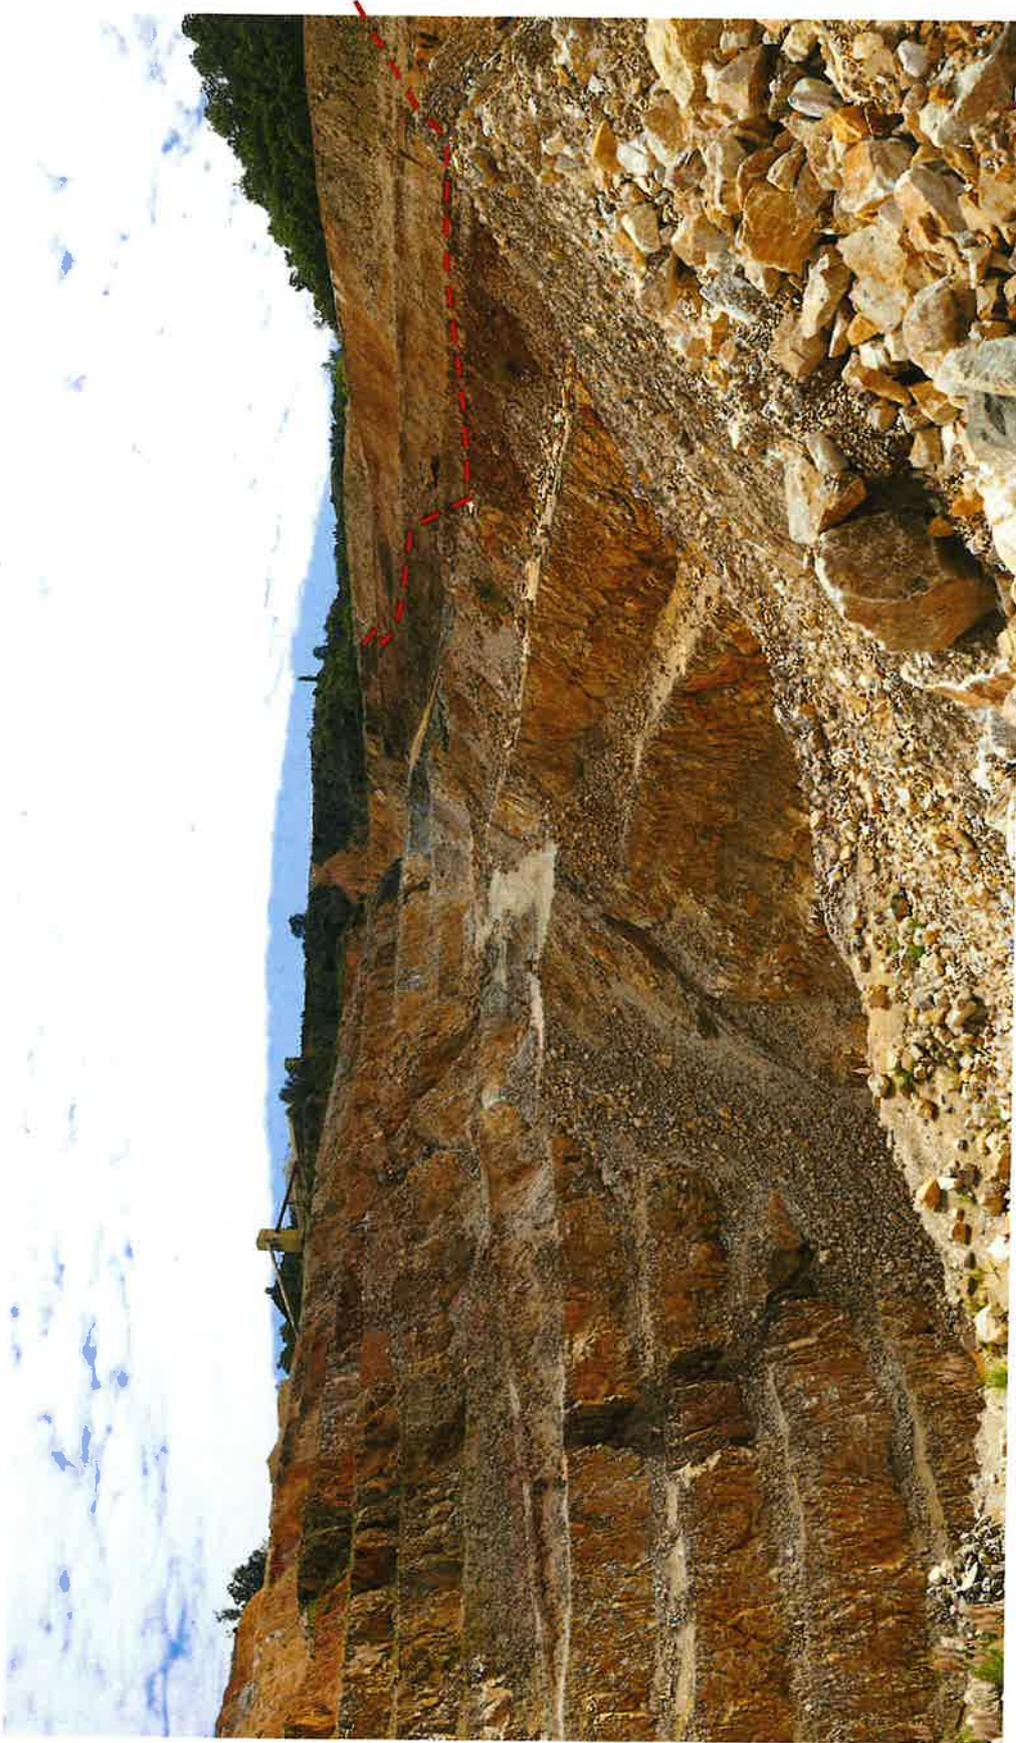
Photo 3: Overview of northern end of North pit. The upper northeast wall is largely in “re-mined” backfill and with boundary nominally annotated.

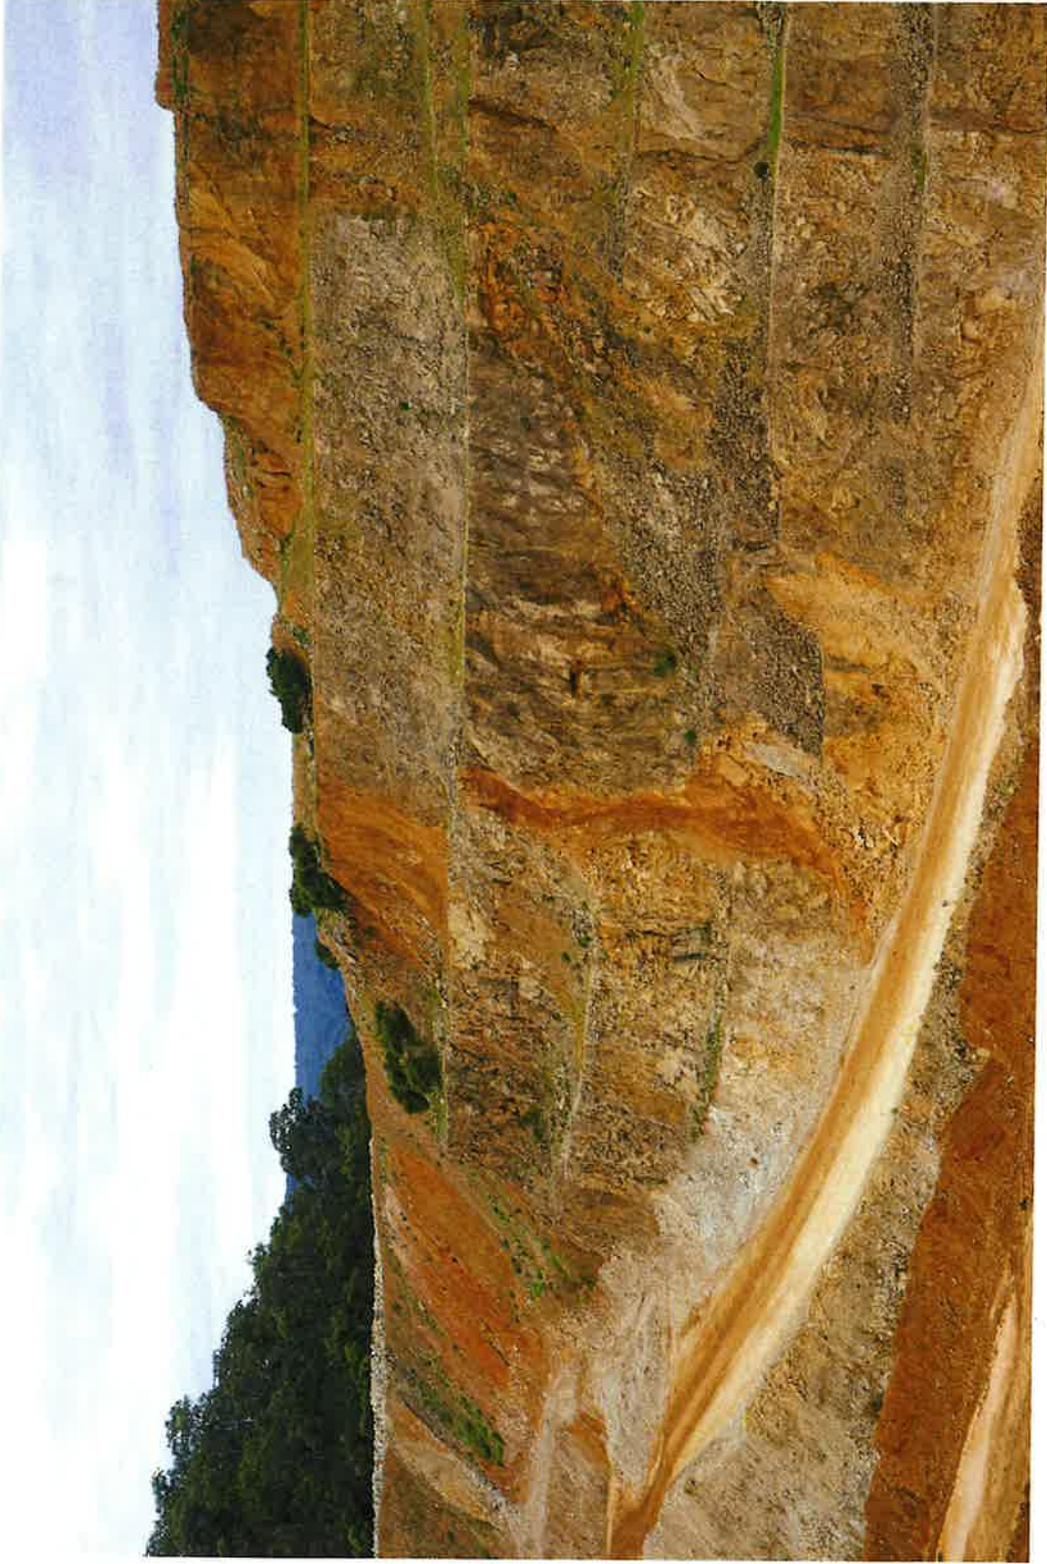
Photo 5: Northern end of east wall in North pit and with recent mobilisation of historic instability dating back to 2008.

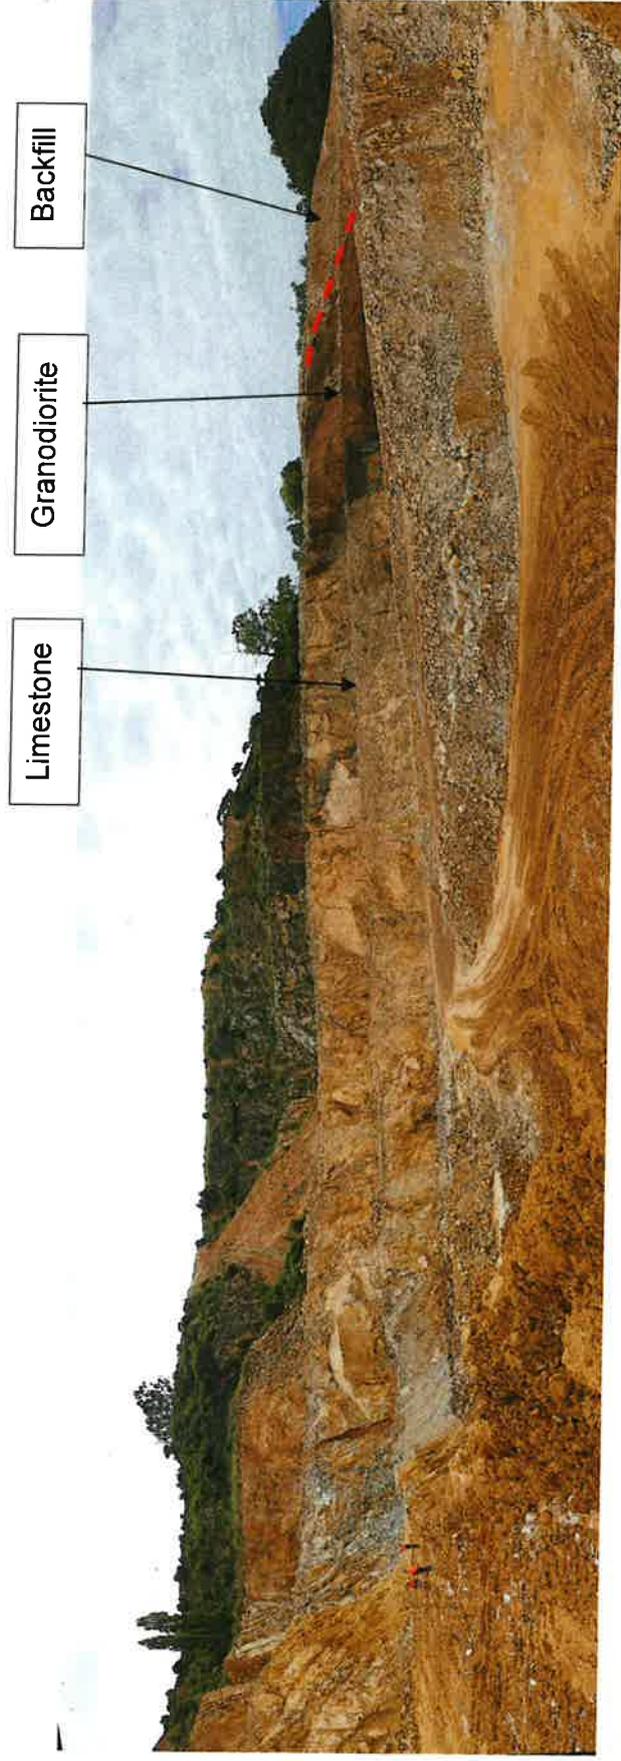
Photo 6: Northern end of North Pit. Note transition in east wall from Limestone to Granodiorite and then to re-mined backfill.

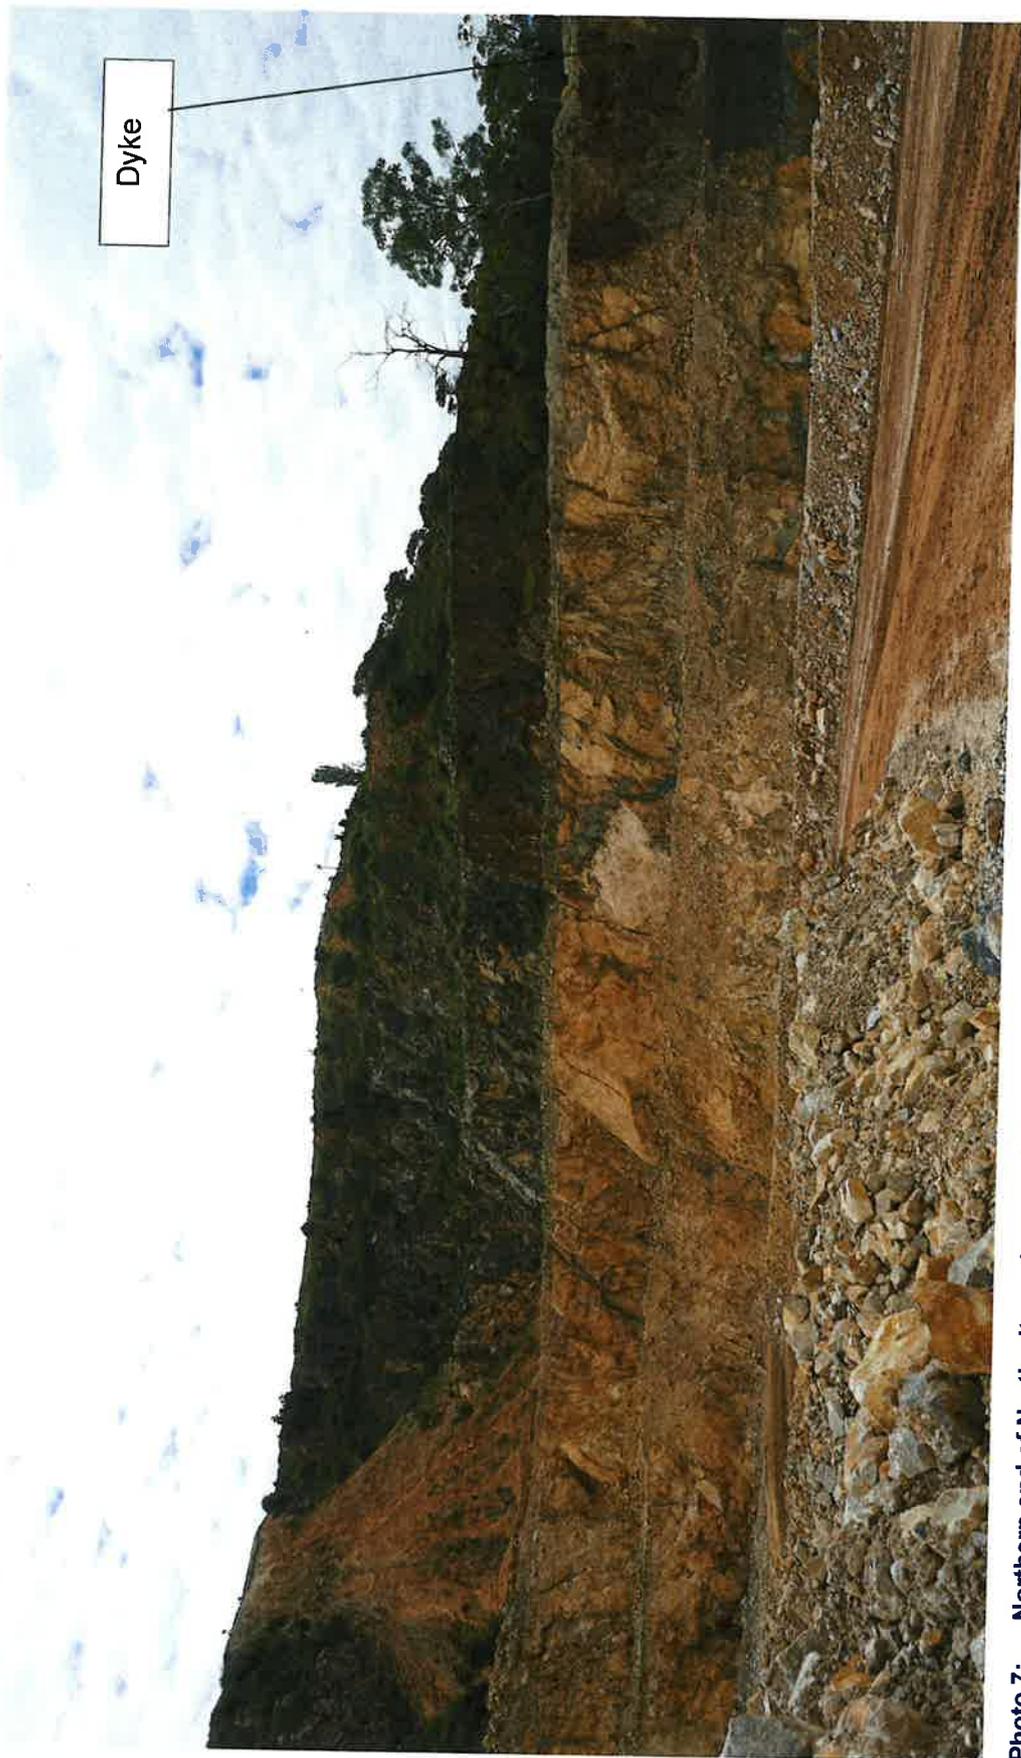
Photo 7: Northern end of North pit, predominantly limestone. Dyke at right has a highly irregular contact and suggests infilling of cavities.

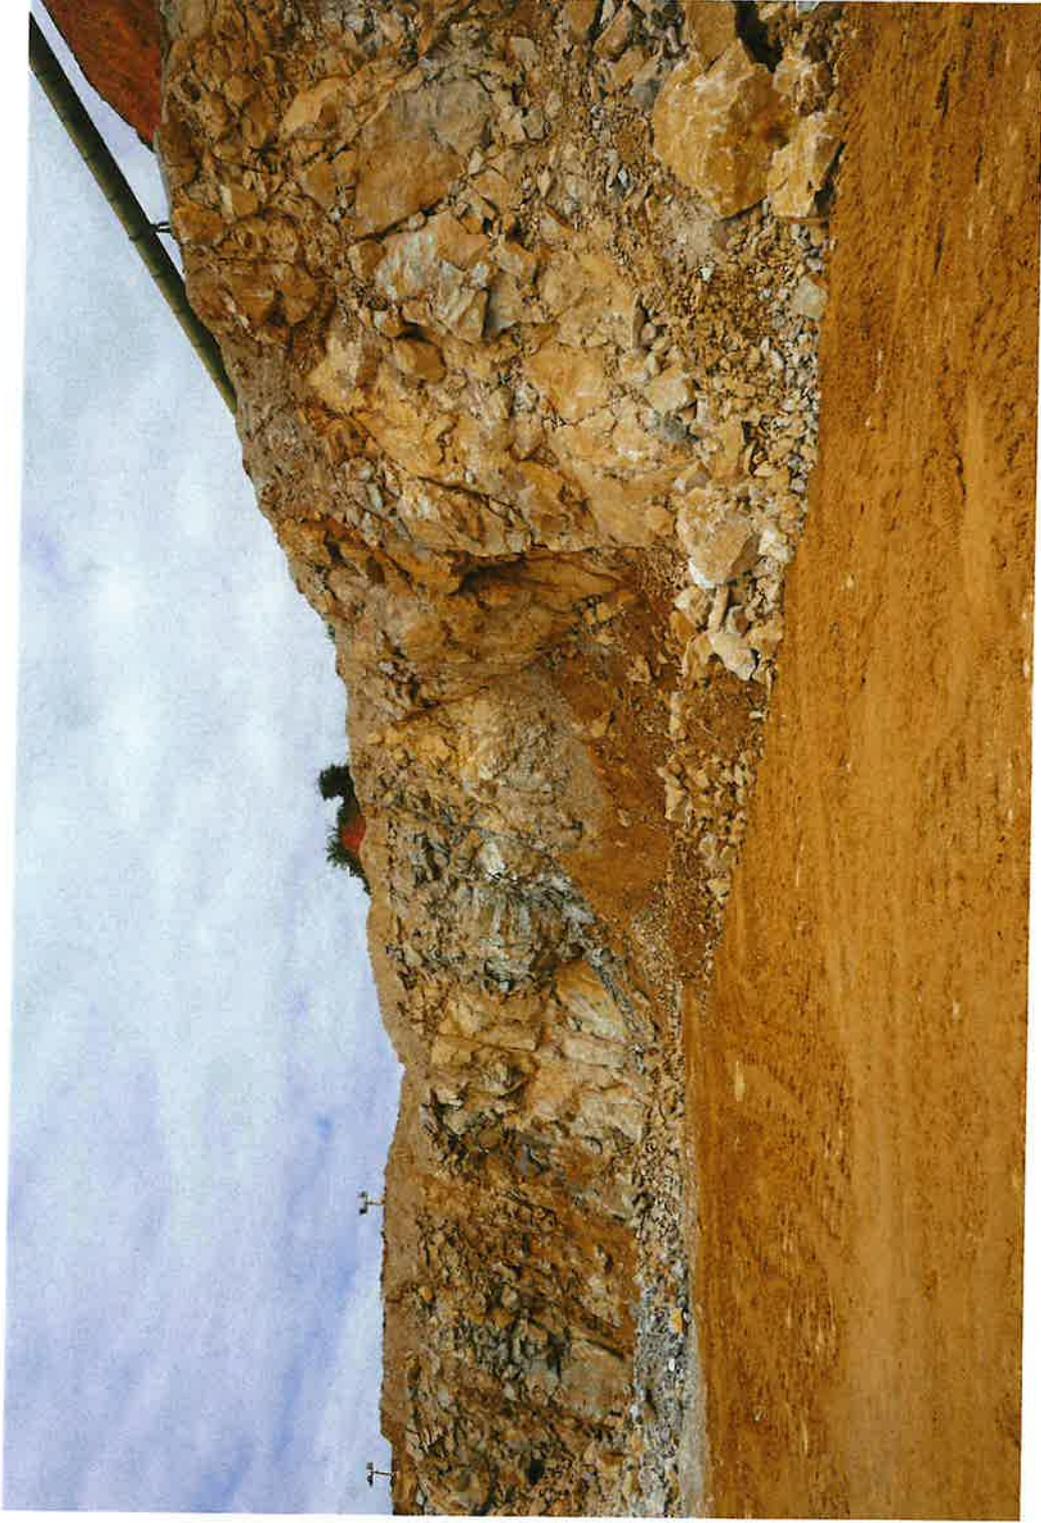
Photo 9: West wall in the northern end of North pit and highlighting variable conditions in wall with both overhang and areas of loose rocks in the face.

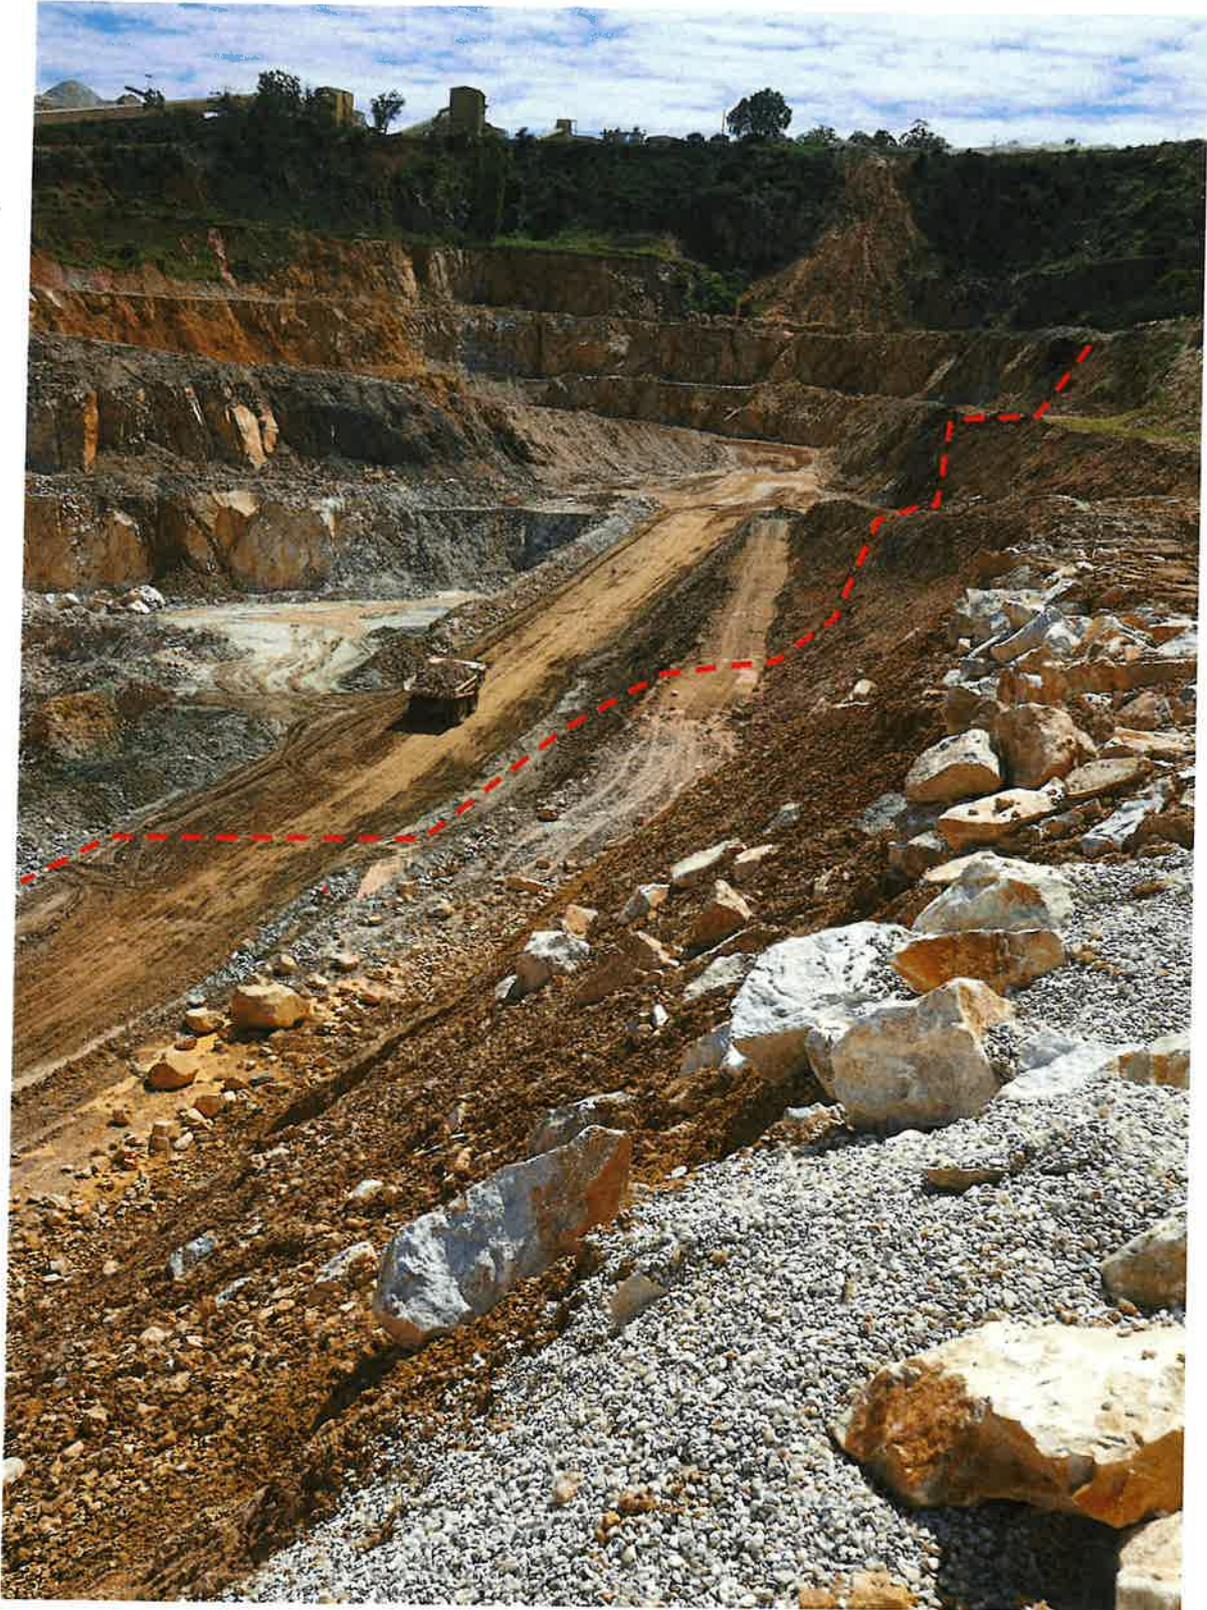
Photo 10: View from road on east wall and looking into northern end of North pit. The nominal extent of backfill annotated. Berm present is wide and in good condition in view of recent rainfall.

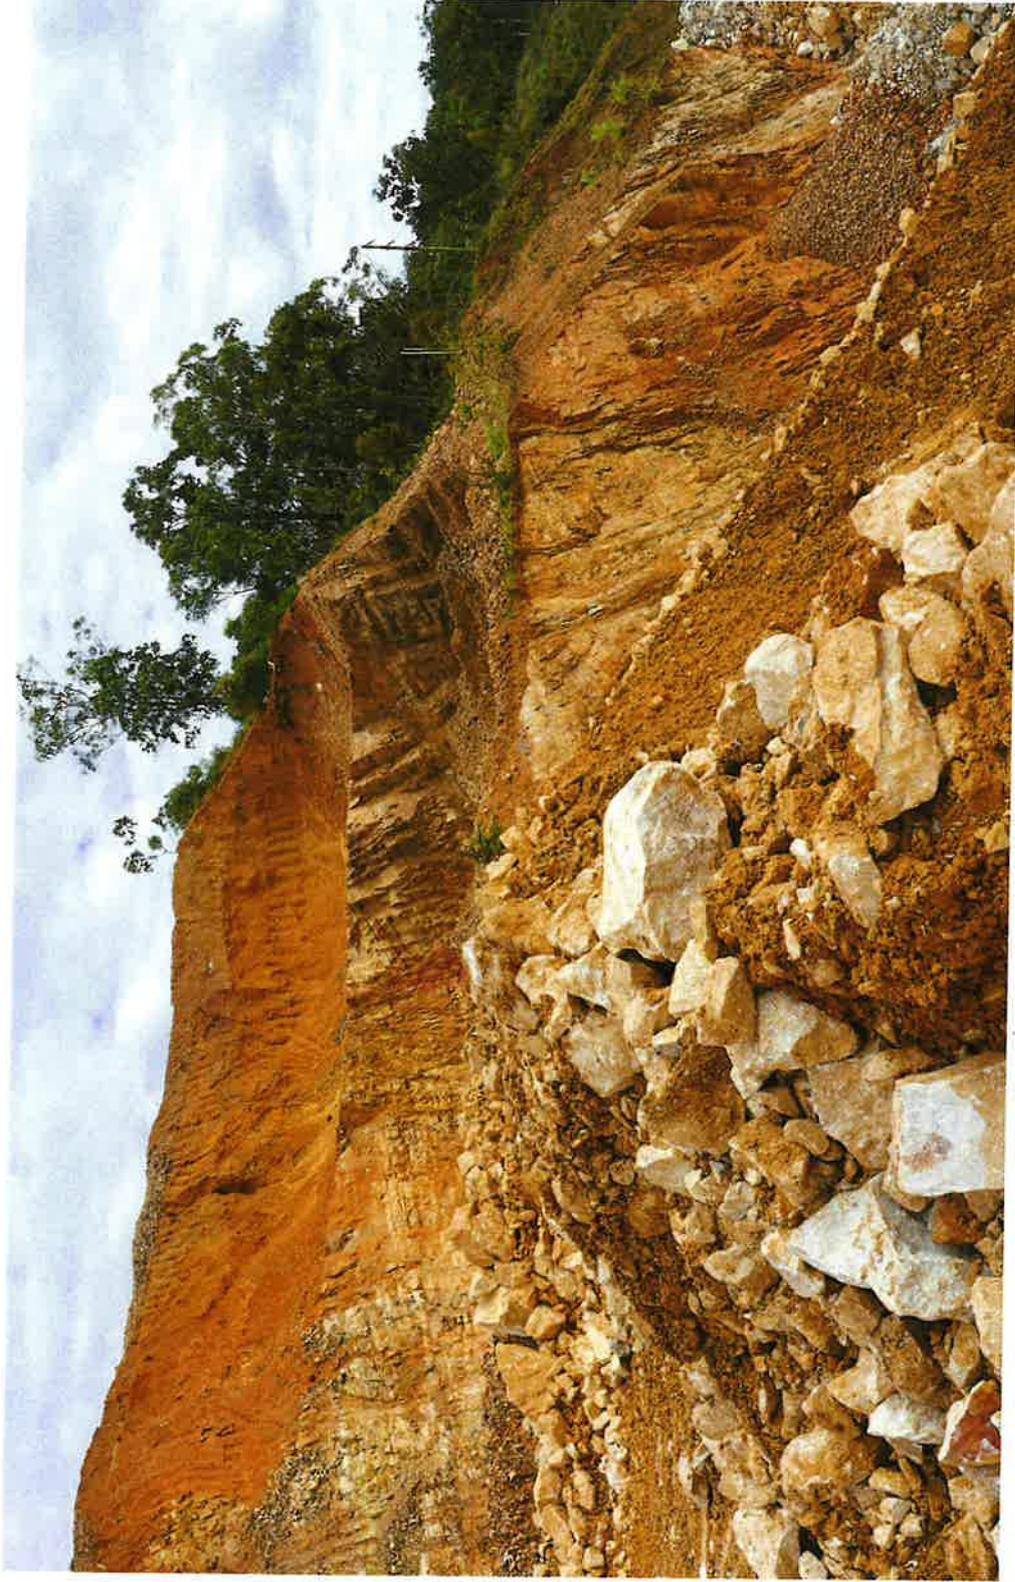
Photo 12: West wall in North pit, immediately south of plant site and with rotation of bedding in sediments, note the strata dips to the south at north. See Photo 1 for location.

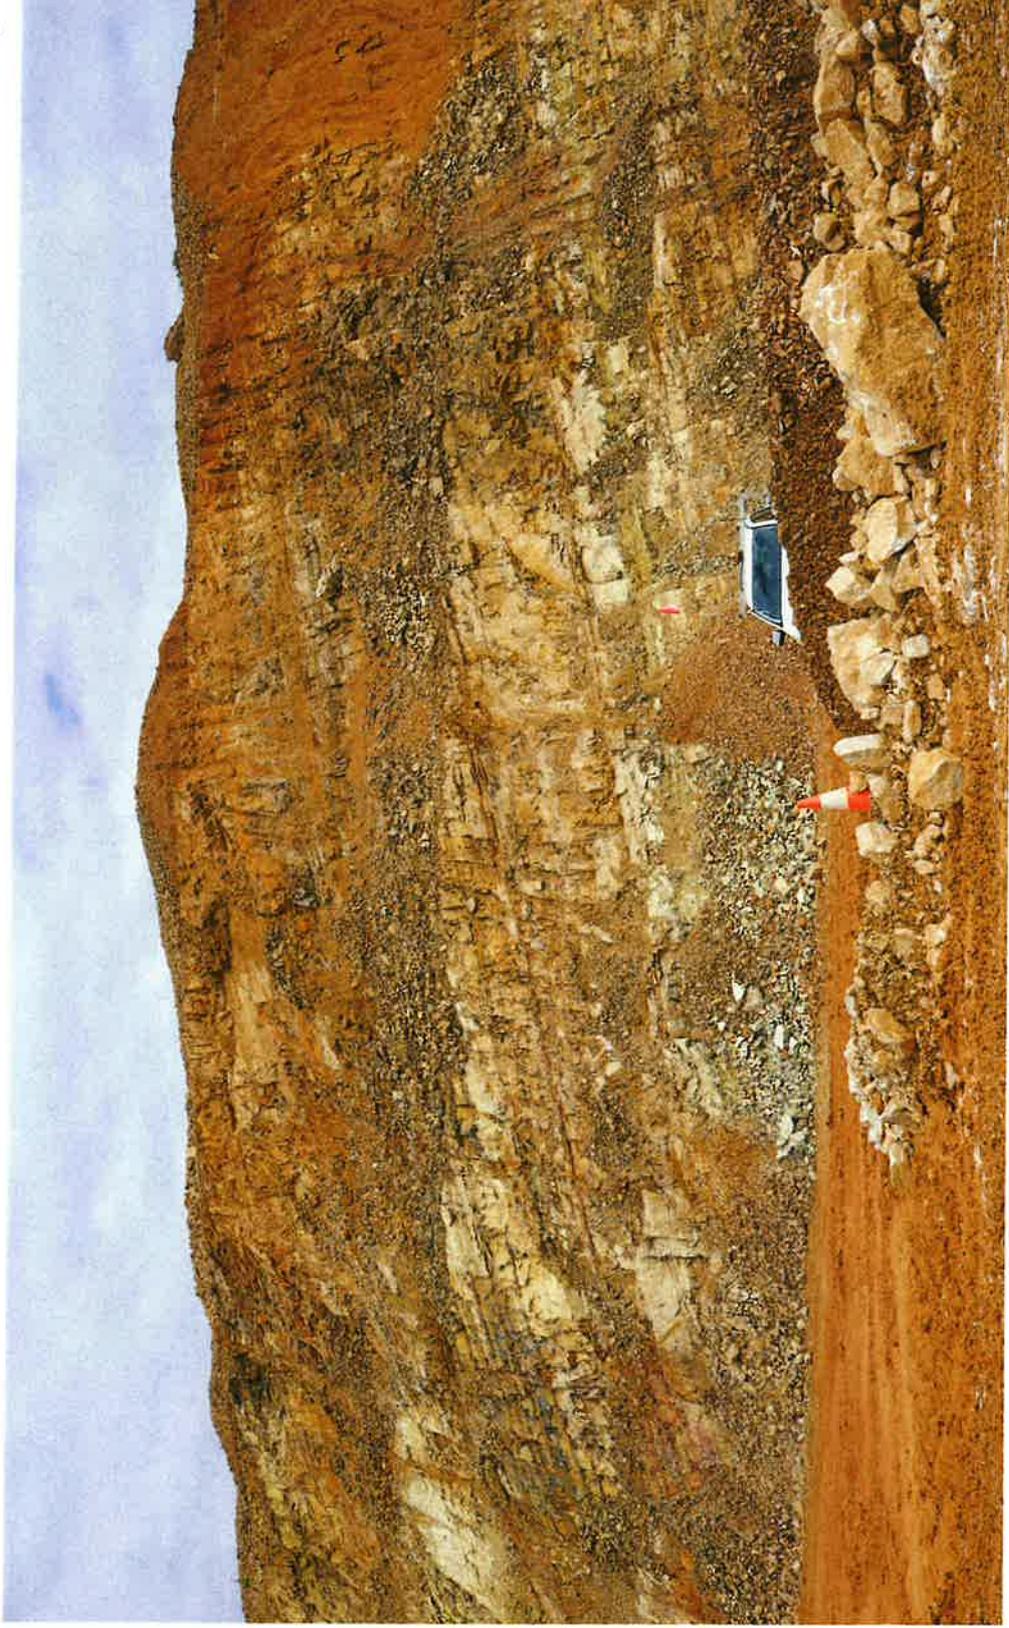
Photo 13: West wall in North pit, south of Photo 12, see Photo 1 for nominal location, and with bedding dipping shallowly to the west.

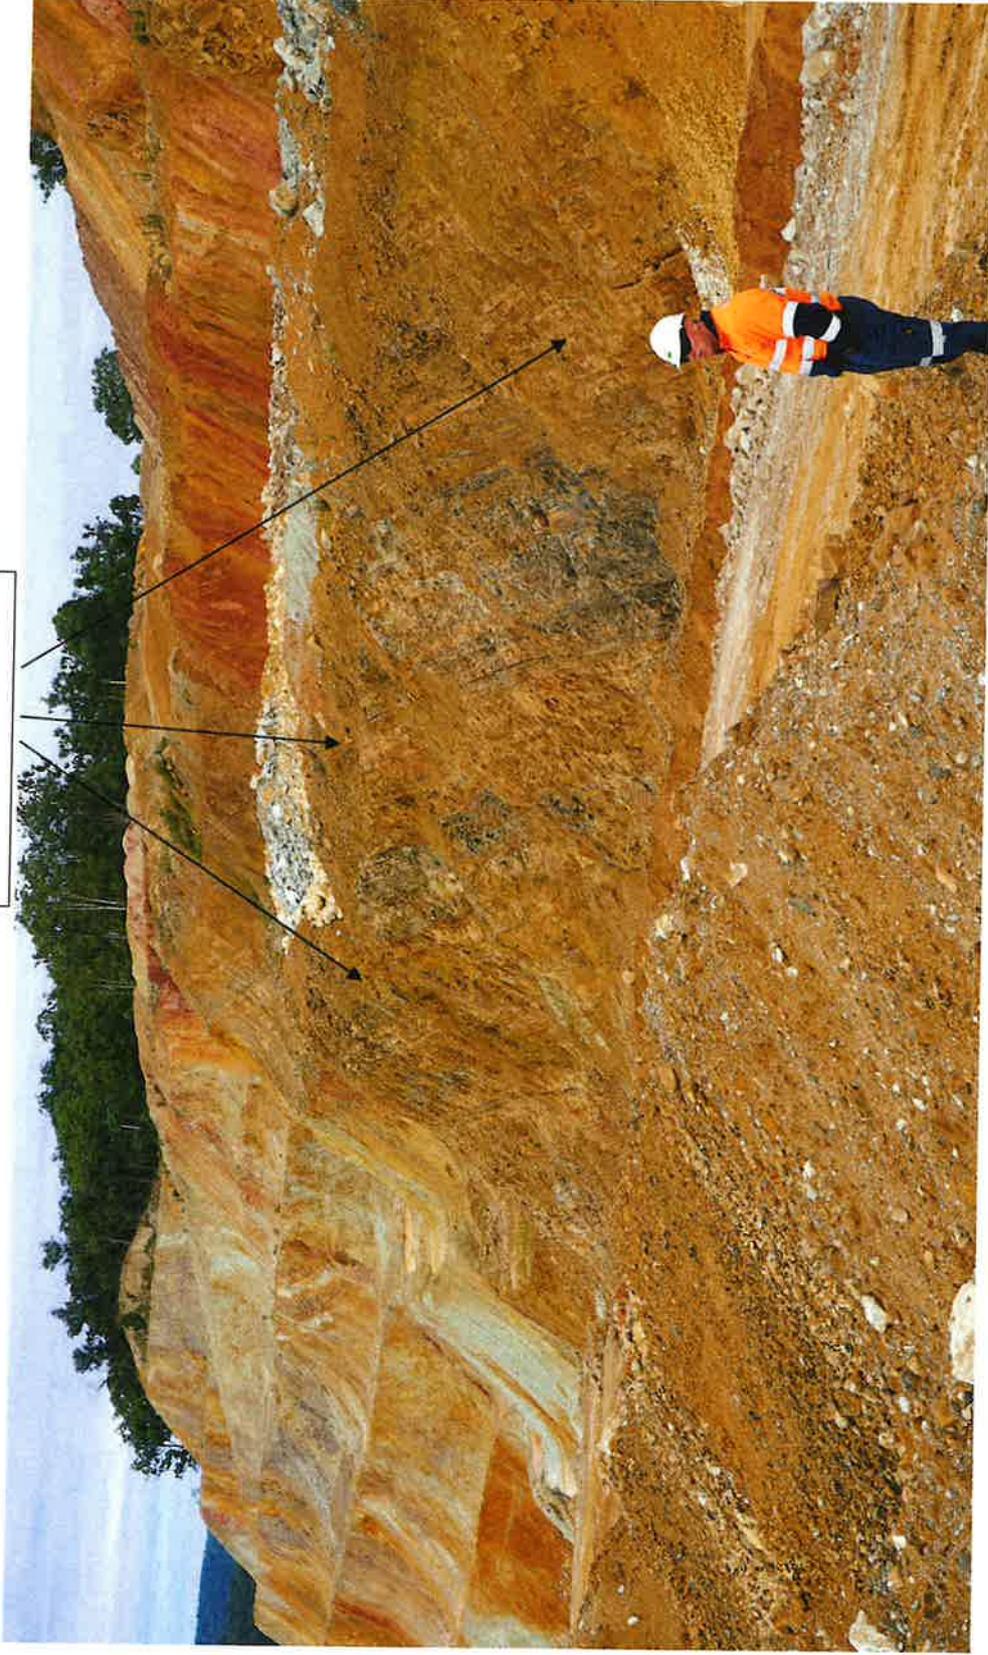
Photo 14: West wall at southern end of North pit, see Photo 1 for nominal location, and with bedding dipping steeply to the west. There are several dilated bedding feature indicating the slope is showing toppling style mechanism and at limit of stability.

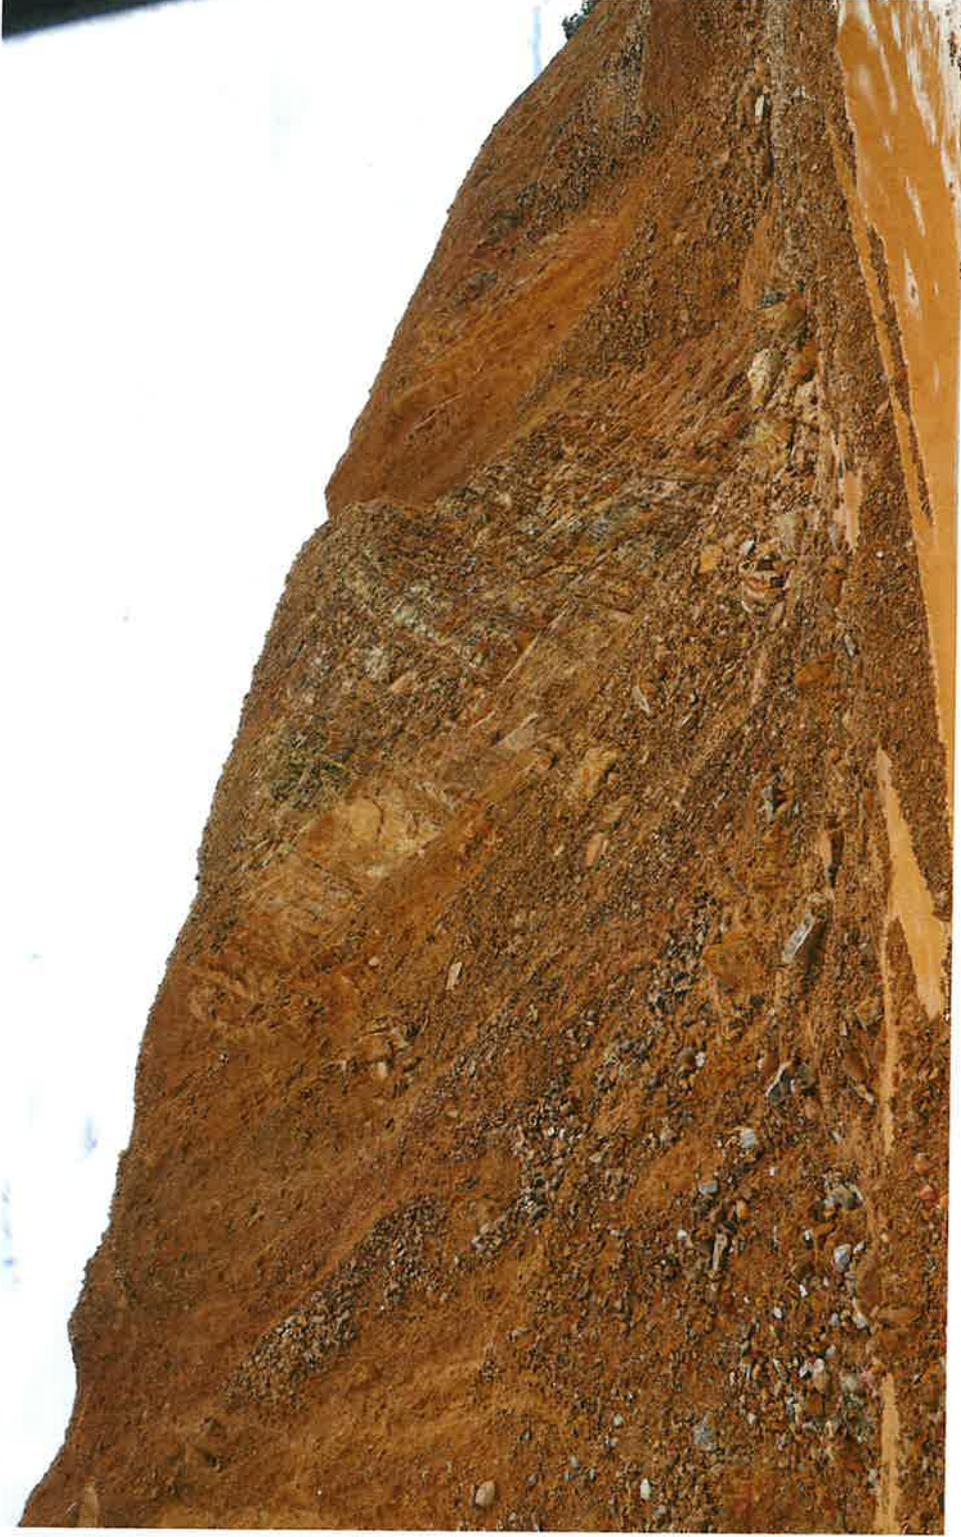
Photo 15: West wall in central part of North pit, see Photo 1 for nominal location. Sediments are variably weathered and PSM infer the bench scale instabilities that have occurred are bench scale toppling in the areas of deeper weathering. If BCL chose to scale these areas, a maximum batter angle of 50° should be utilised.

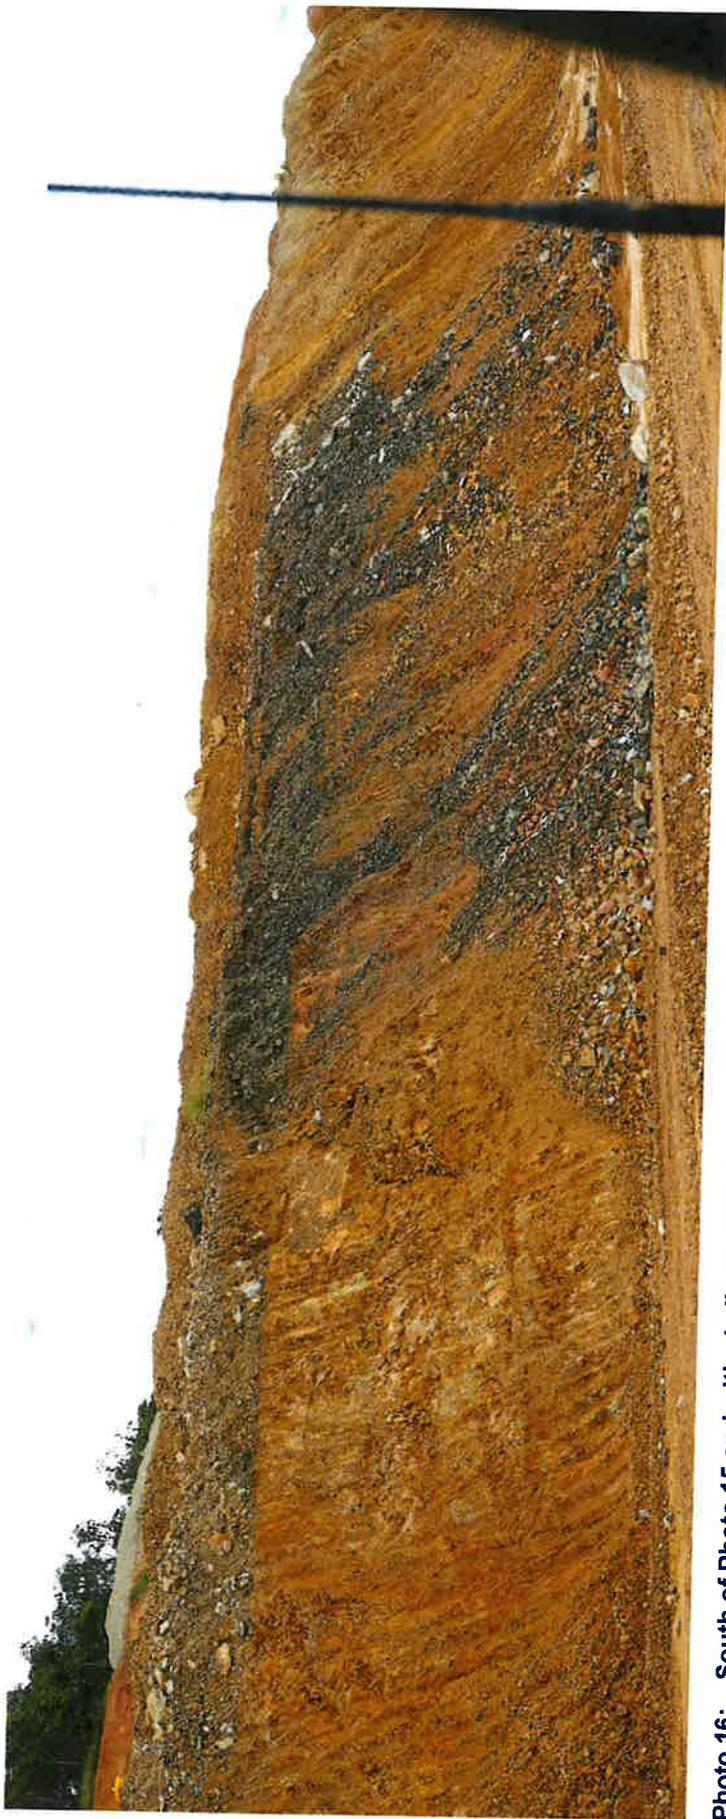
Photo 16: South of Photo 15 and with similar comments applicable.

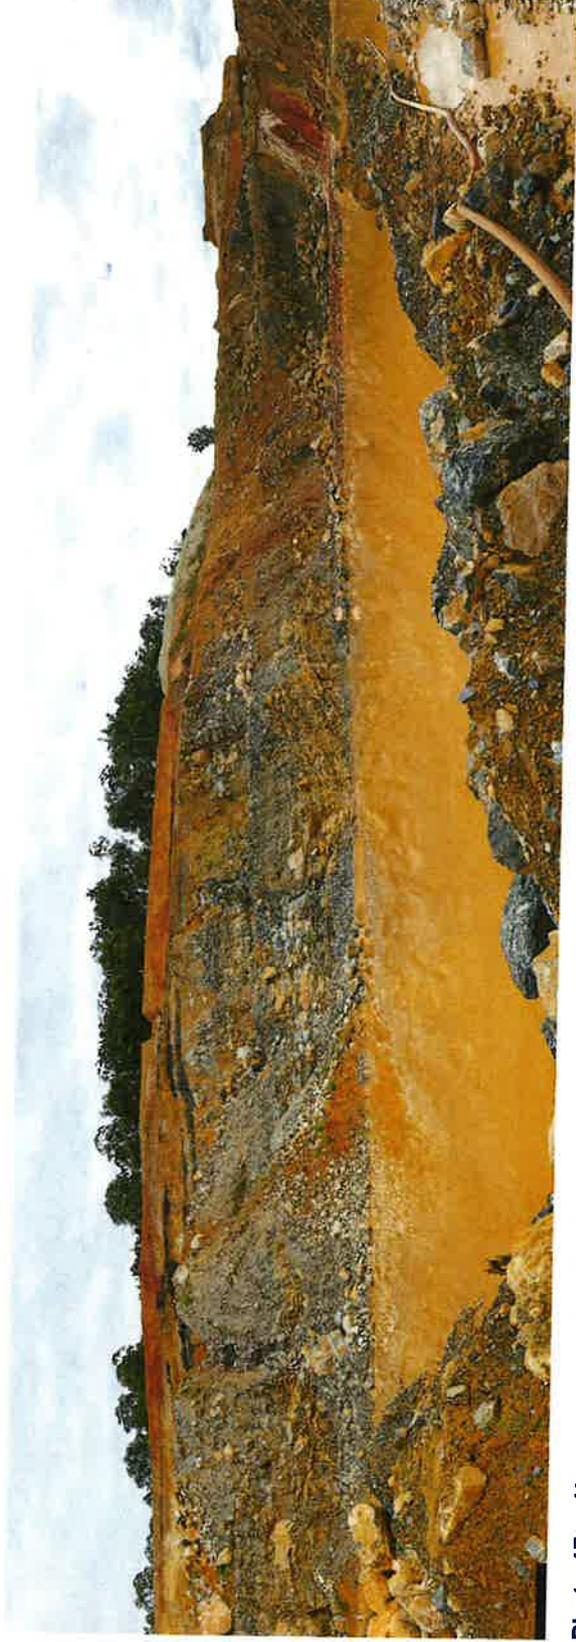
Photo 17: Upper west wall in North pit, with mining of Middle limestone. Area has ponded during recent rainfall and is actively being pumped dry to limit pressures developed on lower part of west wall.
