Marulan South Limestone Mine

Boral Cement Limited

Annual Environmental Management Review

1 July 2021 to 30 June 2022

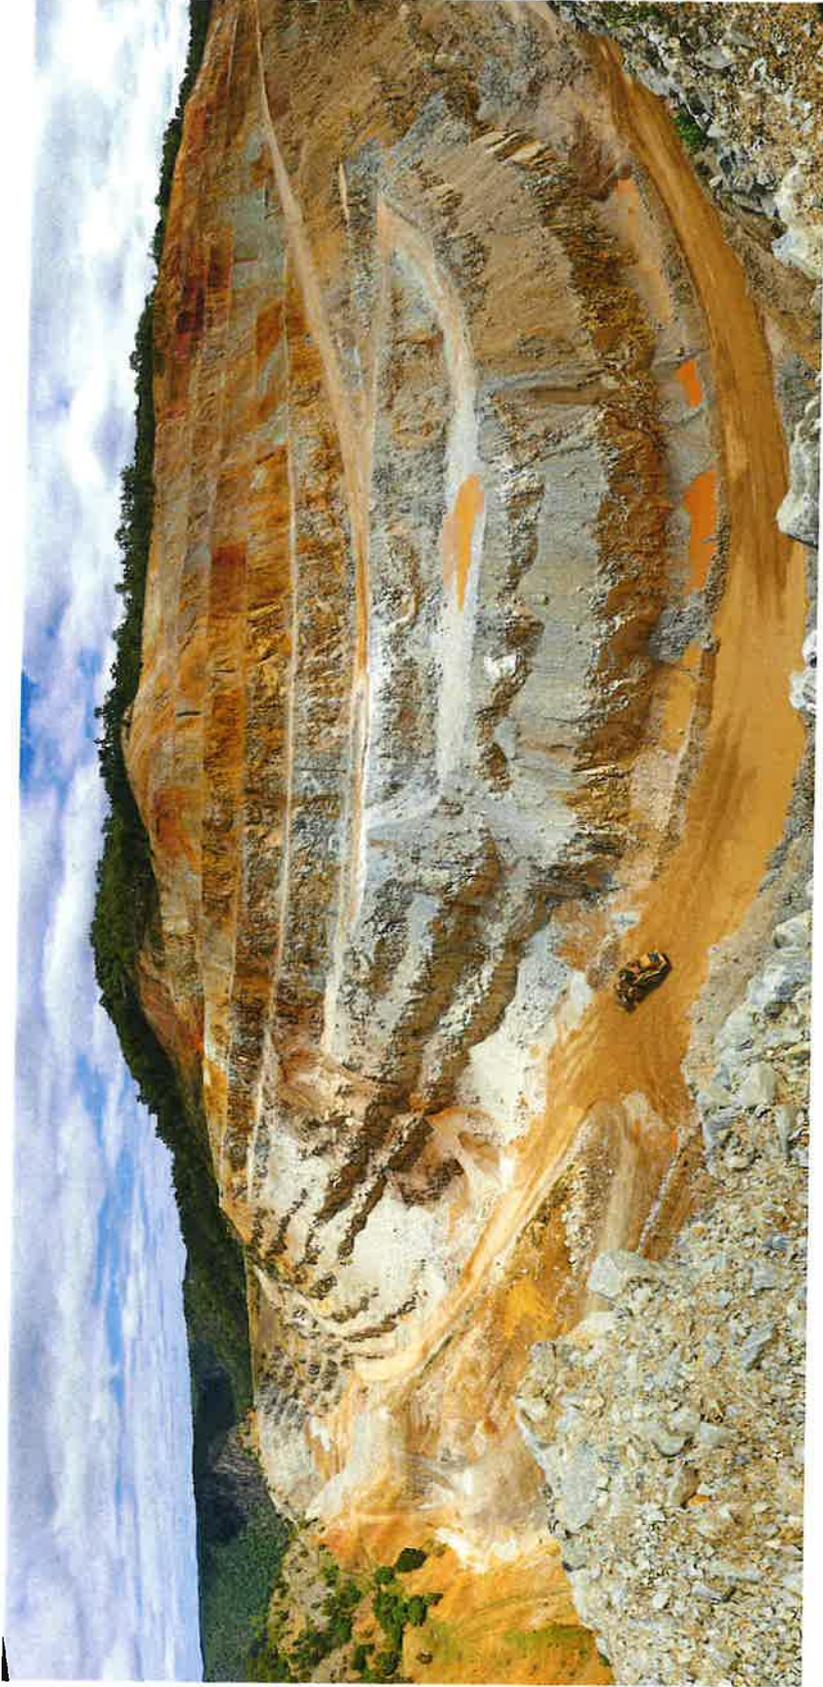
Photo 19: West wall in transition area between North and South pits and with cutback of upper slopes of west wall in progress.

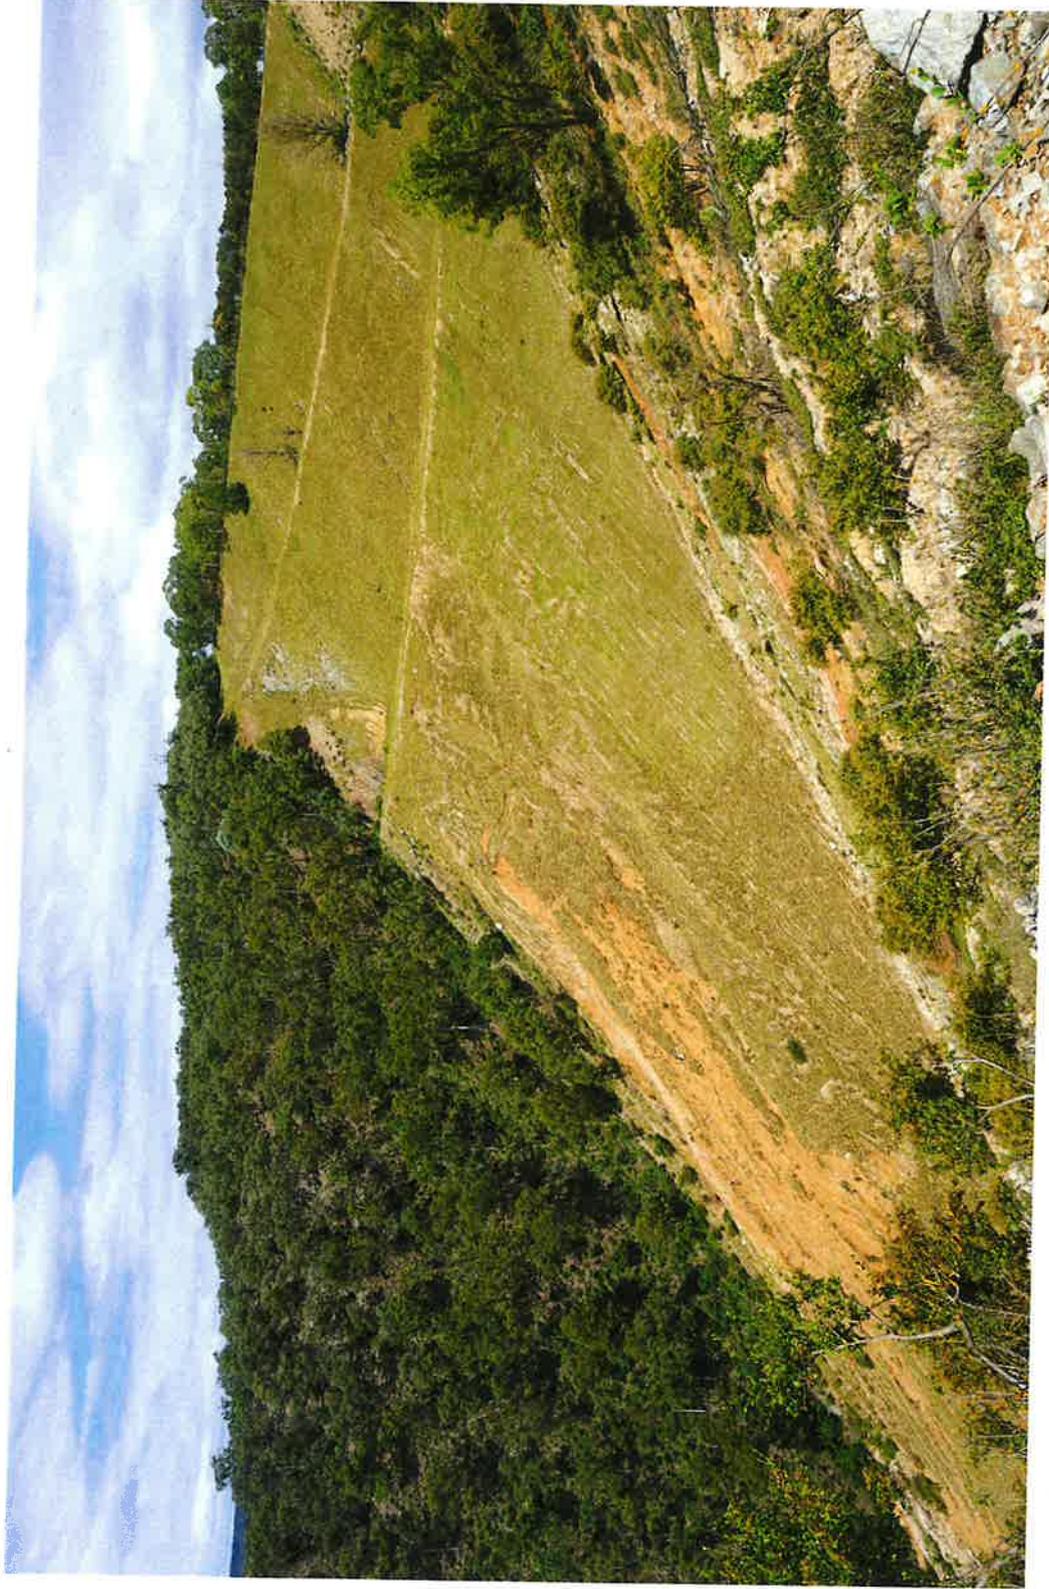
Photo 21: Overview of Barbers Creek dump and with development of a fresh scarp in face of dump.

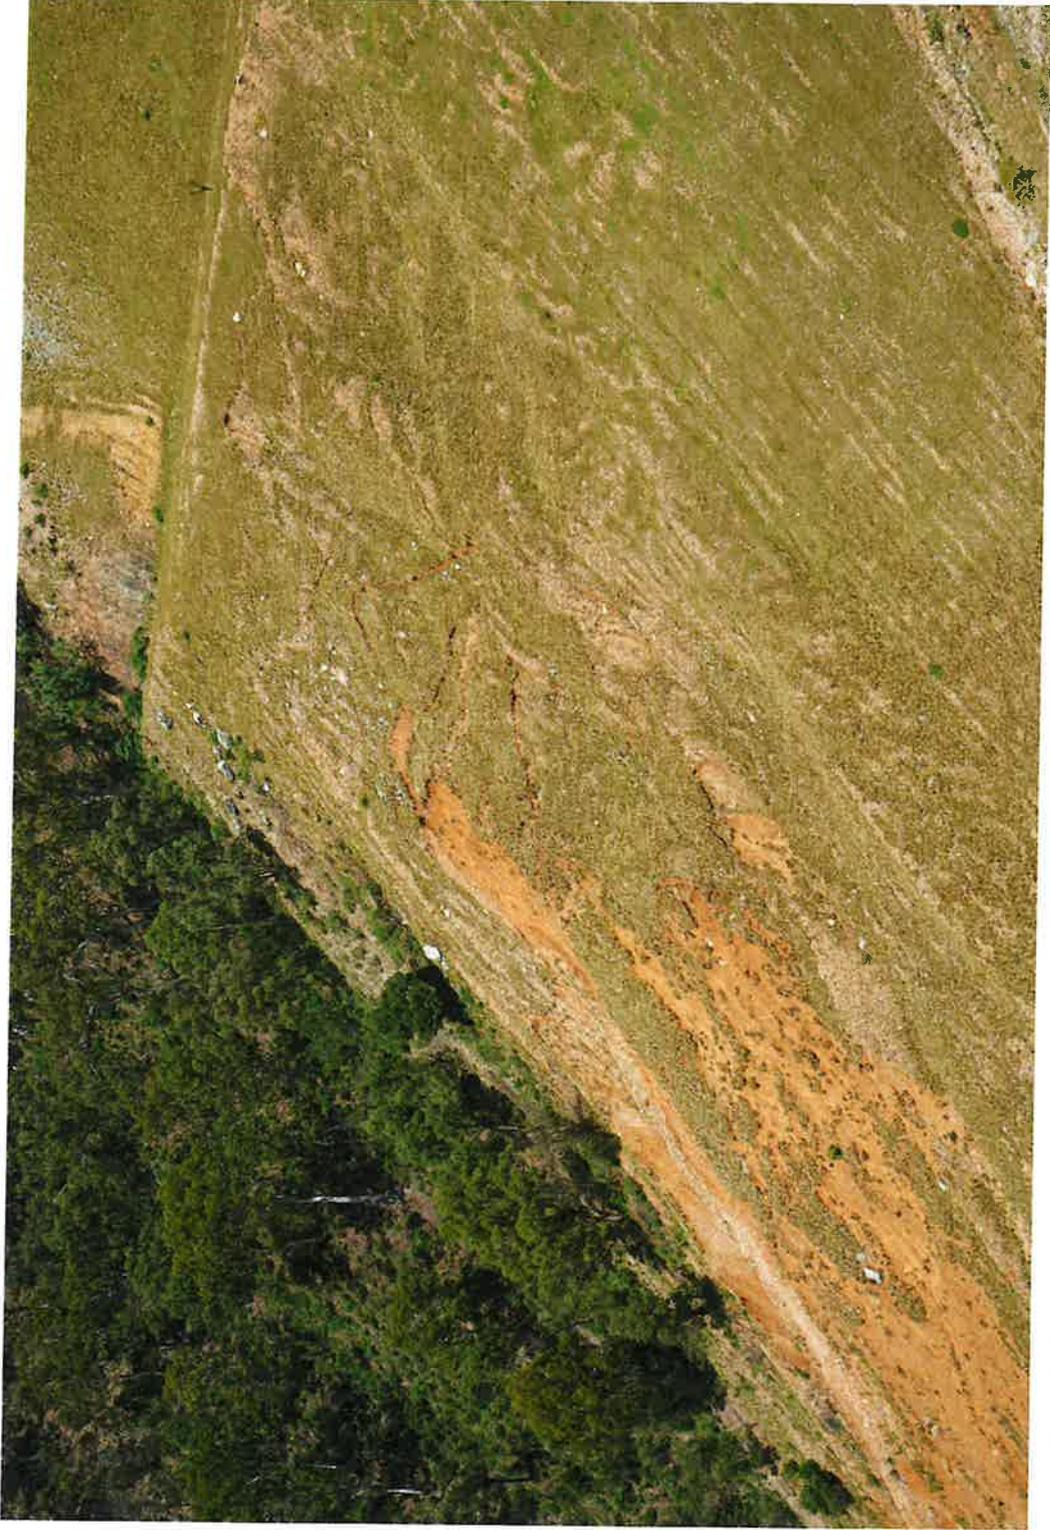
Photo 22: Barbers Creek dump and focusing on fresh scarps in face of dump.

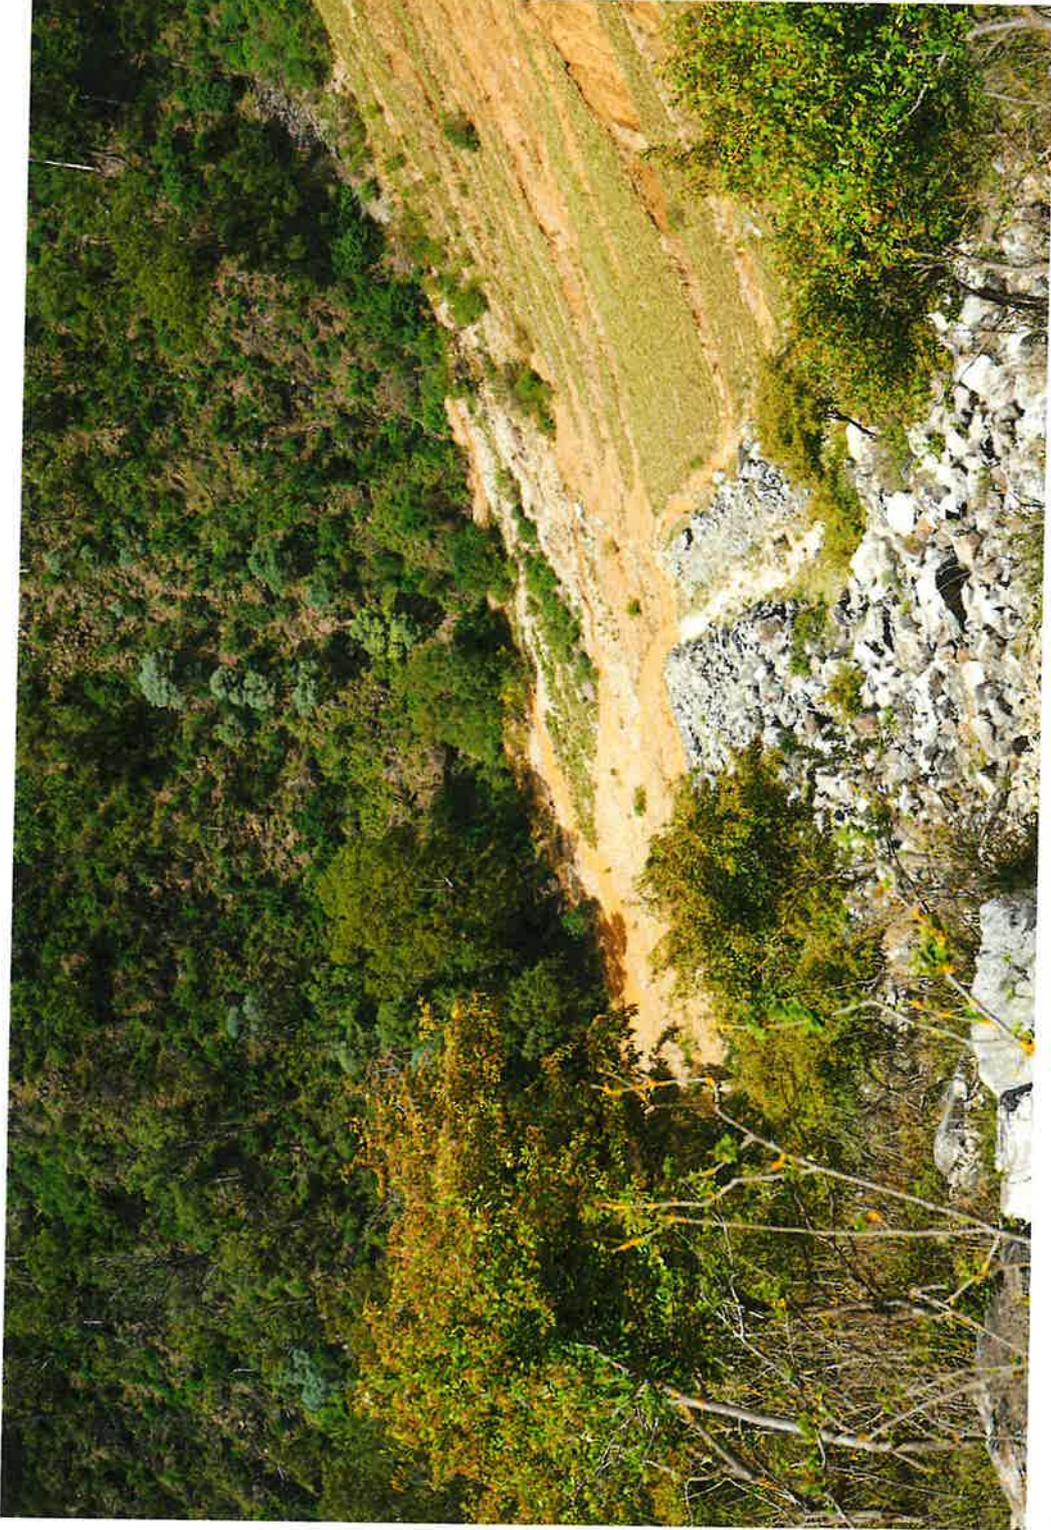
Photo 23: Barbers Creek dump and focusing on toe area with gully developed.

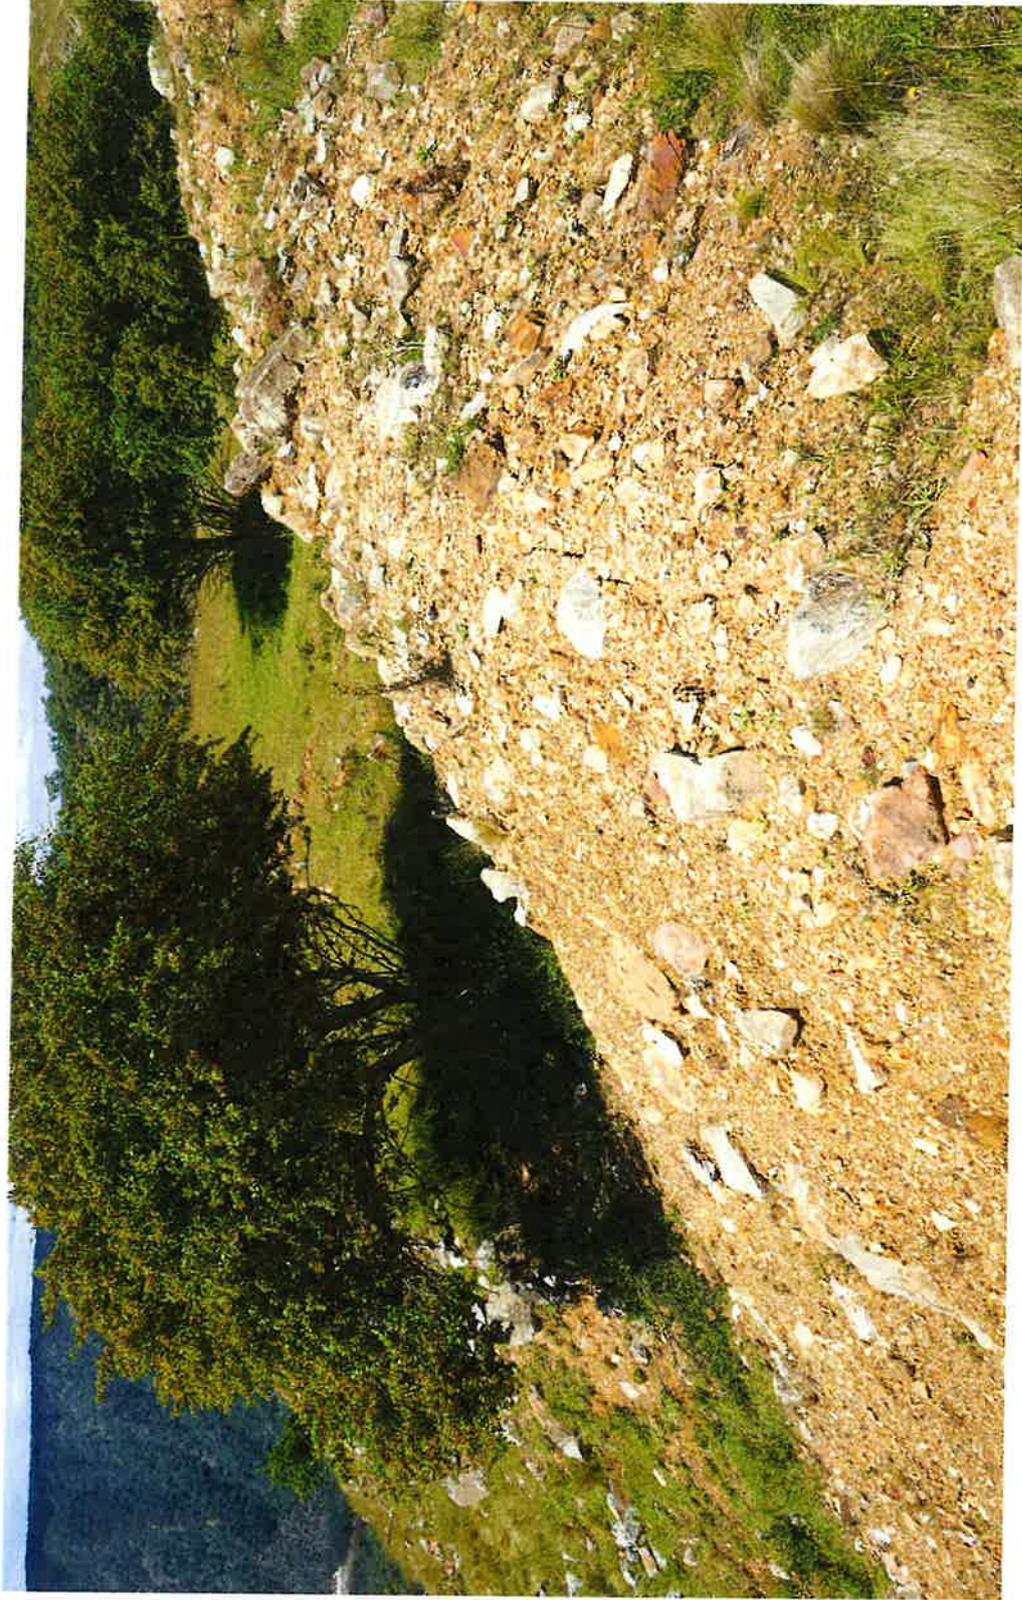
Photo 24: Barbers Creek dump and highlighting recent crack development near crest. Note the pronounced lip is as a result of historic movements.

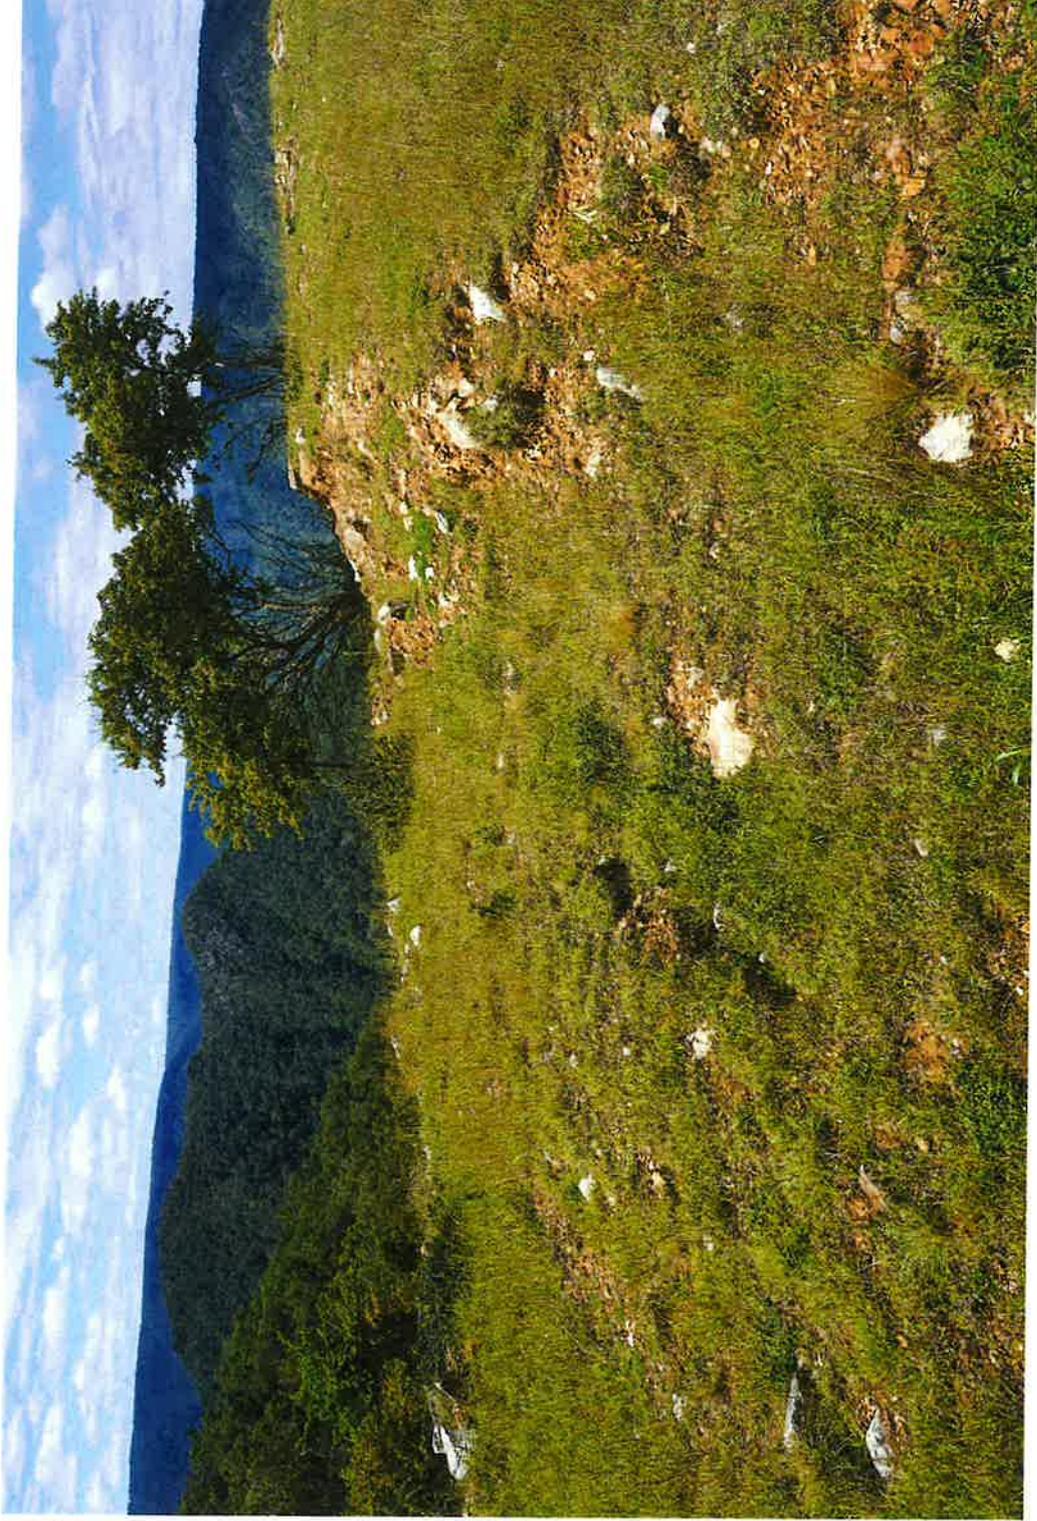
Photo 25: Barbers Creek dump and highlighting lip from historic movements.

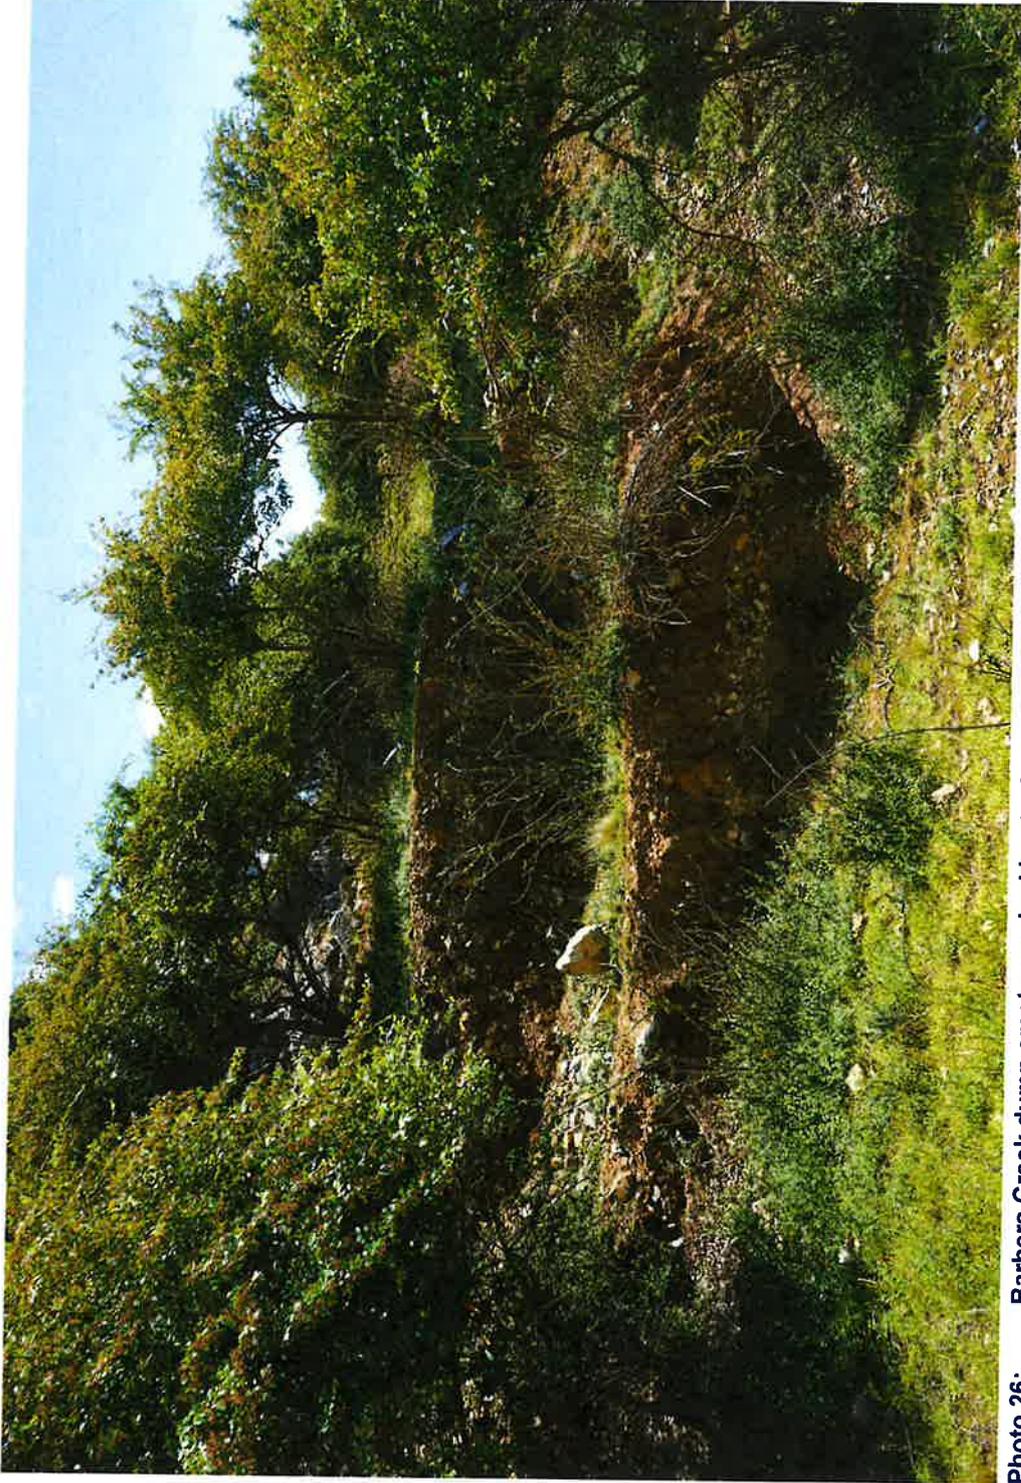
Photo 26: Barbers Creek dump crest area, looking to the west and with two lips highlighting historic movements.

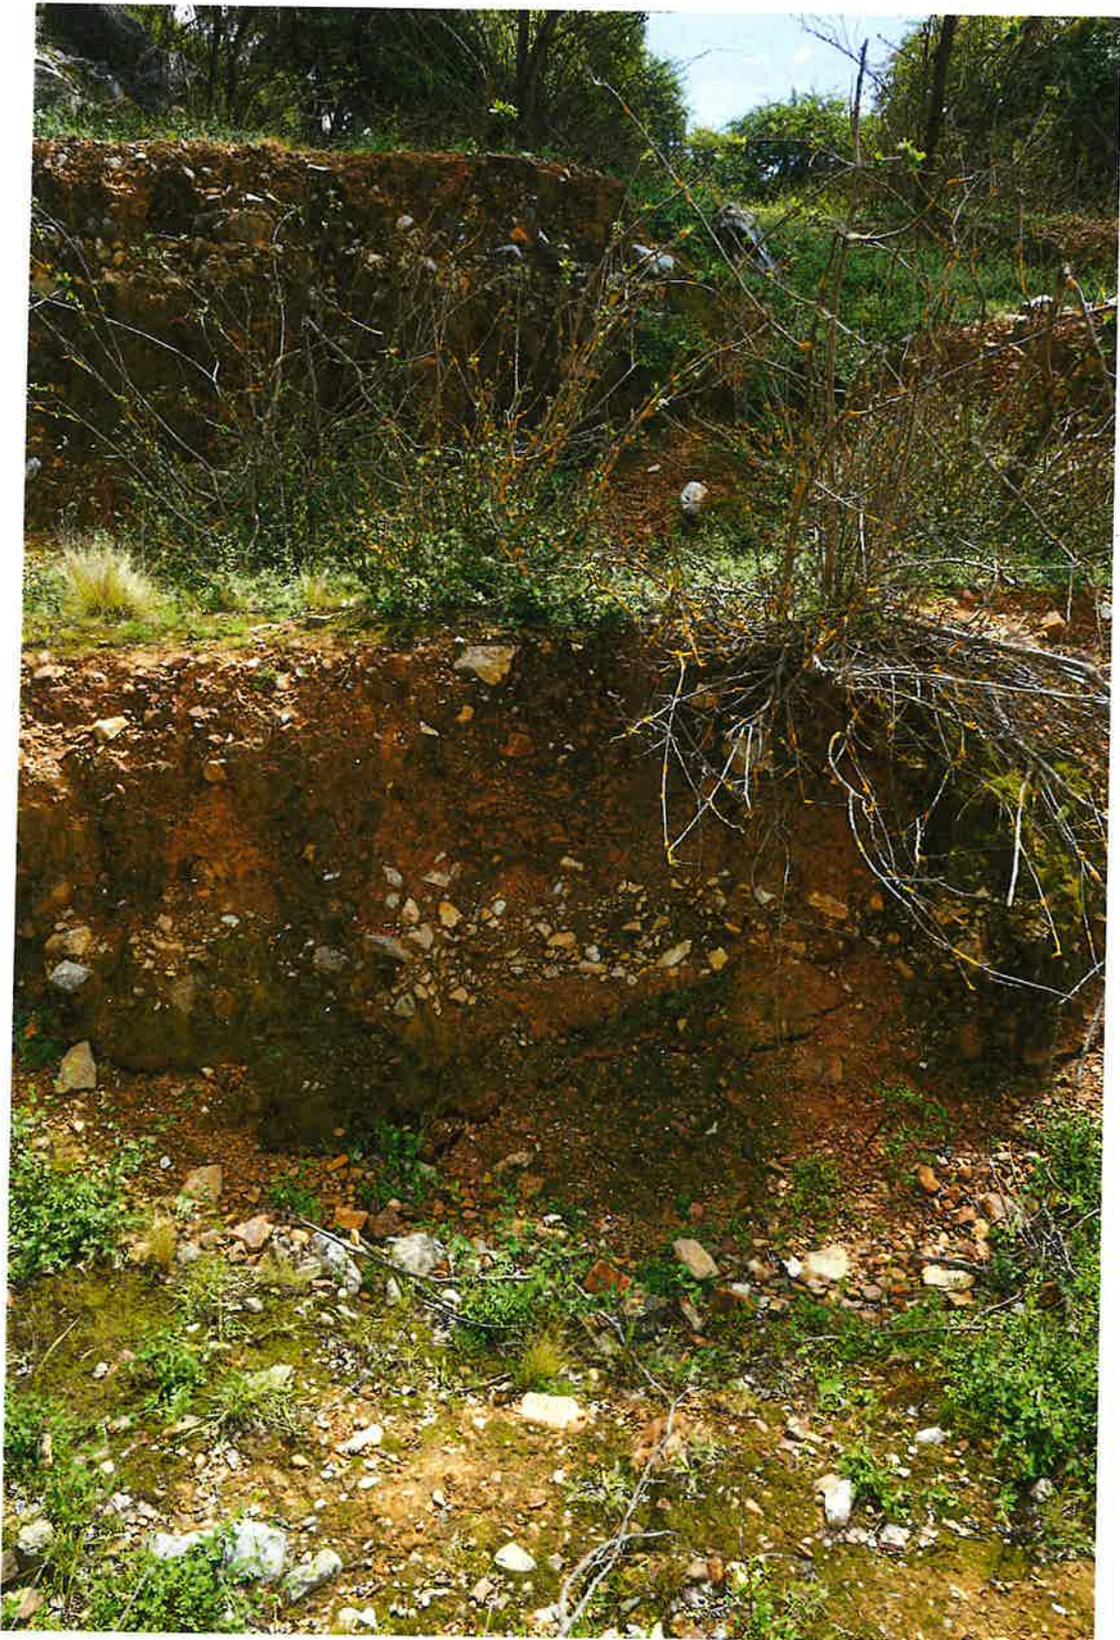
Photo 27: Same view as Photo 26 and note cracking on lower lip indicating recent movement.
