**Dunmore Lakes Sand Project**  
**EPL 11147 Pollution Reduction Program U1**  
**Site Discharge Assessment Progress Report**

**October 2023**

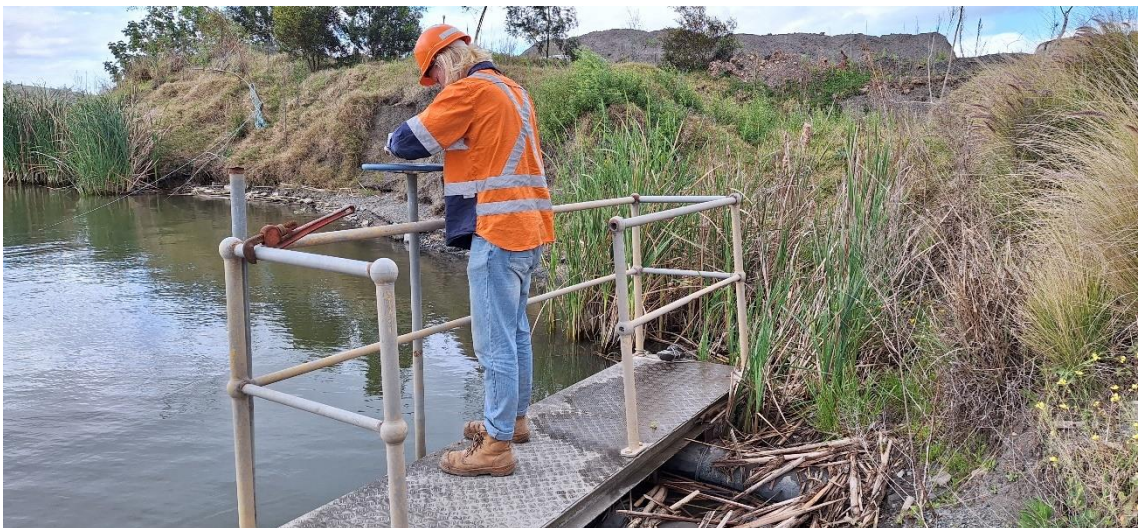
**Plate 1 – Discharge Pipe Butterfly Valve Arrangement**

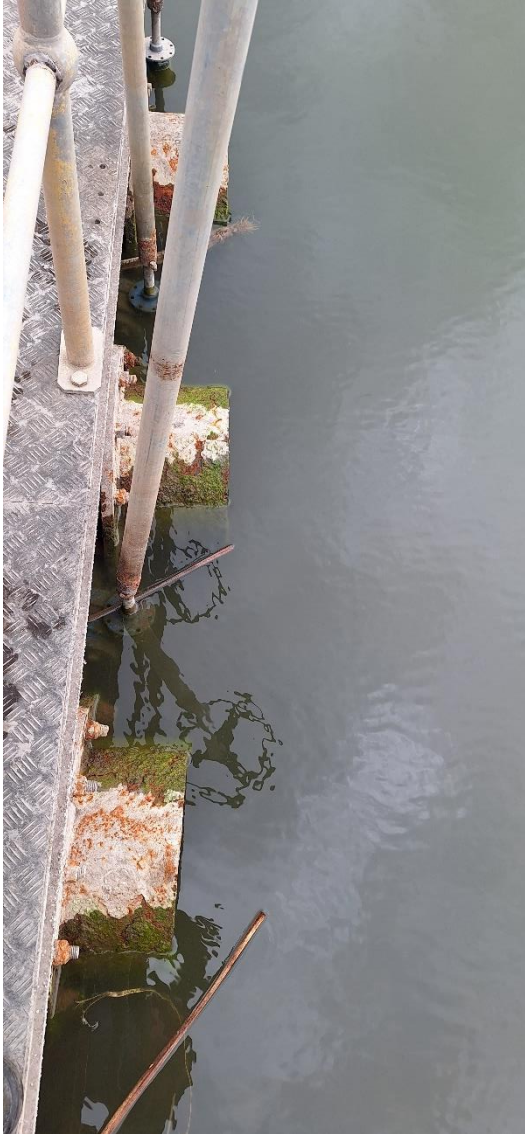
**Plate 2 – Discharge Pipes in with Valves in Closed Position**
