Table 3.1: Boral Cement Berrima - 2016 Annual Noise Assessment - Site Sound Levels for Kiln 6 Upgrade

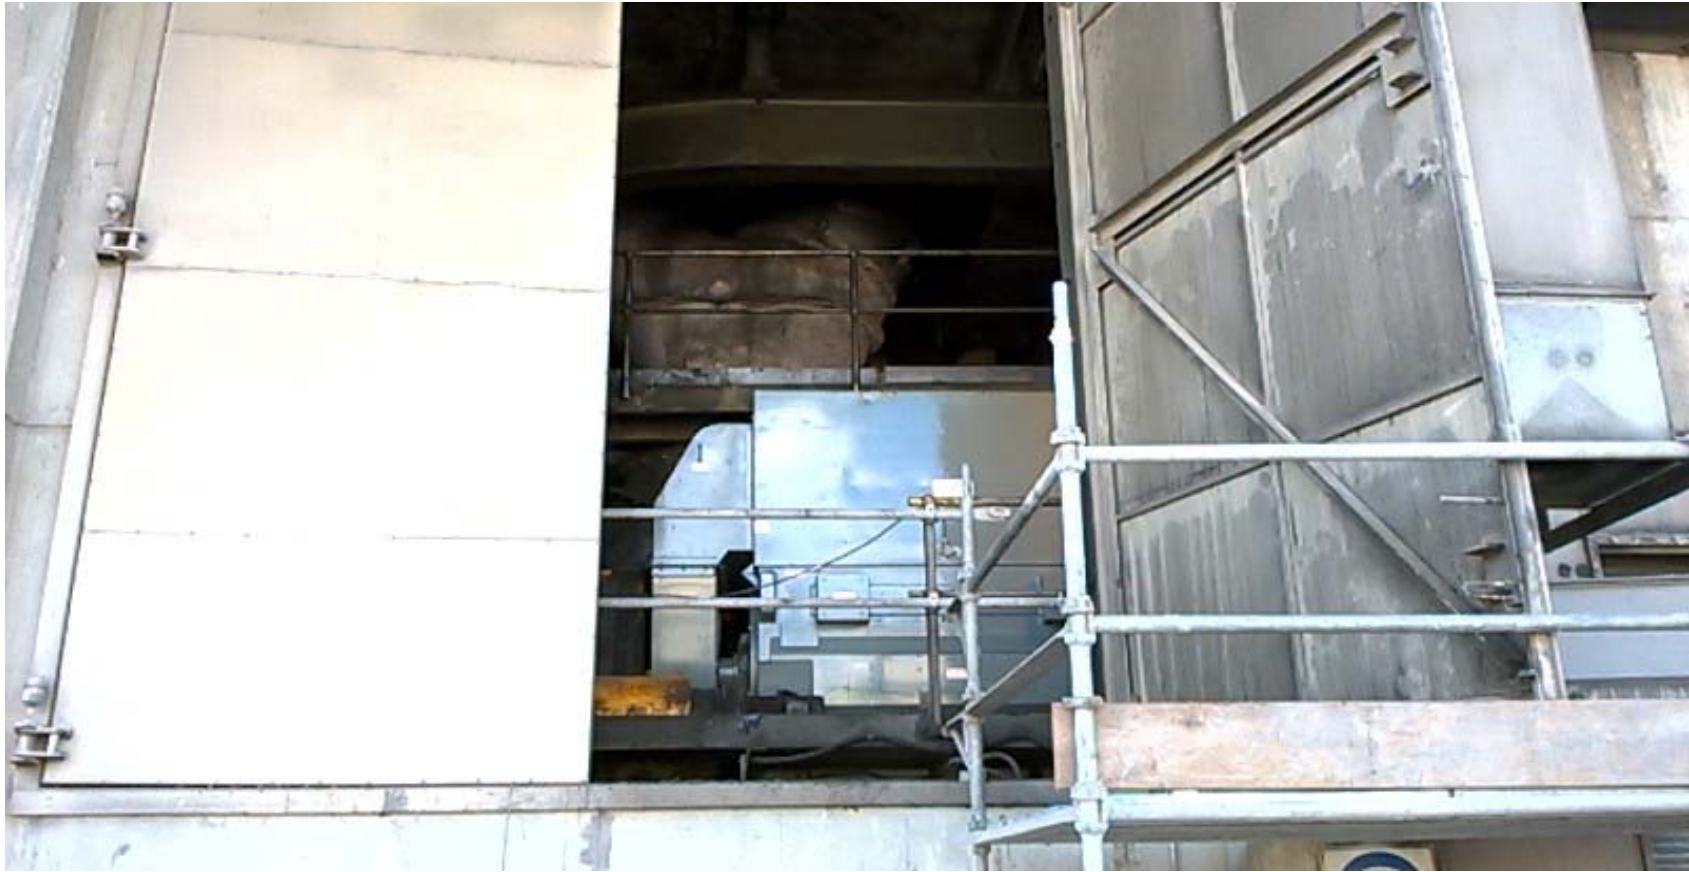
Figure 3.5: Coal Mill fan room door open, southern side of Coal Mill Building

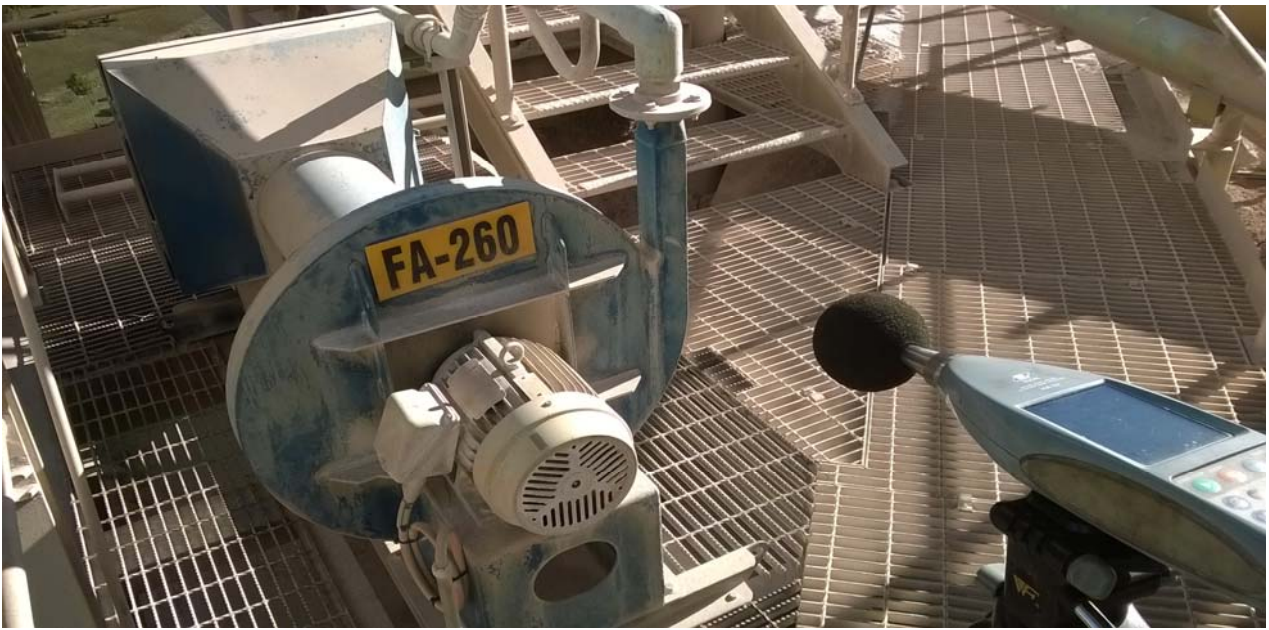
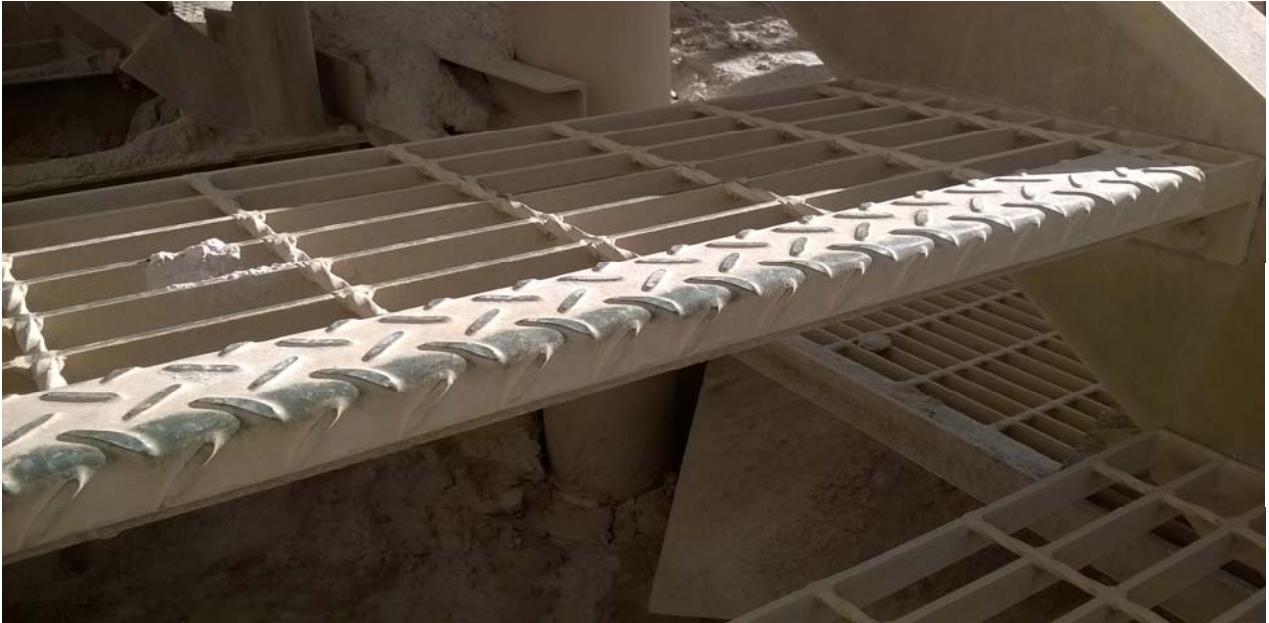
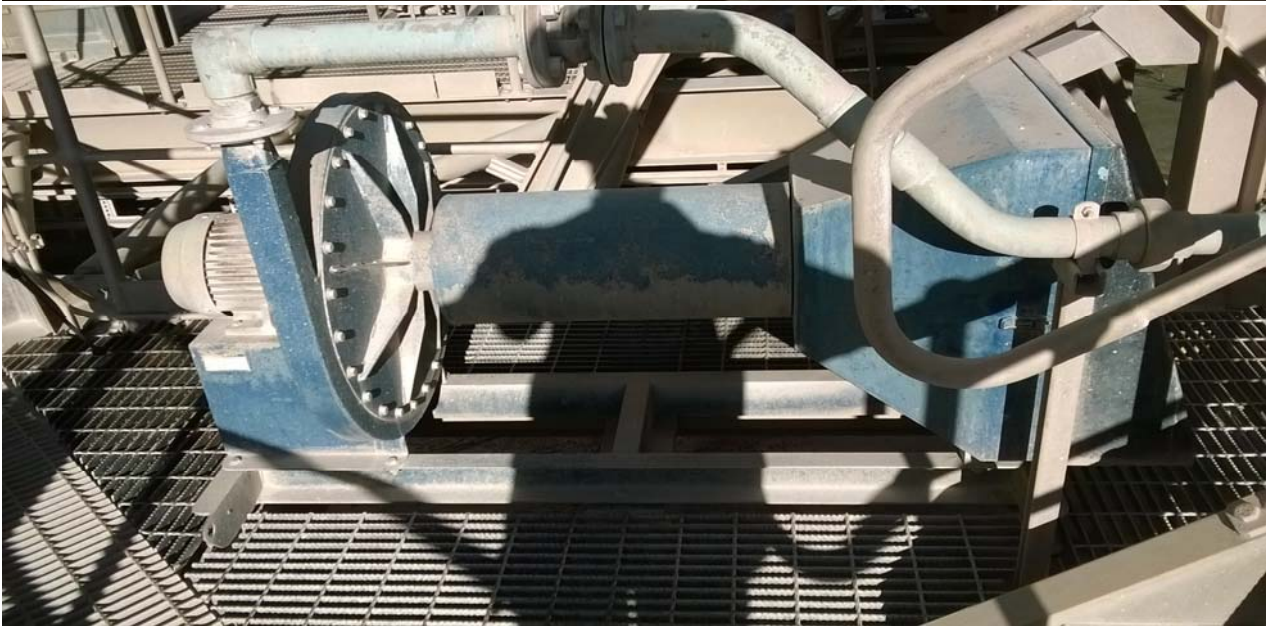
Sound levels on the PHT were similar to or slightly lower than those of the past. The emissions from the top of the Raw Meal silo where baghouse emissions through the roof of the silo occur remain high but were lower than in 2015 (Figure 3.6 shows photos of this area). As noted in 2015, this may be a different location change in condition of the fan or silencer but they are recommended to be reviewed for maintenance condition.

Figure 3.6: Area on top of the Raw Meal Silo Building near FA260 where noise from the baghouse fan below causes elevated sound levels

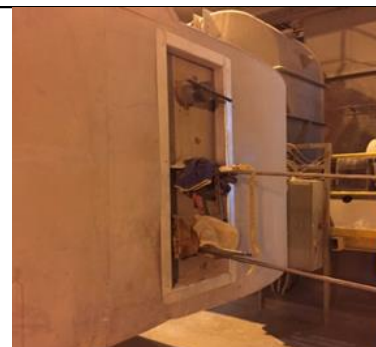
Non-compliant sampling plane; the testing precision will be reduced
 The discharge is assumed to be composed of dry air and moisture

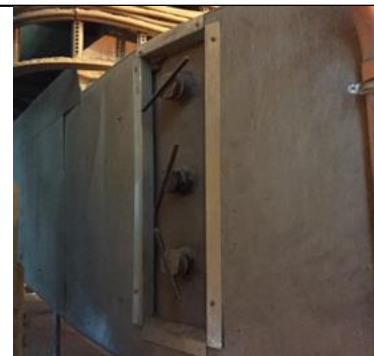
Non-compliant sampling plane; the testing precision will be reduced
The discharge is assumed to be composed of dry air and moisture

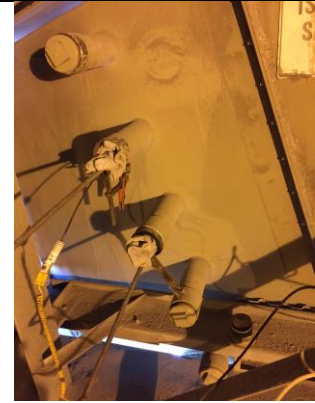
Non-compliant sampling plane; the testing precision will be reduced
The discharge is assumed to be composed of dry air and moisture
