Annex C

Site Inventory

Site Name: Prospect Quarry

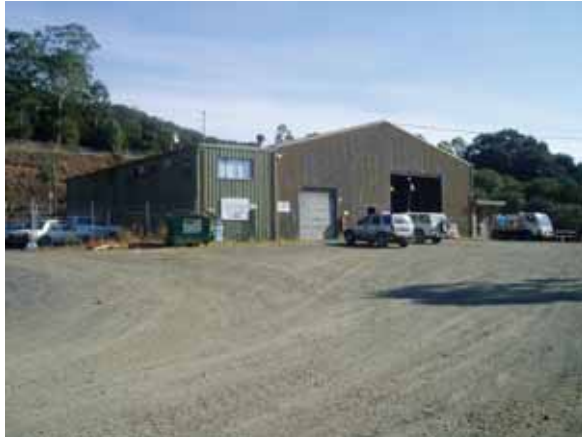
Building/Asset Number	N/A
Building/Asset Name	ACR Shed
Precinct	NW Boundary
Date of construction	c.1970s
Original Use	Workshop and Offices
Current use	Workshop and Offices

The ACR shed is a large profiled metal building with a two storey profiled metal extension to southern elevation. Lean to shelters to Northern elevation. The yard surrounding the shed contains equipment and signage which may have interpretative value.

Demolition of this building is acceptable. Photographs of remnant equipment and machinery could be considered for inclusion in an interpretive display panel together with appropriate documentation.

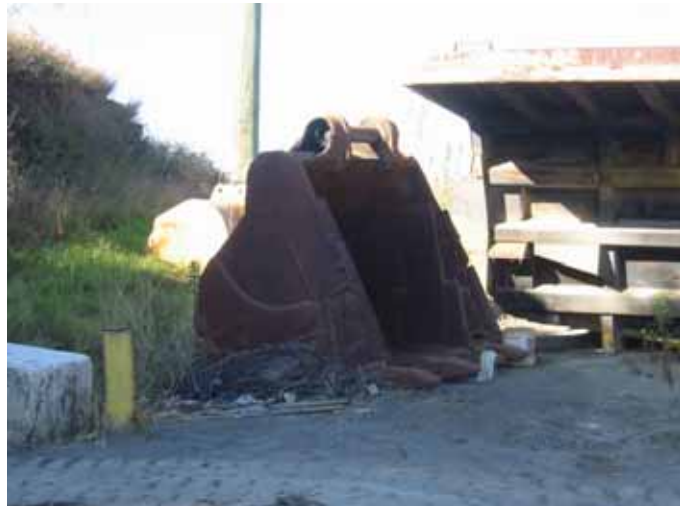
Building/Asset Number	N/A
Building/Asset Name	Excavator Buckets
Precinct	Across the entire quarry
Date of construction	Various
Original Use	Buckets
Current use	Disused

Disused excavator buckets

Has no value as an element of the site interpretation. May be removed from the site.

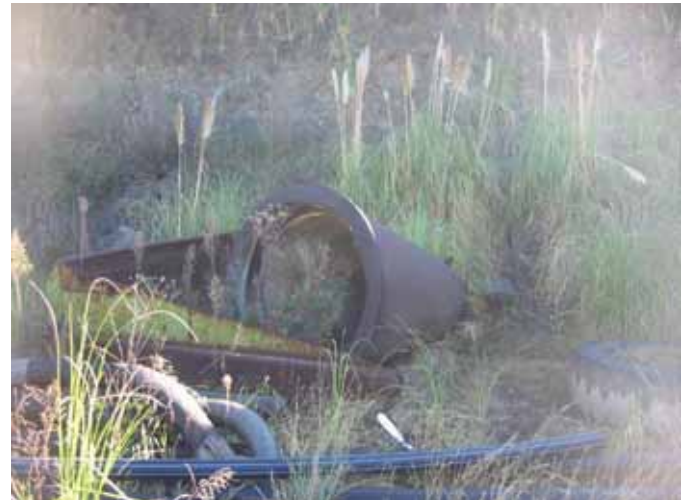
Site Name:	Prospect Quarry
Building/Asset Number	N/A
Building/Asset Name	Cone Crushers
Precinct	South west portion of quarry
Date of construction	Unknown
Original Use	Cone crushers x2
Current use	Disused
Brief description	
Remnant elements associated with a cone crusher, formerly part of the cone crushing plant.	
Development potential	
The Cone Crusher has interpretative potential as an integral element in the quarrying process and could be included in an interpretive display panel that includes photographs of the item, as it is today, adjacent to an image of an 'as original' Cone Crusher with an explanation as to the crushing process. Incorporation of the Cone Crusher into the site interpretation will contribute to informing the local community of the historical development of the quarry.	
Photos

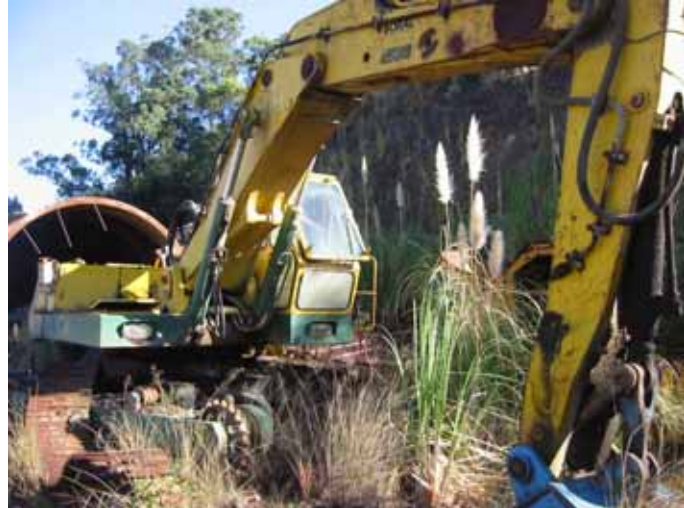
Building/Asset Number	N/A
Building/Asset Name	Excavator
Precinct	South west portion of quarry
Date of construction	Unknown
Original Use	Excavator
Current use	Disused

Disused excavator of likely recent manufacture.

Has no value as an element of the site interpretation. May be removed from the site.

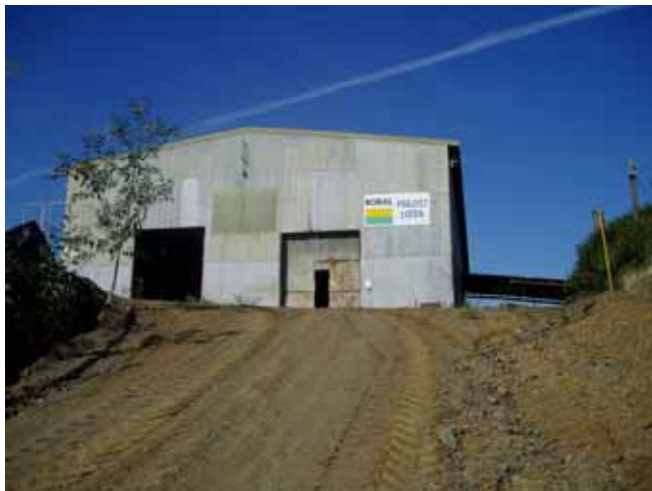
Building/Asset Number	N/A
Building/Asset Name	Licon Building
Precinct	Site Office and Workshop
Date of construction	c.1970's
Original Use	Workshop and warehouse
Current use	Disused

The Licon Building is a large corrugated iron barnlike structure it has two roller doors to front façade and a lean to located to the western elevation. The Licon building is located on a raised ground level surrounded by shrubs.

Boral Plans to demolish this building and remediate the land. Demolition of this building is acceptable.

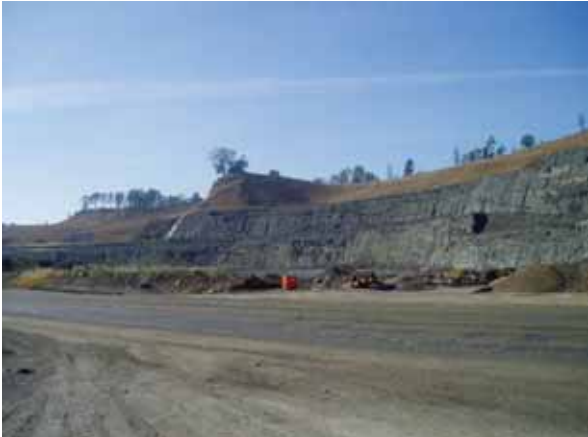
Site Name:	Prospect Quarry
Building/Asset Number	N/A
Building/Asset Name	'One Tree'
Precinct	One tree hill
Date of construction	N/A
Original Use	Remnant of the Greystanes Estate
Current use	N/A
Brief description	
Large Moreton Bay Fig located on the east quarry wall crest.	
Development potential	
The tree has been identified for inclusion into the Nelson's Ridge open space area. It has reached its estimated 150-200 year lifespan for Moreton Bay Figs.	
Photos

A photograph showing a wide, flat, gravel-covered area in the foreground. In the background, there is a steep, rocky quarry wall. A single, large tree is visible on the crest of the quarry wall. The sky is clear and blue.

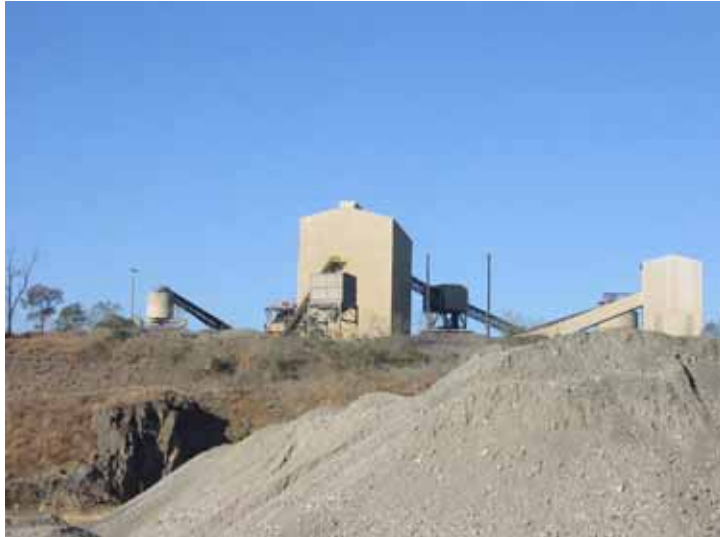
Building/Asset Number	N/A
Building/Asset Name	P2
Precinct	Located in quarry bed
Date of construction	c.1980's
Original Use	Crusher
Current use	Crusher

The P2 crushing plant consists of a large profiled metal building with conveyor belts leading to large storage bins.

The P2 crushing plant has little potential for adaptive reuse. Boral plans to remove this building in December 2006. Demolition of this building is acceptable.

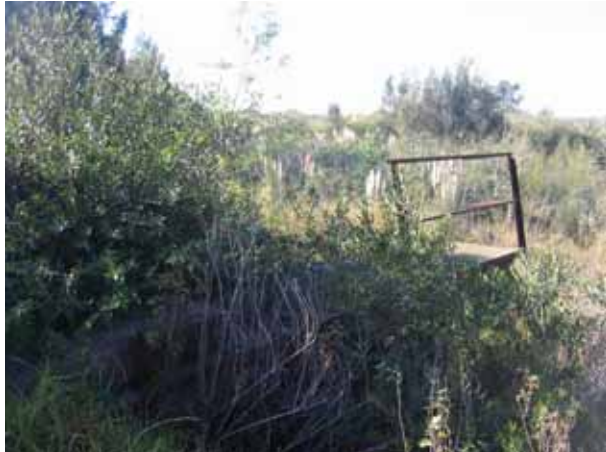
Building/Asset Number	N/A
Building/Asset Name	Platform
Precinct	Widemere
Date of construction	Unknown
Original Use	Platform
Current use	Disused

This platform is a weathered concrete and metal structure currently obscured by vegetation platform that hangs over excavated area in a disused section of quarry.

Has no value as an element of the site interpretation. May be removed from the site.

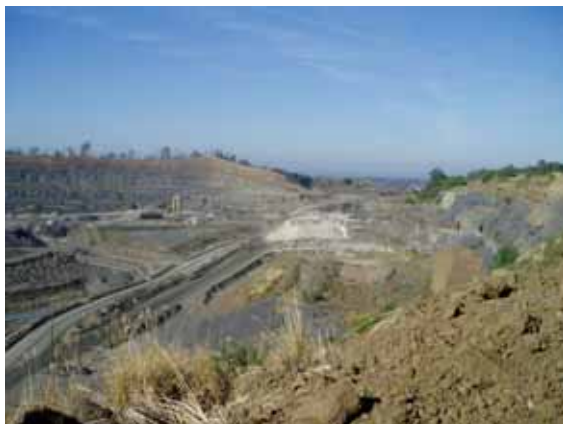
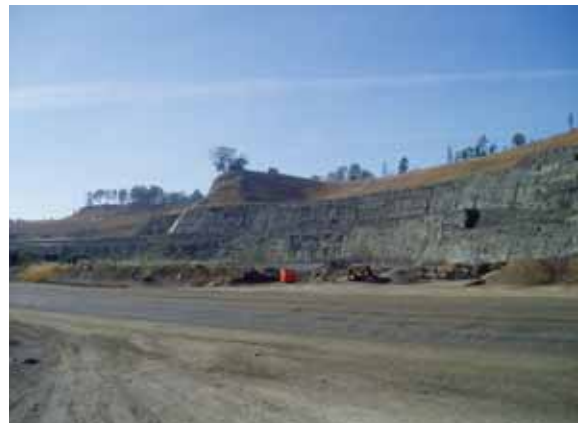
Building/Asset Number	N/A
Building/Asset Name	Quarry Walls
Precinct	Entire Site
Date of construction	Continuous
Original Use	N/A
Current use	N/A

The quarry walls form the boundary of the main Prospect Quarry site. The quarry walls are the exposed natural material and what remains once quarrying has ceased. They are the visually dominant element which clearly demonstrate the former function of the site. The crest of the walls are landscaped and include "One Tree", which dates to the Greystanes Estate.

The walls are currently undergoing rehabilitation in accordance with Boral's safety and rehabilitation standards. The future safety and stability of the walls should be in accordance with the recommendations of a qualified engineer.

The quarry walls and floor are the embodiment of the Boral Quarry Archaeological Site and as such should be retained and conserved. The quarry walls will be retained and provide a backdrop to the future development, demonstrating the industrial history of the site.

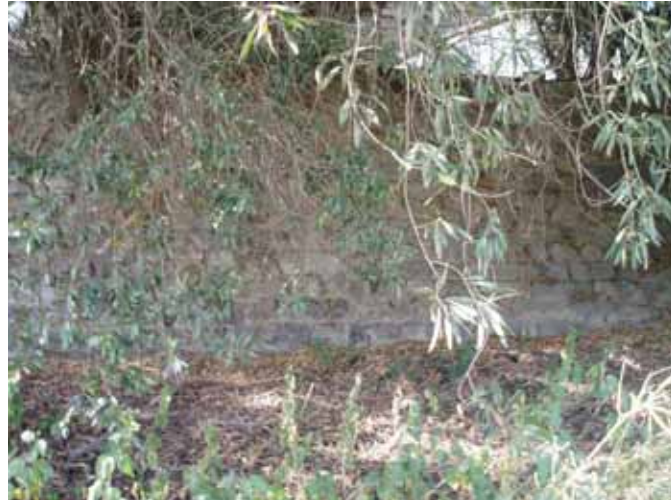
Building/Asset Number	N/A
Building/Asset Name	Railway Embankment
Precinct	Site office and workshop area
Date of construction	1910
Original Use	Railway embankment
Current use	Retaining Wall

Railway embankment of battered masonry retaining wall once part of the former quarry branch line connected to the Prospect line.

The remnant railway embankment represents a particular period in the life of the quarry and as such has historic value that should be included as part of the site interpretation. The alignment of the original branch railway should be identified and marked out, where this is feasible within the proposed development, so that this aspect of the quarry's history is not lost. If not feasible it could be incorporated into an interpretive display panel.

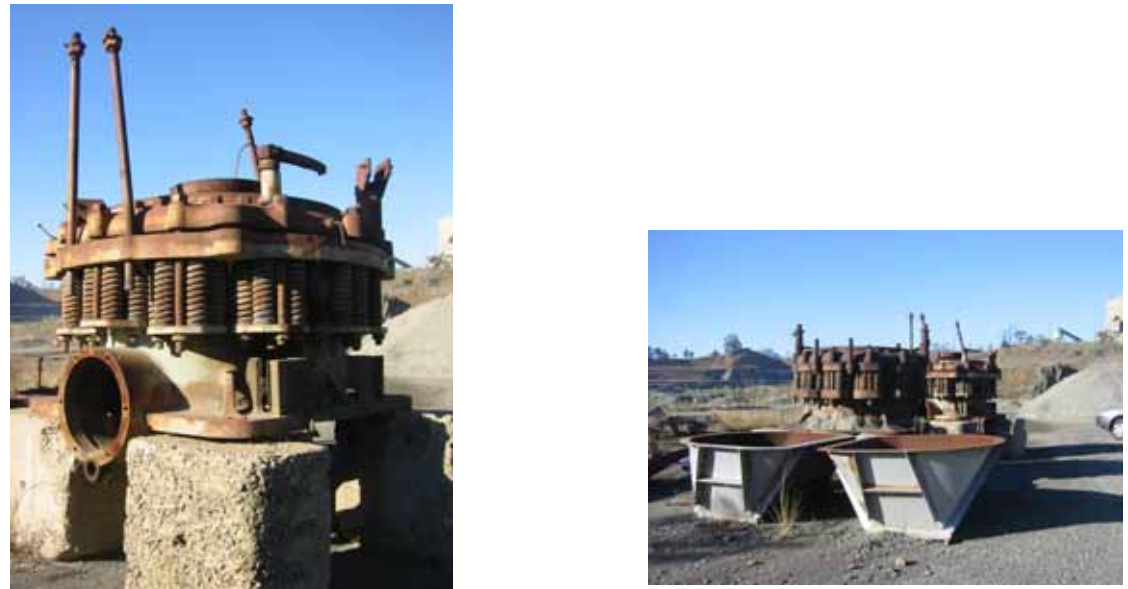
Building/Asset Number	N/A
Building/Asset Name	Short shaft cone crusher
Precinct	Near Site office and workshop
Date of construction	unknown
Original Use	Short shaft cone crusher
Current use	Disused

Brief description
 Component of short shaft cone crusher which originally operated as part of the cone crushing plant.

The short shaft cone crusher has interpretative potential as an integral element in the quarrying process and could be included an interpretive display panel that includes photographs of the item, as it is today, adjacent to an image of an 'as original' short shaft cone crusher with an explanation as to the crushing process. Incorporation of the short shaft cone crusher into the site interpretation will contribute to informing the local community of the historical development of the quarry.

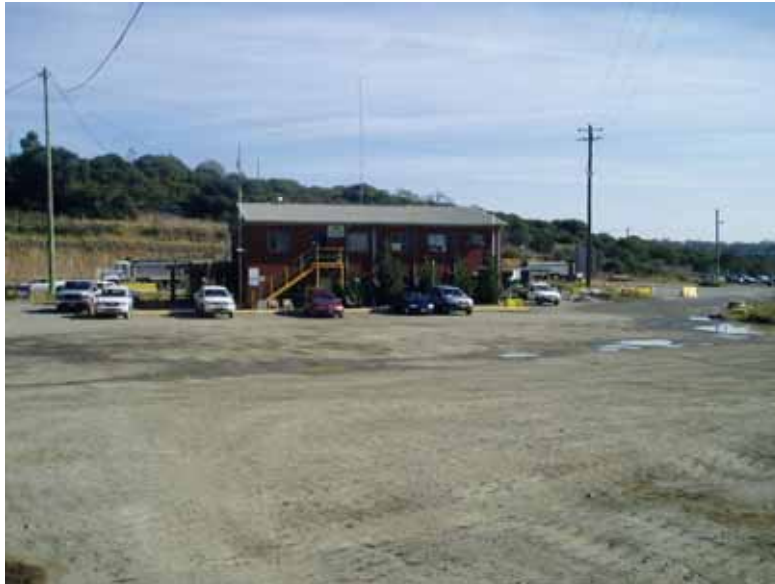
Building/Asset Number	N/A
Building/Asset Name	Site Offices
Precinct	Site Office and Workshop
Date of construction	c. 1970's
Original Use	Site Office
Current use	Site Office

The site office is a two storey red brick building with corrugated iron roof, external metal stairs to office on second floor. First floor houses first aid room and tea room.

Has no value as an element of the site interpretation May be demolished.

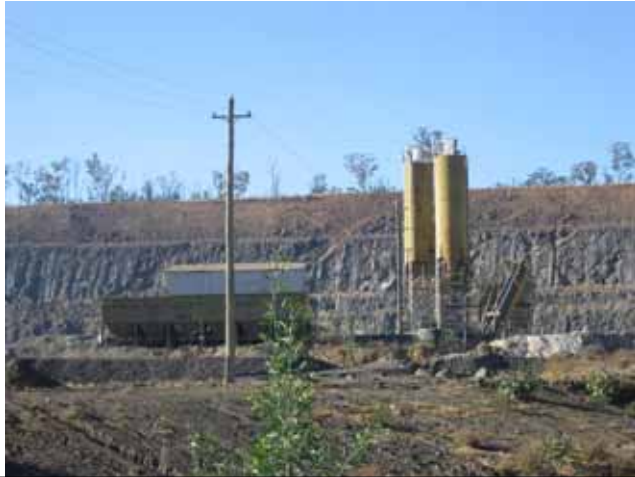
Building/Asset Number	N/A
Building/Asset Name	STAB Plant
Precinct	Located within quarry bed
Date of construction	C.1970's
Original Use	Stabilisation Plant
Current use	Stabilisation Plant

This component of the site consists of three large metal silos connected by conveyor belts to storage bins with hoppers for loading product into trucks

This is considered to have little potential for adaptive reuse. Boral plans to remove this building and remediate the land underneath it. Demolition of this building is acceptable.

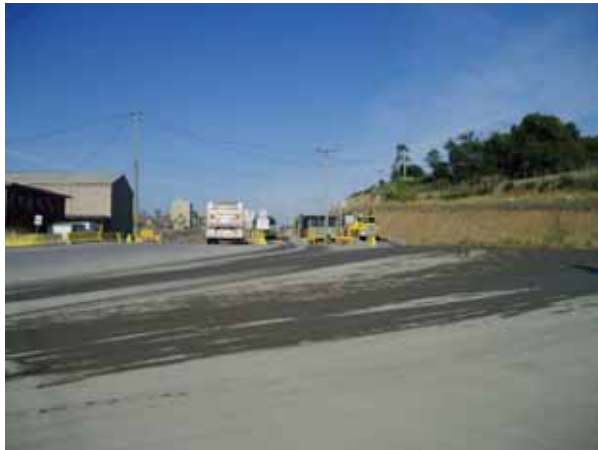
Building/Asset Number	N/A
Building/Asset Name	Weigh Station
Precinct	Site Office and Workshop
Date of construction	C.1990's
Original Use	Weighbridge
Current use	Weighbridge

This structure consists of a metal building located between two raised concrete weighbridges of modern construction.

Has no value as an element of the site interpretation. Demolition of this structure is acceptable.

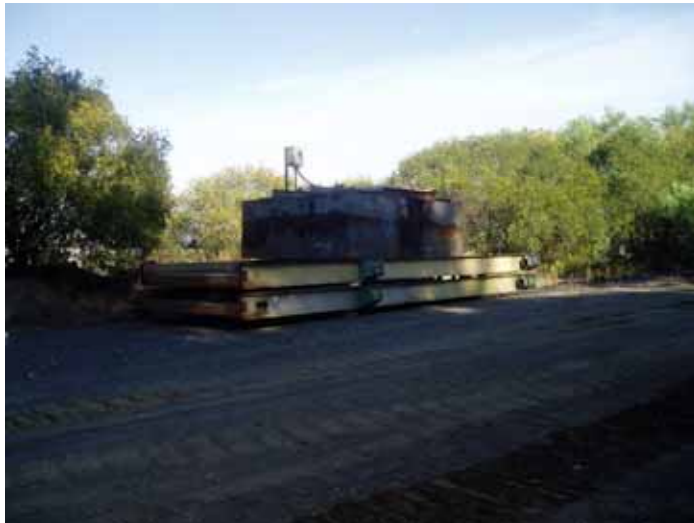
Building/Asset Number	N/A
Building/Asset Name	Weighbridge
Precinct	South west portion of quarry
Date of construction	Modern era
Original Use	Weighbridge
Current use	Disused

Dismantled iron weighbridge, apparently near complete.

Has no value as an element of the site interpretation. May be removed from the site.

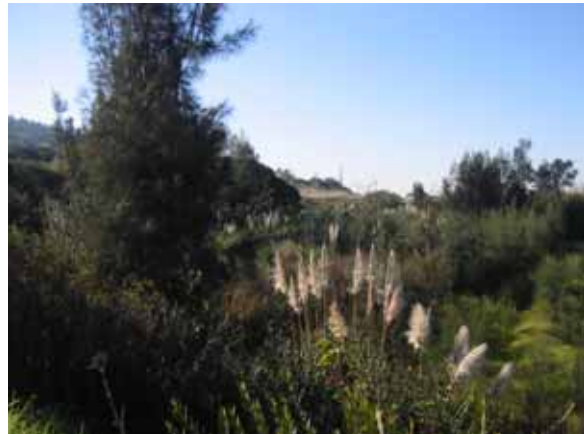
Building/Asset Number	N/A
Building/Asset Name	Widemere East
Precinct	Widemere East
Date of construction	Unknown
Original Use	Quarry and open area
Current use	Car parking are and disused

Widemere Quarry is located to the south of the main Prospect Quarry and has been partially excavated. The unexcavated portion is a mix of overgrown greenfield site and an extensive gravel car park area.

This portion of the site has been identified for subdivision and development. The historical background indicates that this area has been used for agricultural purposes since settlement of the area; however, past studies have not identified this area as having archaeological research potential.

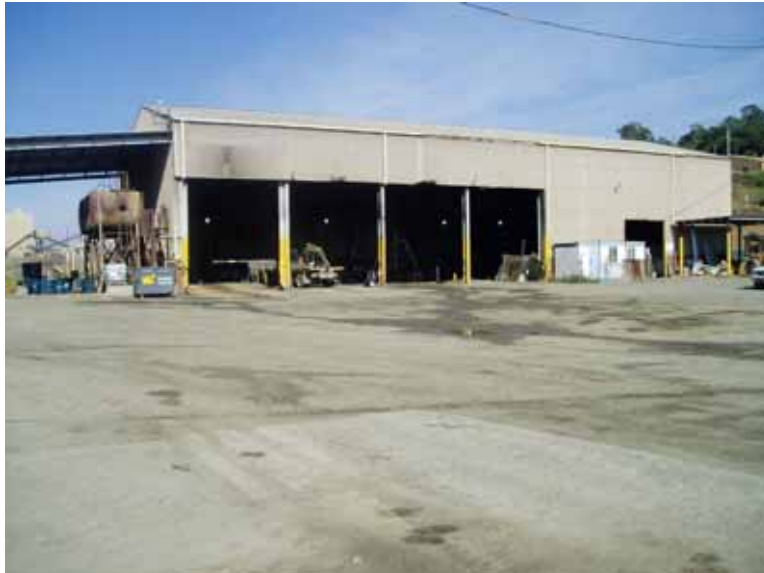
Building/Asset Number	N/A
Building/Asset Name	Workshop
Precinct	Site Office and Workshop
Date of construction	Unknown
Original Use	Workshop
Current use	Workshop

This building is in the form of a large barn. It is constructed of profiled metal and has several lean to additions the largest of which is located at the eastern elevation. This workshop building is not considered to be unusual or unique.

Has no value as an element of the site interpretation. Demolition of this building is acceptable.
