Dunmore Hard Rock Quarry Annual Review

1 July 2022 – 30 June 2023

Dunmore Hard Rock Quarry Annual Review Title Block

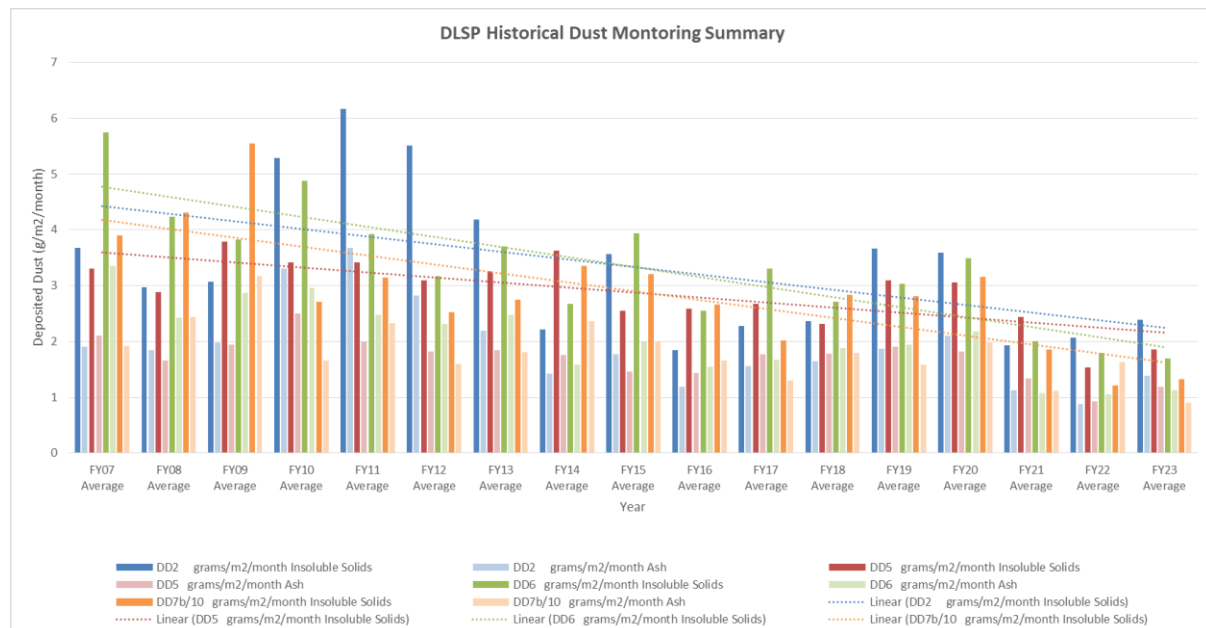
Figure 8 Historical Dust Monitoring Data

The DQ site has been collecting deposited dust data since 2002. A graph of long-term trends can be found in Figure 8 below and shows that deposited dust has typically decreased over time.

A general trend that has been observed is that measured deposited dust is typically higher in dry summer months than winter months, which is to be expected. This trend is also confirmed with the PM₁₀ measurements and is generally reflective of regional conditions as a whole.

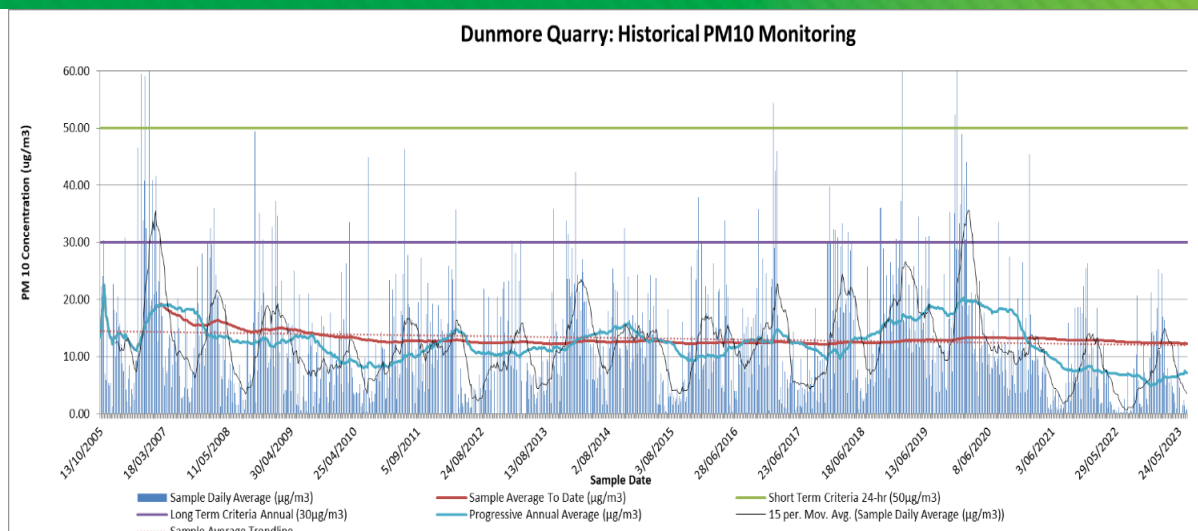
Figure 9 Historical PM₁₀ Monitoring Data

Figure 9 shows a 90 day average in black, which illustrates a seasonal fluctuation of measured PM₁₀ values. A trend can be observed that PM₁₀ values are typically higher during summer dry periods and are lower during the winter periods.

These trends indicate the measured PM₁₀ and deposited dust values are typically influenced by ambient local conditions rather than development operations at DLSP.

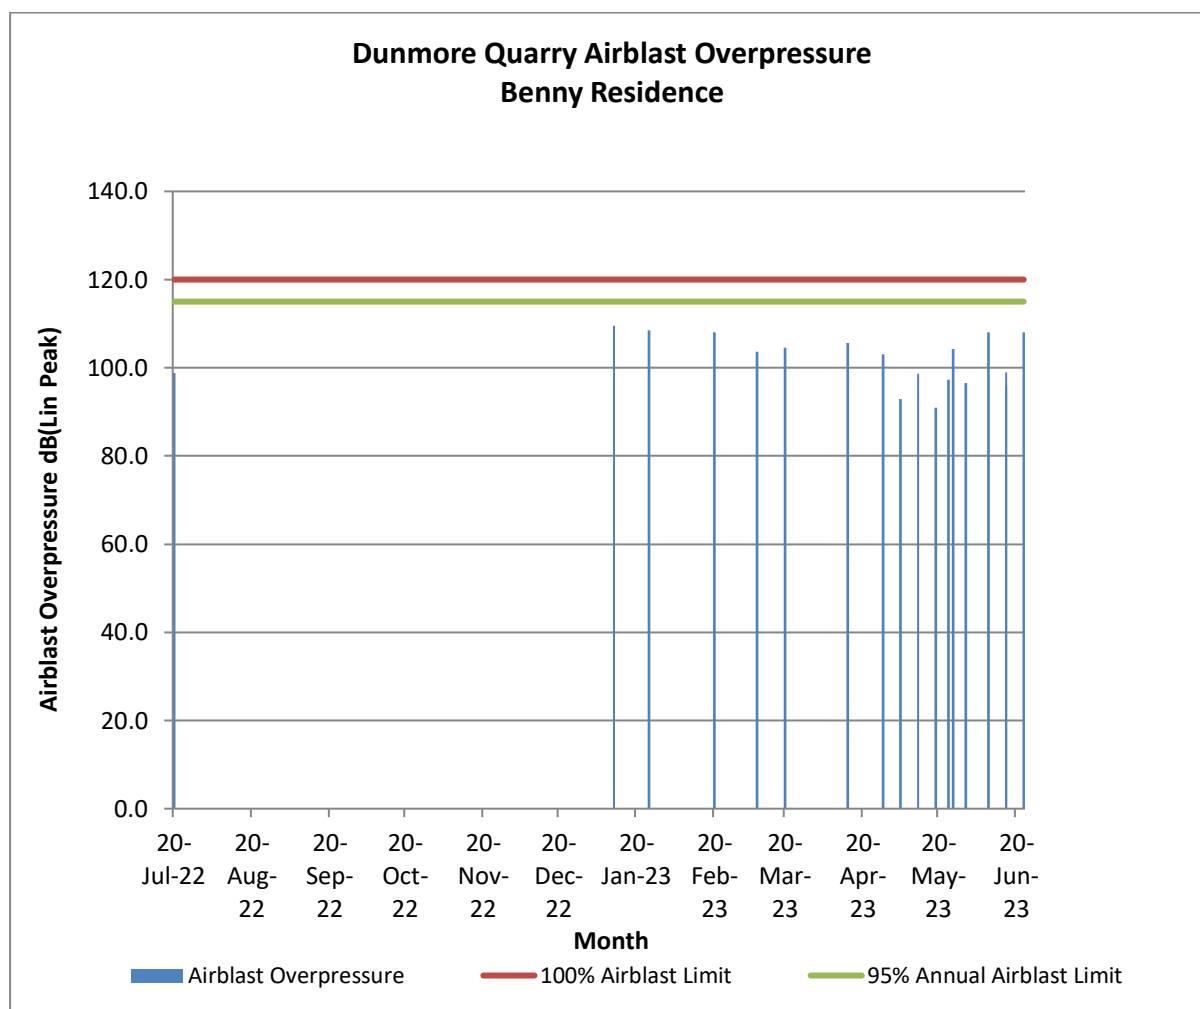
Figure 11 FY23 Overpressure Data

Figure 11 and Figure 12 details a visual representation of the blast monitoring in FY23. A number of blasts did not trigger, and therefore aren't represented in the figures below. The data table associated with these can be found in Appendix D.

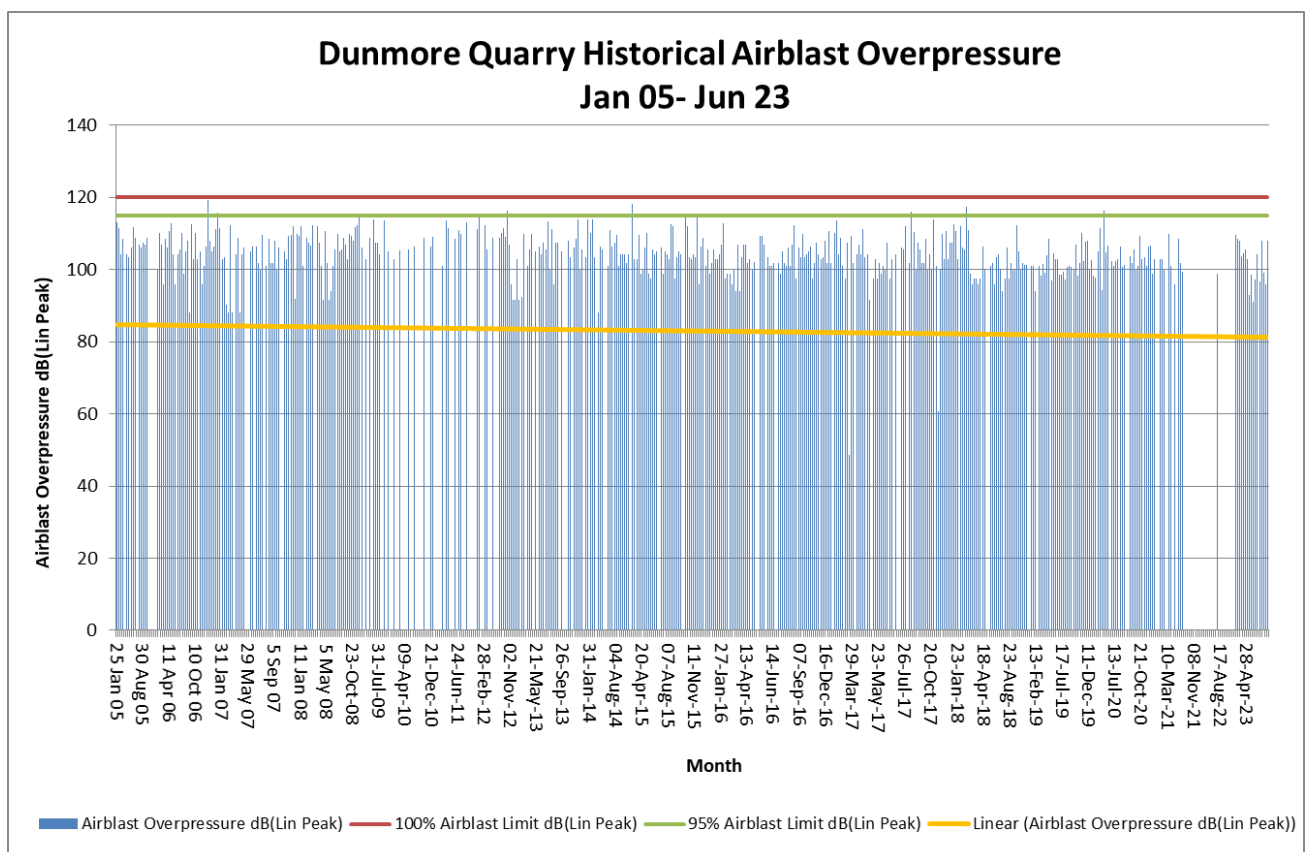
Figure 13 Historical Overpressure Data

A visual representation of historical blast monitoring data can be seen below in Figures 13 and 14.

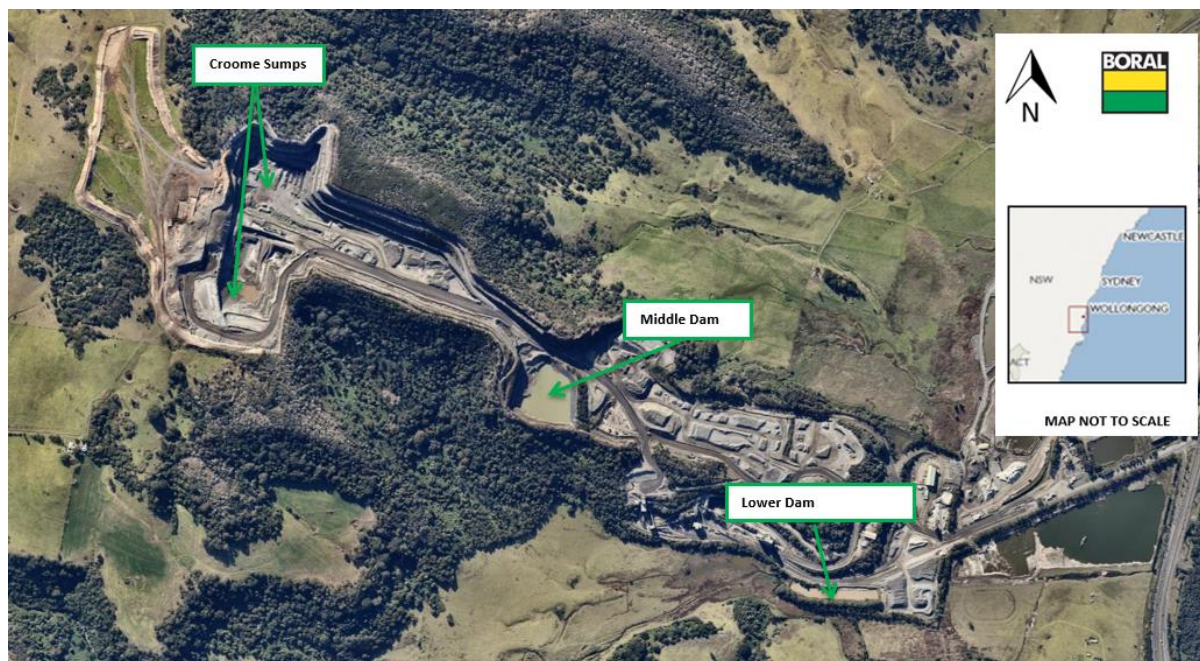
Figure 27 Water Storage Locations

All process water was sourced by either the Lower Dam, Middle Dam or Croome Sumps, which are offline from Rocklow Creek as per water management upgrades undertaken in 2008 under MOD 4. The Location of water storage infrastructure is shown below in Figure 27.

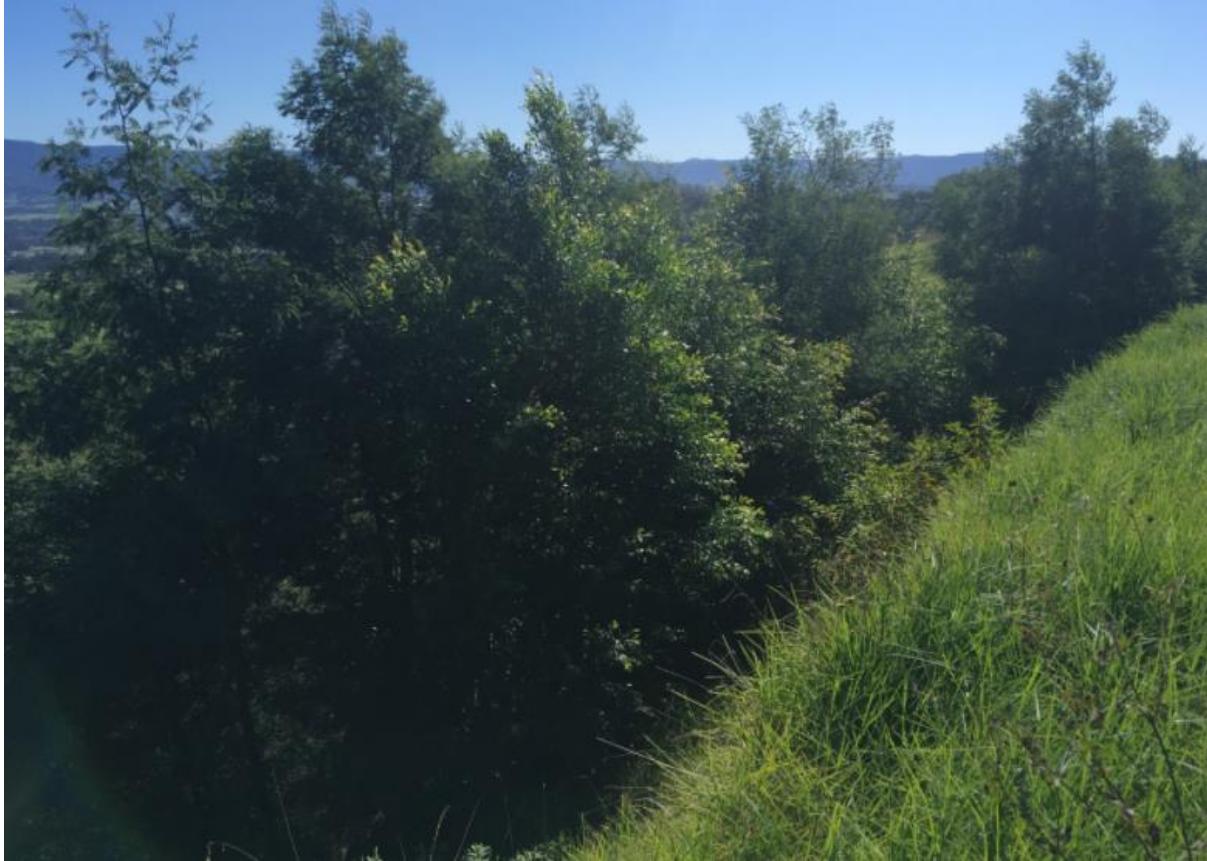
Most areas of the site are currently operational and as such rehabilitation is not able to commence on the majority of areas within the quarry until the completion of extraction activities. When practical, progressive rehabilitation of the site will be undertaken in conjunction with on-going quarrying works. Hydroseeding of the Croome West Bund is now well established with trees as shown below in Figure 30.

Figure 30 Hydroseeding cover and trees over Croome West Bund
