Dunmore Hard Rock Quarry Annual Review

1 July 2023 – 30 June 2024

Name of operation	Boral Dunmore Hard Rock Quarry
Name of operator	Boral Resources (NSW) Pty Ltd
Development consent	DA-470-11-2003
Name of holder of development consent	Boral Resources (NSW) Pty Ltd
Water licence number	WAL#25152 Ref# 10AL103610
Name of holder of water licence	Boral Resources (NSW) Pty Ltd
Name of holder of EPL	Boral Resources (NSW) Pty Ltd
Annual Review start date	1 July 2023
Annual Review end date	30 June 2024
<p>I, Brodie Bolton, certify that this audit is a true and accurate record of the compliance statuses of the Dunmore Hard Rock Quarry for the period of the 2024 Financial Year and that I am authorised to make this statement on behalf of Boral Resources (NSW) Pty Ltd.</p>	
<p>Note</p> <p>The annual review is an 'environmental audit' for the purposes of section 122B(2) of the Environmental Planning and Assessment Act 1979. Section 122E provides that a person must not include false or misleading information (or provide information for inclusion in) an audit report produced to the Minister in connection with an environmental audit if the person knows that the information is false or misleading

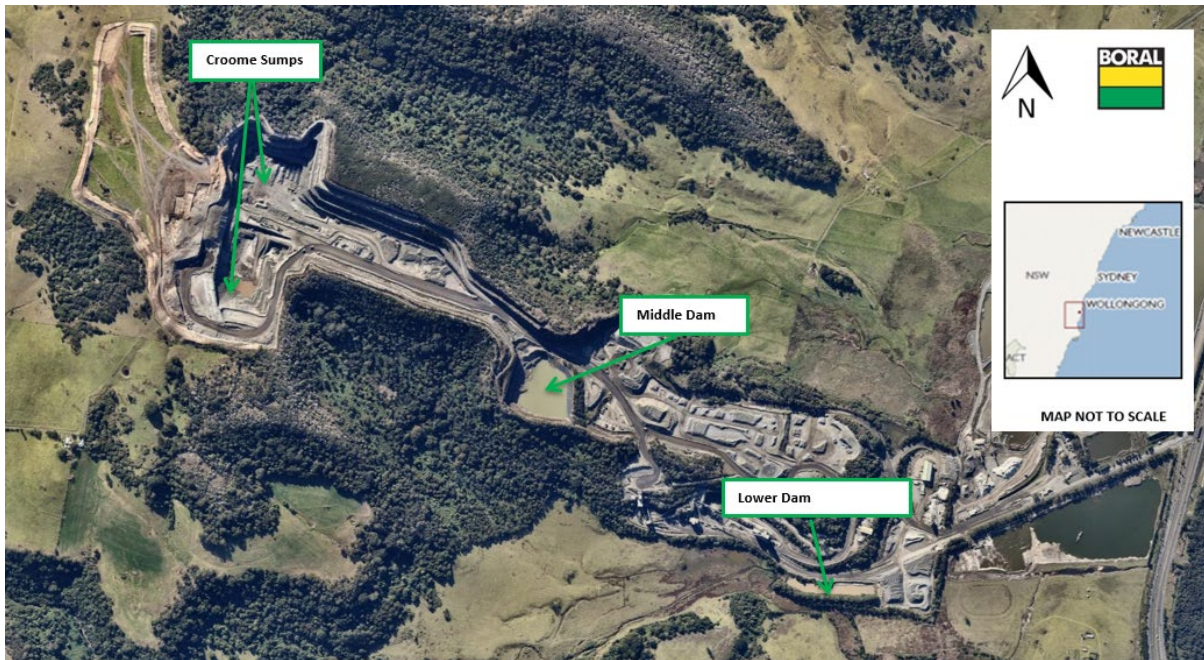
Figure 27 Water Storage Locations

All process water was sourced by either the Lower Dam, Middle Dam or Croome Sumps, which are offline from Rocklow Creek as per water management upgrades undertaken in 2008 under MOD 4. The Location of water storage infrastructure is shown below in Figure 27.

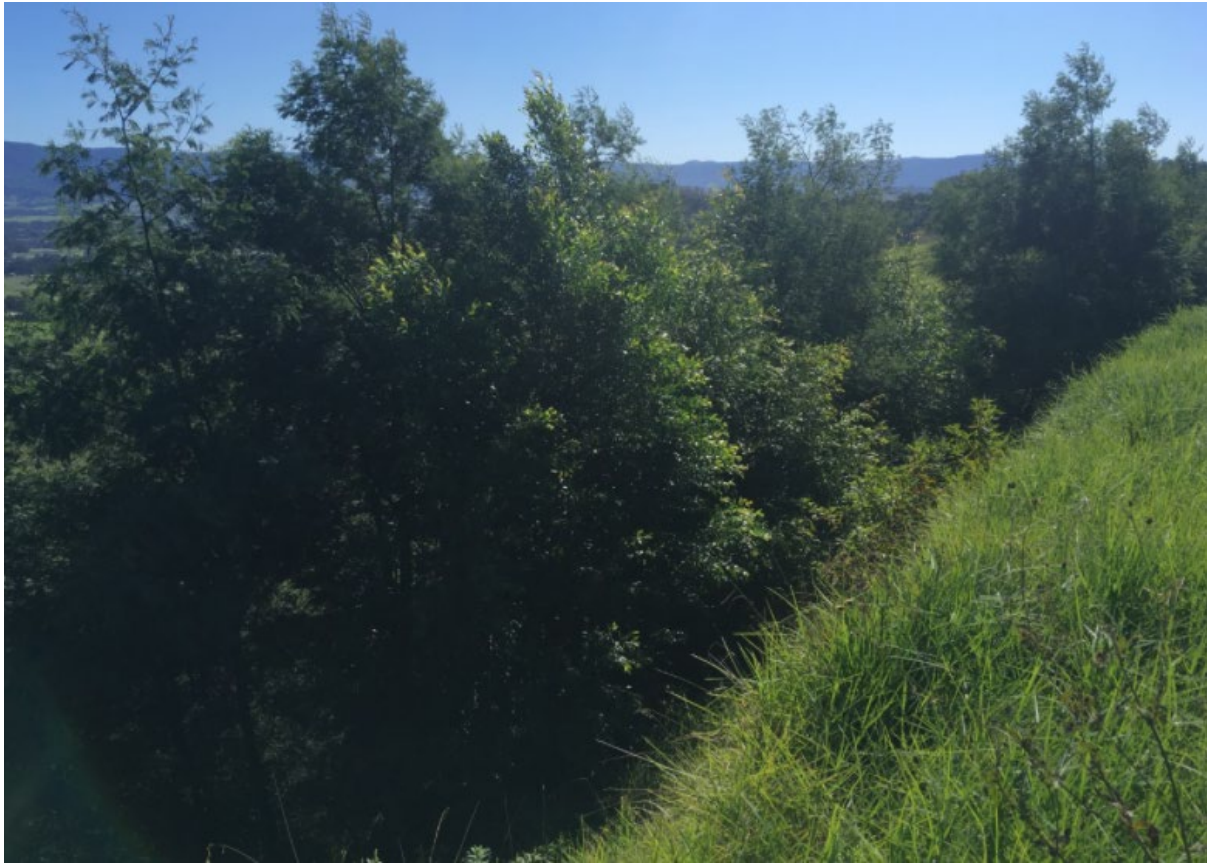
Figure 30 Hydroseeding cover and trees over Croome West Bund

Most areas of the site are currently operational and as such rehabilitation is not able to commence on the majority of areas within the quarry until the completion of extraction activities. When practical, progressive rehabilitation of the site will be undertaken in conjunction with on-going quarrying works. Hydroseeding of the Croome West Bund is now well established with trees as shown below in Figure 30.
