Annual Review

Marulan South Limestone Mine Continued Operations Project Boral Cement Limited

This Annual Review has been prepared in accordance with Condition D11 of SSD 7009 and covers the operation over the 2024-2025 period. This review has been structured in accordance with the Department of Planning and Environment guidelines for the preparation of Annual Reviews.

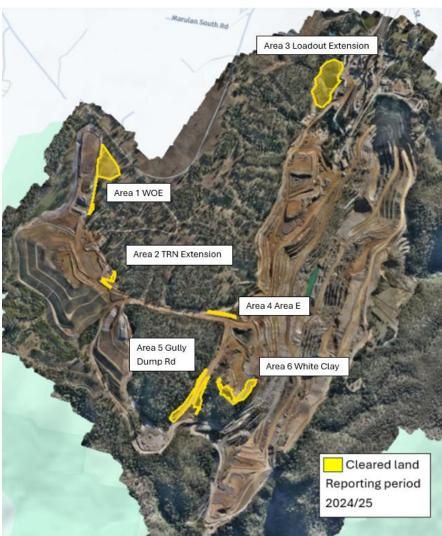
Plate 1- Vegetation Cleared in reporting period 2024-2025.

A combined total of 12.35 hectares were cleared; shown on Plate 1 below during the 2024/2025 reporting period.

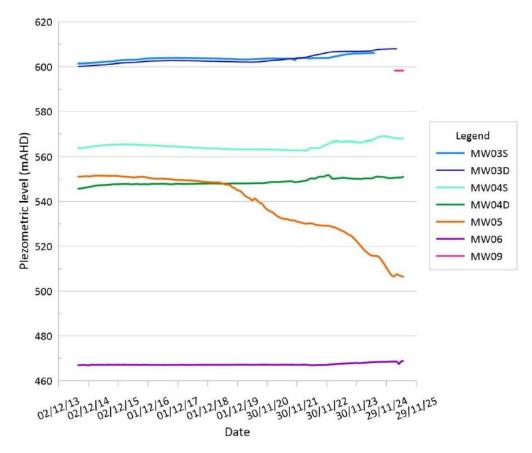
Graph 7.10 – Average Monthly Groundwater Levels from Monitoring Bores

The standing water level in monitoring bore MW05 presents a gradual decline from March 2017 until May 2019, plateaued for 18 months from 2021-2022 and has accelerated again until present. It is becoming clear that MW05 has been impacted by the mine extraction. The decrease in standing water level observed at MW05 was expected based on groundwater modelling predictions of pit development. It is believed that the rapid decline was a result of the removal of the cross-cutting dolerite dyke in the North Pit which appeared to be 'damming' groundwater up-dip. Since the water level of this bore is artificially high (perched) it is also not reflective of the impact the quarry is having on regional groundwater levels. MW03 and MW04 are more accurate representations of the surrounding granite groundwater systems which have not as yet been impacted by the limestone removal within the mine. Graph 7.10 below shows that bore levels as monitored since 2014.

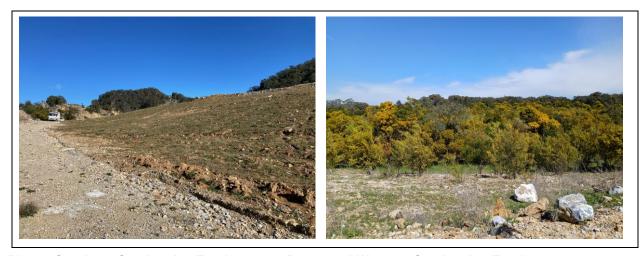
Plate 3 Southern Overburden Emplacement Batter and Western Overburden Emplacement Rehabilitation

During the reporting period a portion of the lower batter of the Southern Emplacement rehabilitation batters was shaped, topsoiled, groundcover established through seedbank in the topsoil and tubestock planted (Image 1 of Plate 3). The tubestock that was planted had specialised fertiliser applied and companion planting in a wire protective cage to prevent grazing and promote survival rate with an aim to better understand factors that affect the success of tubestock planting.

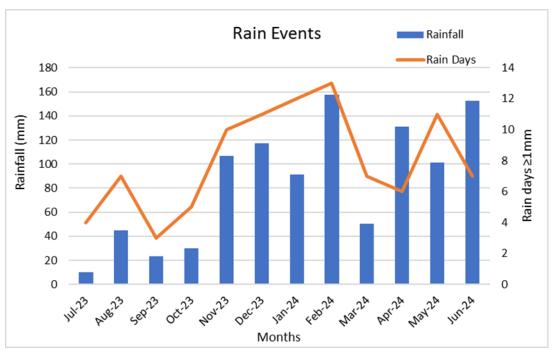
Graph 1.1- Monthly rainfall and number of rain days

A total of 1016.6mm of rainfall with 96 rain days was recorded at the site weather station during the financial year. This was lower than the previous reporting period that recorded 1614mm with 149 rain days, but higher than the annual average with intense storm events. Rainfall was highest during February 2024 with 157.4mm and was the lowest in July 2023 with 10mm. The number of rain days ranged from 3-13 days per month.

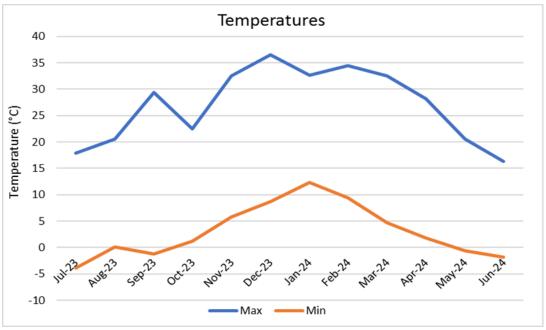
Graph 1.2– Monthly Minimum and Maximum Temperatures

Temperatures were hottest in summer months with the highest maximum of 36.5°C in December 2023 and were coldest during the winter months with a lowest minimum of -3.9°C in July 2023 (Graph 1.2). Frosts are common in the June to July period. The average maximum and minimum temperatures for the financial year were 27°C and 3.0°C respectively, which were higher maximums and minimums than recorded in the previous period.

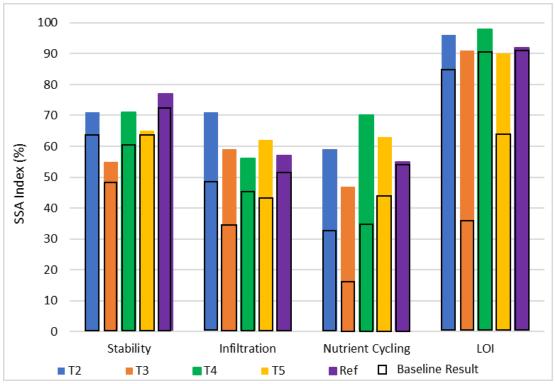
Graph 2.1- Soil Surface Assessment Index (%) Baseline result= July 2020 (April 21 for T5)

The LOI is a good indication of vegetation cover and is related to the SSA parameters. The proportion of bare ground is now negligible at all sites due to increased native ground cover, annual weed growth and increase leaf litter. Although improvements have been observed, it is recommended that the LOI is improved a little more to reach a similar score to the reference site. This can be done by minimising the proportion of bare ground on the site by increasing vegetation cover through planting and seeding methods.

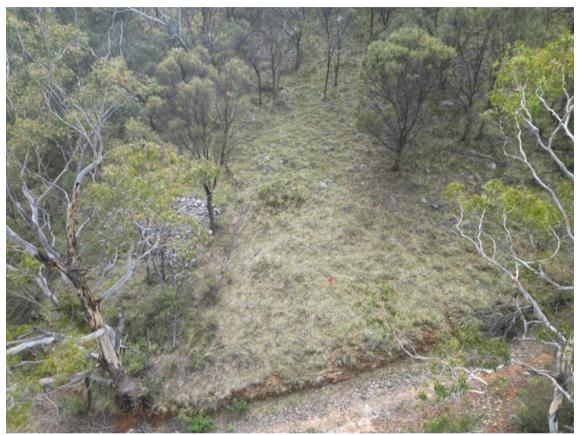
Plate 2- RVA2 Aerial view

RVA2 is located near the Maggie Dump area, towards the southern end of the site. This area is also classed at 'remnant vegetation'. Its coordinates are S34°47'15.31" E150°1'7.52". Unlike other areas of the mine, this site is scattered with Xanthorrhoea, a native grasstree. An aerial view of the RVA2 site is pictured below in Plate 2.

An old track runs through the site and there is a large pile of rock which has been dumped. There was no presence of feral animals, mine rubbish, fire disturbance or erosion. Weed presence was approximately 25% which is mostly *Nassella trichotoma* which is considered a high threat weed.

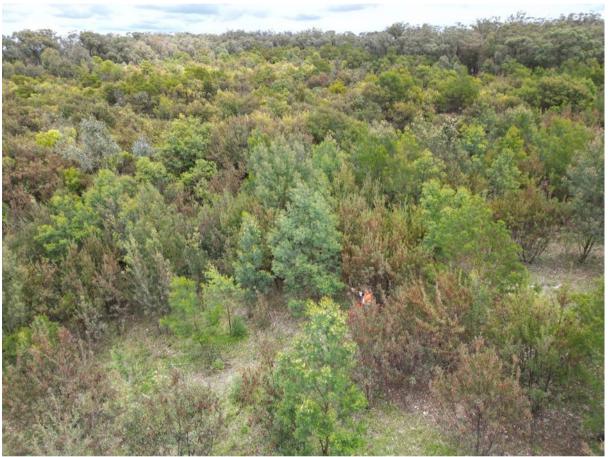
Plate 3- RVA3 Aerial View

RVA 3 is located on a previously rehabilitated site which is labelled as Site 5 in the Ecosystem Function Analysis monitoring program. This site is located on the first bench of the western overburden emplacement and was first rehabilitated in January 2019, at coordinates S34°46'42.41" E150°0'36.77". The site is dominated by acacias which are naturally regenerating. An aerial view of the RVA3 site is pictured below in Plate 3.

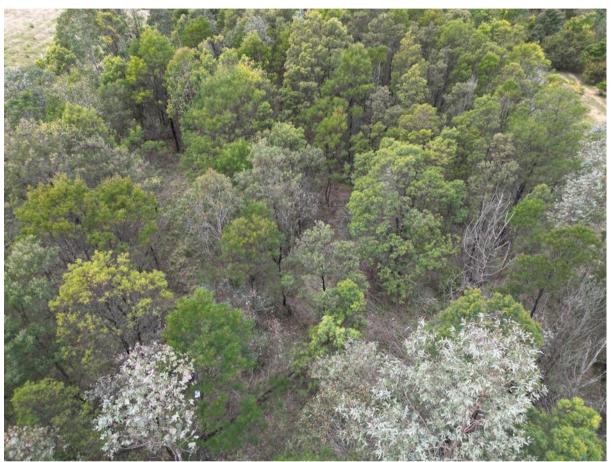
Plate 4- RVA4 Aerial View

RVA4 is located immediately south of the WOE, situated directly below the active rehabilitation areas. Its coordinates are S34°46'49.86" E150°0'40.27". Rehabilitation of this site was first conducted in 2005. The vegetation can now be described as a monoculture of *Acacia mearnsii* which appear to be heading toward the end of their lifespan, and some older trees had fallen over. There is a scatter of younger Eucalypts emerging. An aerial view of the RVA4 site is pictured below in Plate 4.

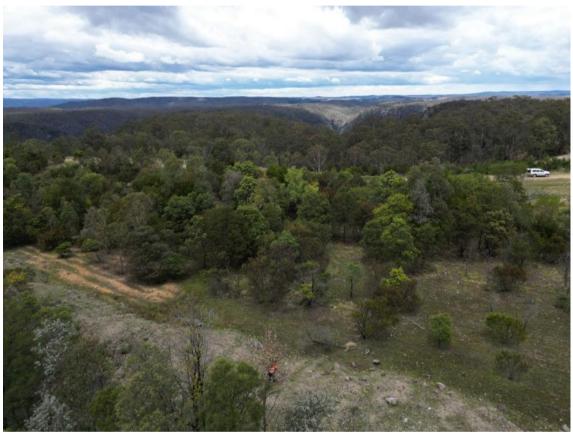
Plate 5- RVA5 Aerial View

RVA5 is positioned on a bank at the far south of the WOE, adjacent to the native woodlands. Its coordinates are S34°46'53.03" E150°0'36.50". This site is representative of the rehabilitation conducted on the western overburden emplacement in February 2017. Revegetation was done by direct seeding. Bundles of large fallen logs, bark and other organic material classed as "Salvaged Habitat" were positioned on the slope to improve habitat complexity. This area is comprised mostly of *A. decurrens* and lower half of the site is dominated by weed species which is progressively taking over the bare patches on the lower half of the site. An aerial view of the RVA5 site is pictured below in Plate 5.

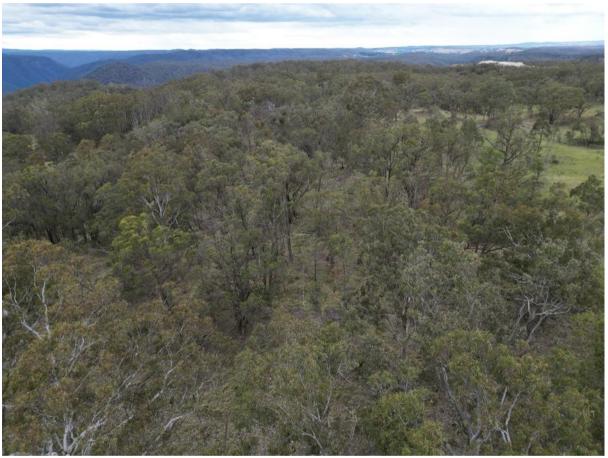
Plate 6- RVA6 Aerial View

RVA6 is situated to the South-West of the WOE. Its coordinates are S34°46'52.97" E150°0'36.75". It is classed as 'remnant vegetation' however the quality of this vegetation community has been compromised by an assumed history of disturbance which occurred approximately 25 years ago. This has led to a relatively sparse understory of native plants and a lack of old growth canopy trees. There is a thick layer of leaf litter on the soil surface and a moderate canopy predominantly of Eucalyptus species. An aerial view of the RVA6 site is pictured below in Plate 6.

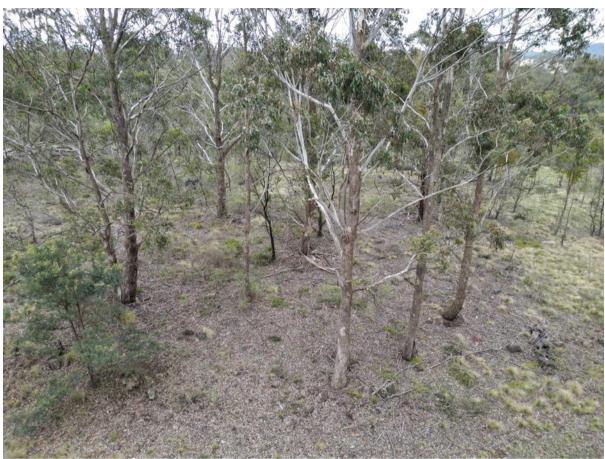
Plate 7- RVA7 Aerial View

RVA7 is an area of 'remnant vegetation' to the North of Lime Dump Road and has not been exposed to any prior disturbance. Its coordinates are S34°46'52.53" E150°0'35.05". There is evidence of natural regeneration in the area. An aerial view of the RVA7 site is pictured below in Plate 7.

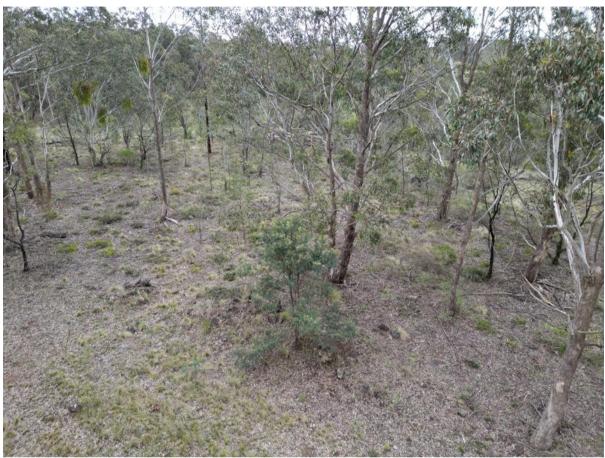
Plate 8- RVA8 Aerial View

RVA8 is located on the southern side of Lime Dump Road and is also an area of 'remnant vegetation'. Its coordinates are S34°46'30.11" E150°1'16.38". An aerial view of the RVA8 site is pictured below in Plate 8.

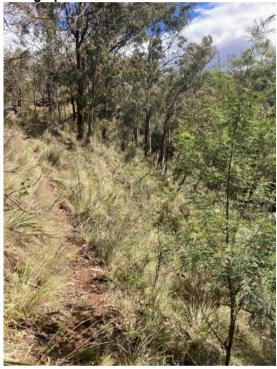
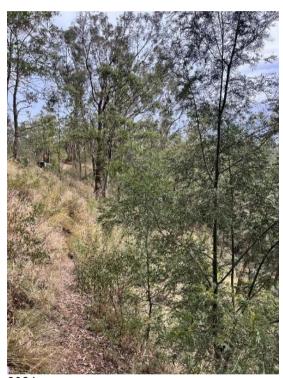
RVA 1 North 2023

RVA1 is classed as 'remnant vegetation' and is located on a steep bank adjacent to Bryces gully on the eastern side of the extraction area. Some mine rubbish is present, including cables and electrical wiring. Weed density has been estimated at approximately 10%, and this predominantly consists of *Nassella trichotoma*. No evidence of fire disturbance, grazing or erosion is present. There was scat present in this area, although only that of native fauna.

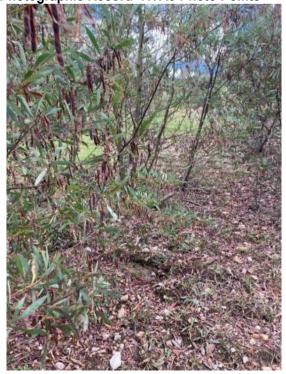
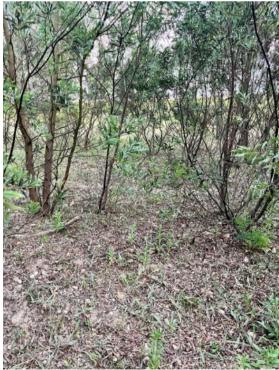
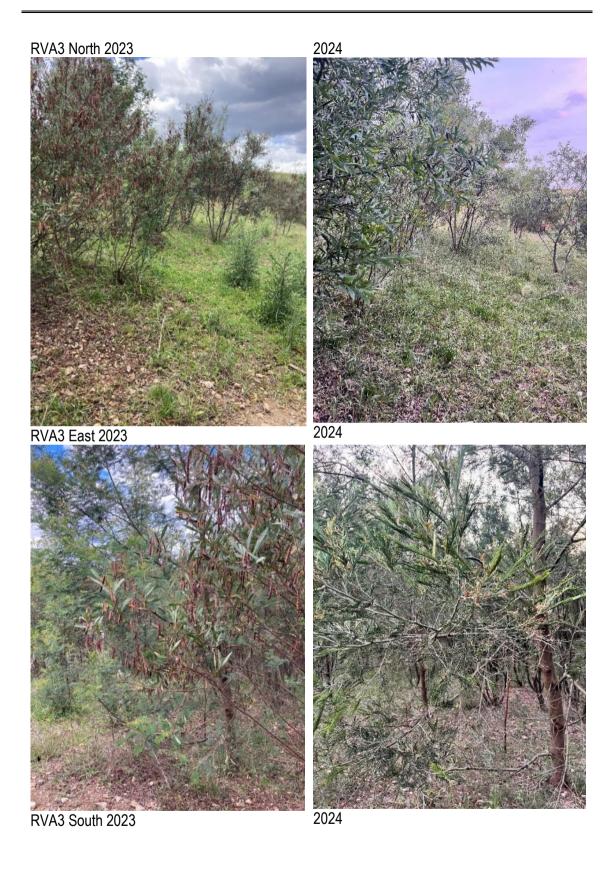
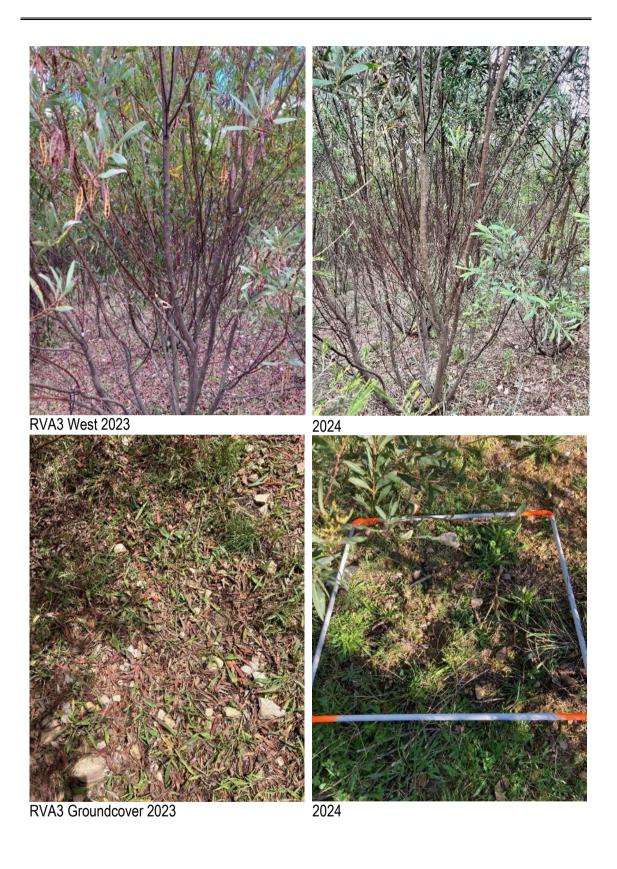
Photographic Record- RVA3 Photo Points

The ground is covered with dense grasses and approximately 30% weed species. Deer, wombat and kangaroo scat was present at this site. There was no mine rubbish, erosion or any other mine disturbance observed.

Site ID	Recommendations for remedial action				
RVA1	Removal of mine rubbish				
RVA2	Treatment of Nassella trichotoma				
RVA3	Feral animal control plan including deer				
RVA4	Feral animal control plan including deer				
	Native seed sowing or planting of tubestock, in particular on the lower				
RVA5	half of this embankment.				
RVA6	No actions required				
	Treatment of Nassella trichotoma				
RVA7	Removal of mine rubbish				
RVA8	Treatment of Nassella trichotoma

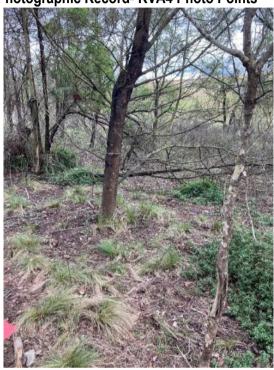
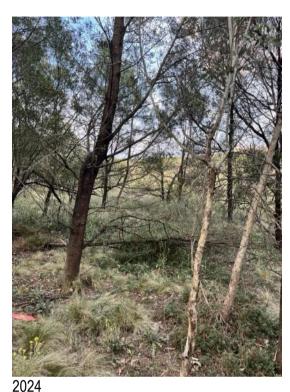
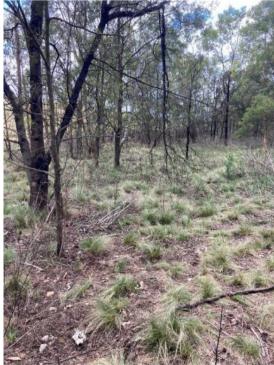
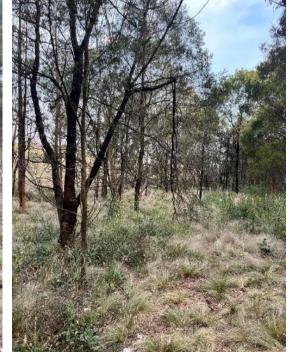
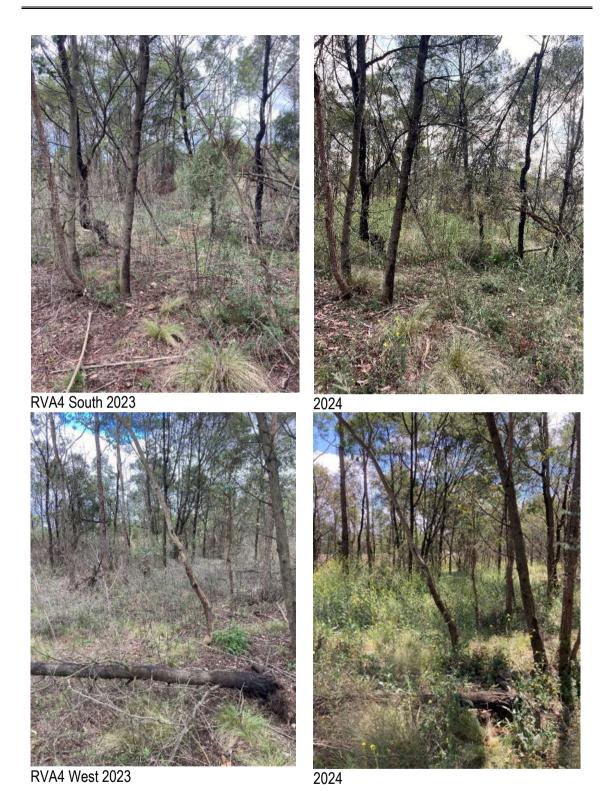
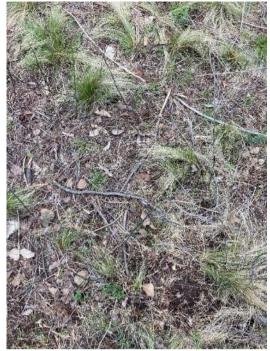
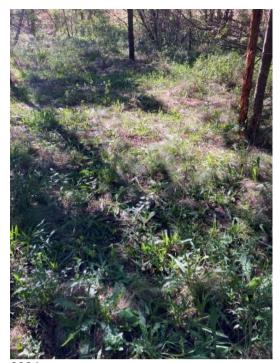
Photographic Record- RVA4 Photo Points

Groundcover is dominated by a dense layer of broadleaf weeds and grasses. A deer antler was found at this site, as well as evidence of deer grazing on bark of trees. Deer, rabbit, kangaroo and wombat scat was visible. There was no evidence of human disturbance or mine rubbish. The weed cover percentage was estimated at 20%, and no erosion was evident.

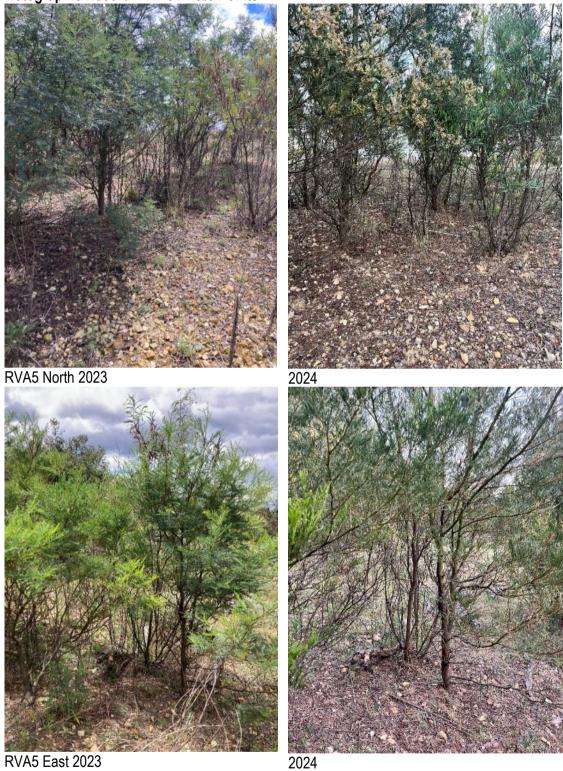
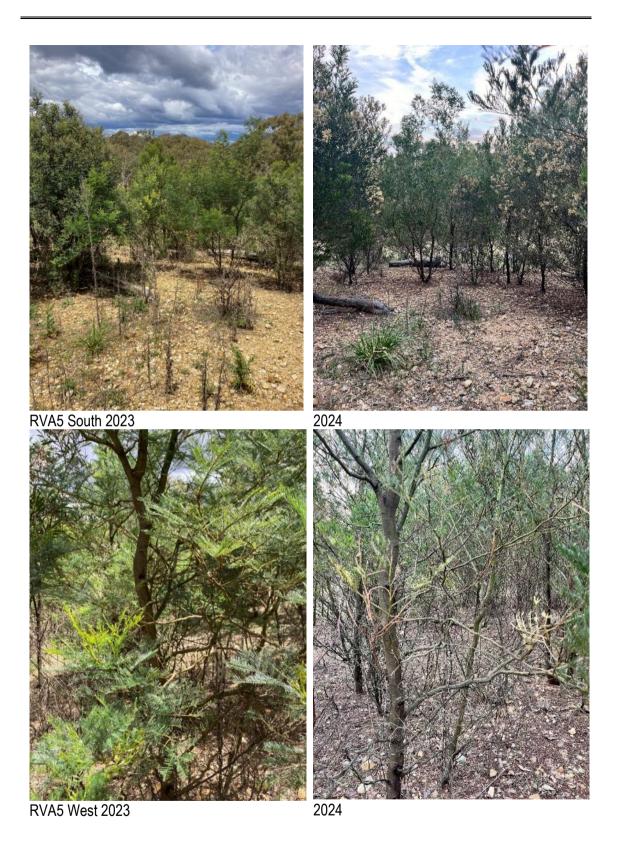
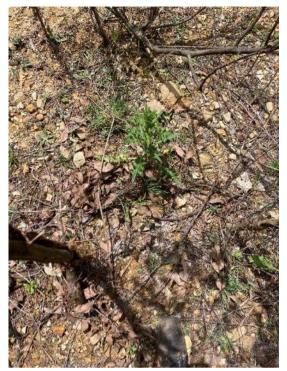
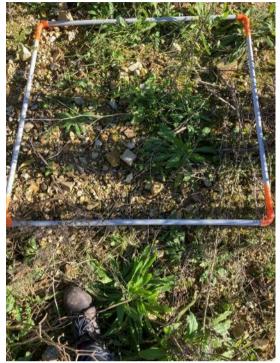
Photographic Record- RVA5 Photo Points

This area is comprised mostly of *A. decurrens* and lower half of the site is dominated by weed species which is progressively taking over the bare patches on the lower half of the site. The weed cover was estimated at approximately 30%. A small amount of rilling is present although no sediment problems are evident. Feral and native animal scat is present. There is no mine rubbish or evidence of recent fire damage. There has been no mine disturbance at this site.

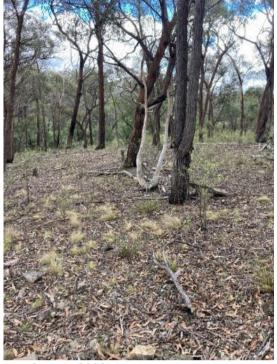
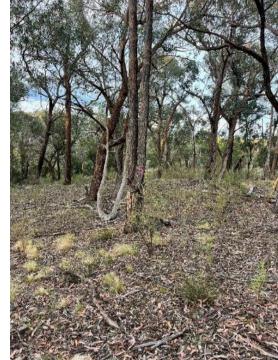
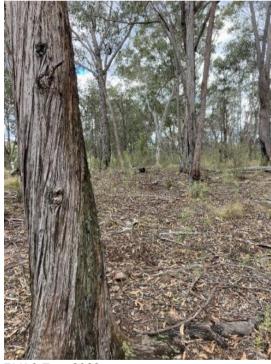
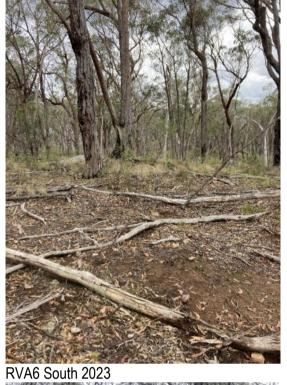
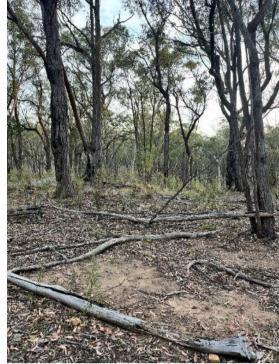
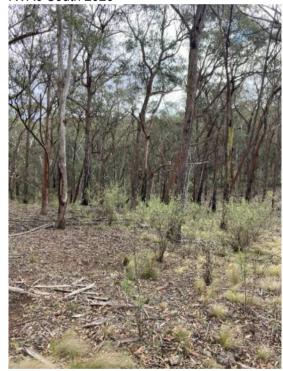
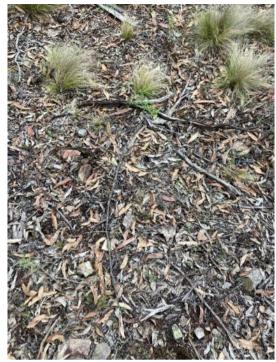
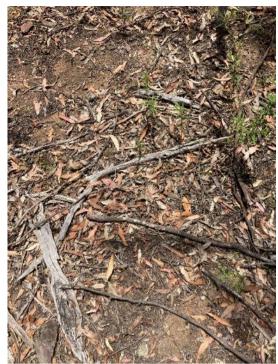
Photographic Record- RVA6 Photo Points

There is previous evidence of a cooler burning fire on tree bark and evidence of regrowth in the shrub layer. Older large trees are present with hollows suitable for habitat of larger birds and arboreal mammals. No erosion is evident at the site. There was no evidence of native or feral animal grazing or scats. The percent of weeds was very low, at 2% cover. There is evidence of natural regeneration in the understorey. No remedial actions have been recommended for this site.

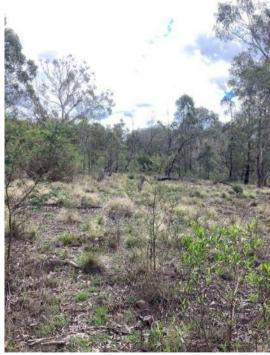
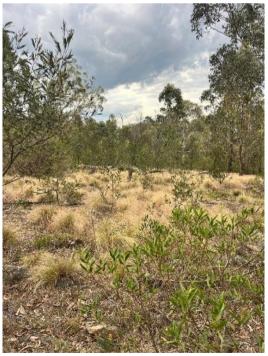
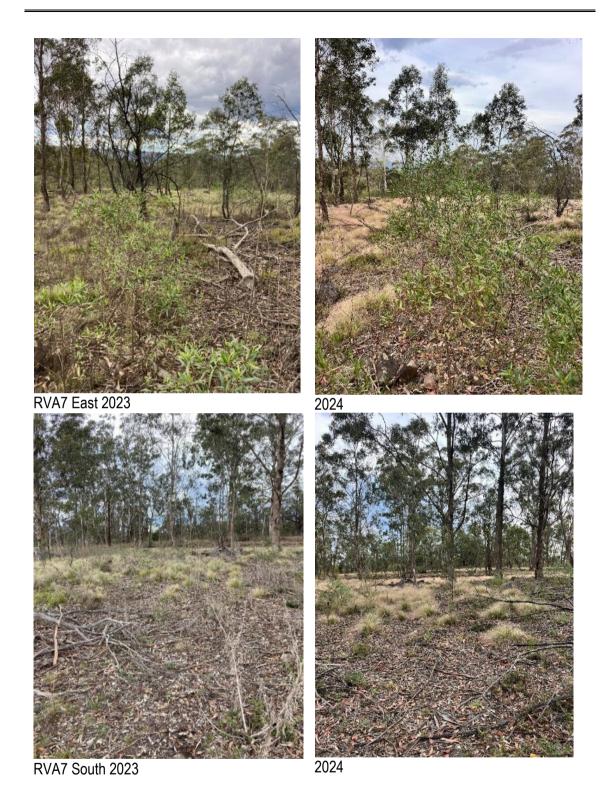
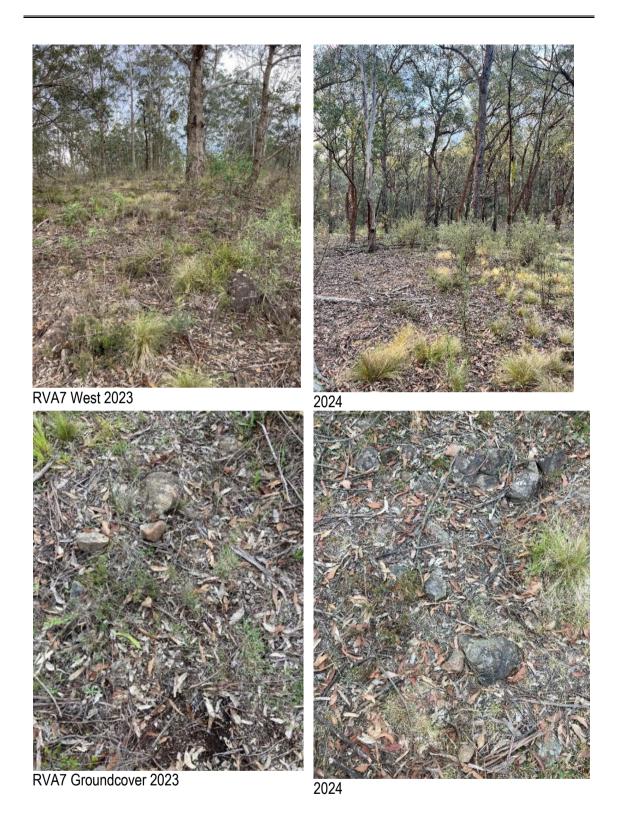
Photographic Record- RVA7 Photo Points

There is a high percentage of weed cover (50%), which is predominantly *Nassella trichotoma*. There were no signs of feral or native animals at this site, and no evidence of fire disturbance or erosion is present. A section of wire was visible which was classed as mine rubbish.

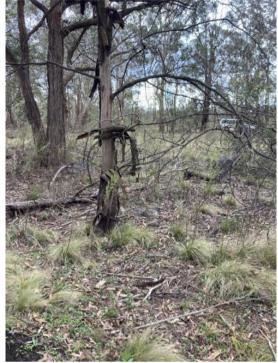
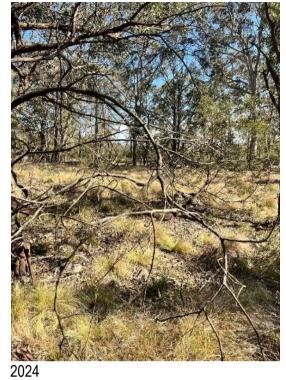
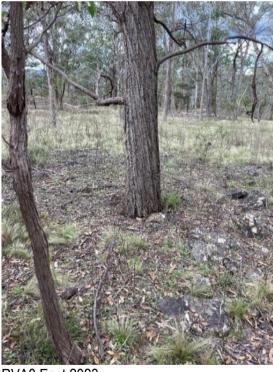
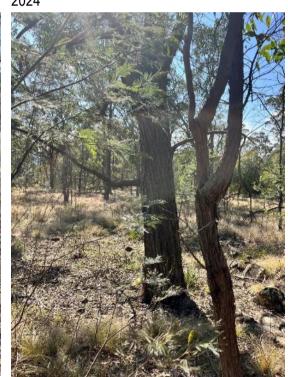
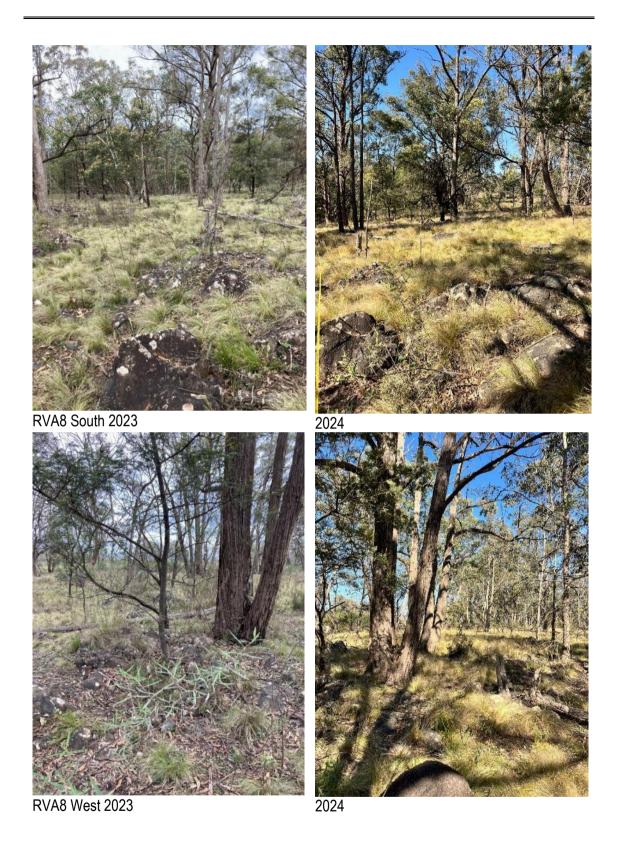
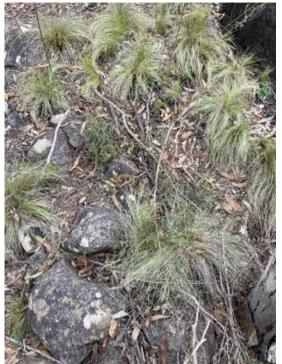
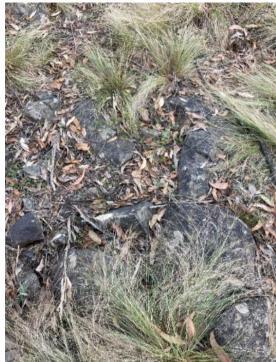
Photographic Record- RVA8 Photo Points

Similarly to RVA7, a high density of *Nassella trichotoma* was present at RVA8, at approximately 60% coverage. There is evidence of natural regeneration, and rabbit scat was present at this site. No human disturbance, mine rubbish, erosion or fire disturbance was observed.

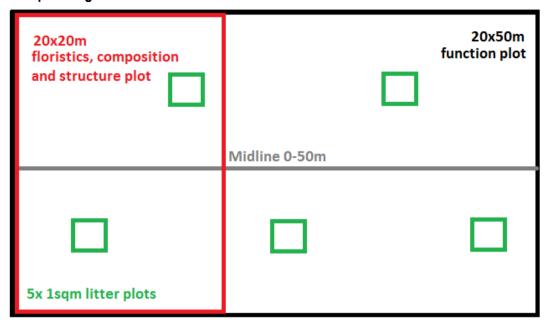
BAM plot diagram

in future. The survey plots are established as depicted in the plot diagram below.

The vegetation composition is assessed within the 20x20m (400m² plot). Within this plot, the total count of native plant species (richness) within the six growth form groups is recorded. The growth form groups include Tree, Shrub, Grass and grass-like, Forb, Fern and Other. The three dominant species (defined by contributing most to the total cover) within each growth form group are recorded. It is to be noted whether each species is native, high threat weed (HTW) or non-HTW which is outlined in the "High Threat Weeds and Widely Cultivated Native Species lists" found on the BAM-C webpage.

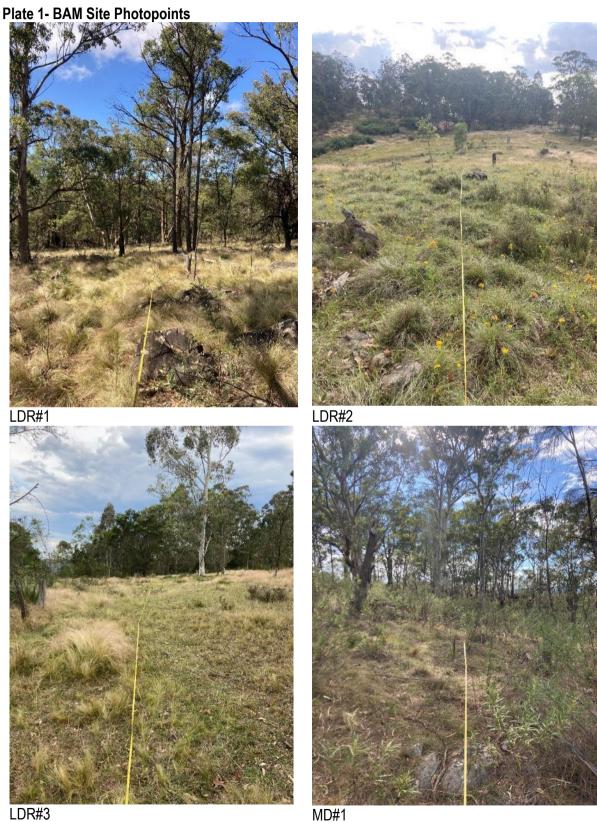
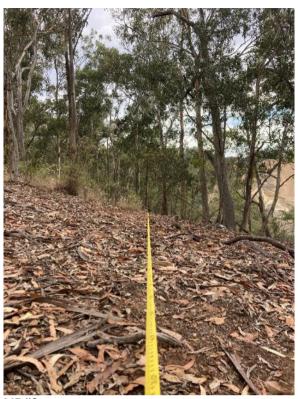
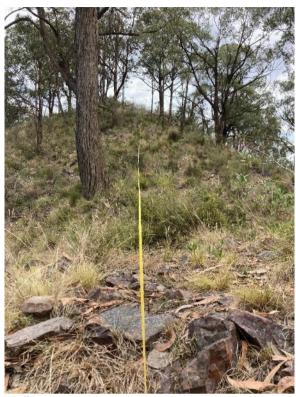
Photopoints from the midline at 0m of each BAM plot are presented in Plate 1 below.

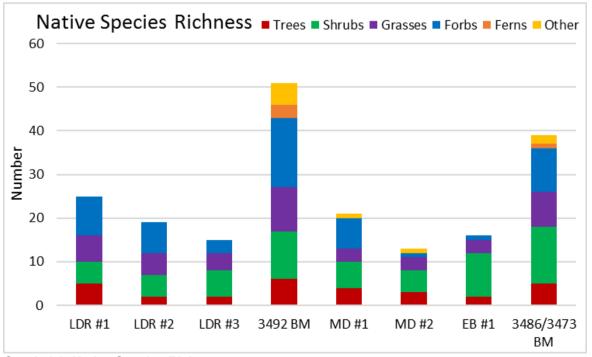
Graph 4.1- Native Species Richness

The Maggie Dump (MD) and Eastern Batters (EB) were also below the associated species richness benchmarks for PCTs 3486 and 3473 (Graph 4.1). The benchmark tree richness was 5, however 2 to 4 tree species were identified in the plots. Similarly, the shrub benchmark was 13 species, but 5 to 10 species were listed in the plots. A total of 8 grass species and 10 forb species were listed as benchmark, while 3 grasses and 1 to 7 forbs were identified in the plots. No ferns were identified in the plots, and only one 'other' species was identified at MD. The total number of species across all growth form groups ranged from 13-21, which compares to the benchmark total of 39 species.

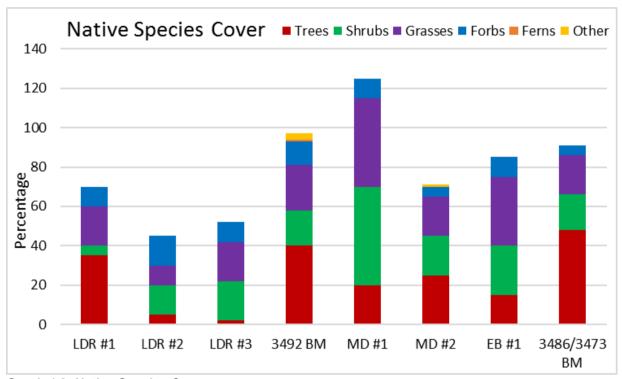
Graph 4.2- Native Species Cover

Graph 4.2 shows the native species percent cover of the BAM plots broken into each of the 6 growth form groups. The BAM plot tree species cover has not yet reached the benchmarks of 40% at PCT 3492 and 48% at PCTs 3486 and 3473. The native shrub cover benchmark is 18% across all PCTs. The LDR shrub cover was below or at benchmark with cover ranging from 5-20%, whereas MD and EB plots were all above benchmark, ranging from 20-50% cover. BAM plot native grass cover percentages range from 10-45%, with all but one (LDR#2) of the plots above the benchmark of 20%. The BAM plot native forb cover ranged from 5-15%, which was on par the benchmarks of 12% (PCT 3492) and 5% (PCTs 3486 and 3473). Fern cover was absent from all BAM 6 plots, and 1% of 'Other' was present at MD#2. Fern and 'Other' covers were 1% and 3% respectively at benchmark PCT 3492 and were both 0% at benchmark PCTs 3486 and 3473.

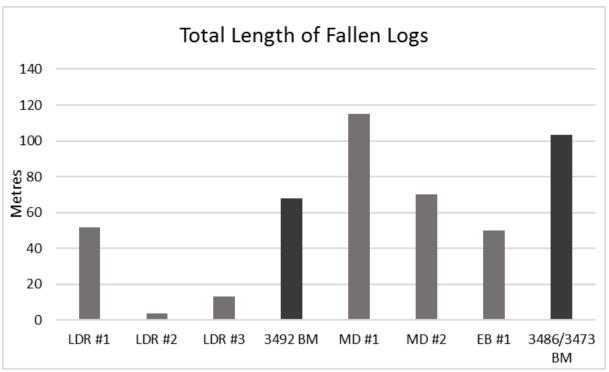
Graph 4.5- Total Log Lengths

The BAM plots are compared to benchmark scores for the total length of fallen logs in total metres in Graph 4.5 below. Total length of logs ranges from 4m at LDR#2 to 115m at MD#1. Plot MD#2 is the only plot above the benchmark score of 103.5m for PCTs 3486/3473.

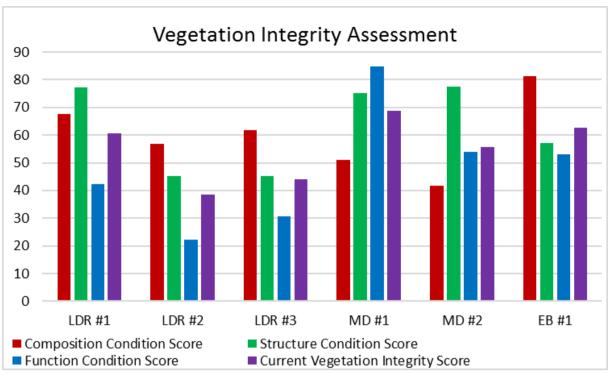
Graph 4.6- Vegetation Integrity Assessment

Graph 4.6 shows an assessment of the three condition attributes and the vegetation integrity scores for the BAM plots. These scores are calculated from the BAM-C output based on the raw data provided in Appendix B and PCT benchmarks. Composition condition (native plant species richness) scores range from 41.7 at MD#2 to 81.4 at EB#1. Structure (native plant foliage cover) was lowest at LDR#2 and LDR#3 with scores of 45.2 and 45.1 respectively, and highest at MD#2 with a score of 77.4. Function scores had the highest range, from 22.1 to 84.4 with the lowest and highest scores recorded at LDR#2 and MD#1 respectively. Overall, the vegetation integrity, which is used as a measure of vegetation condition was lowest at LDR#2 (VI=38.4) and highest at MD#1 (VI=68.7).

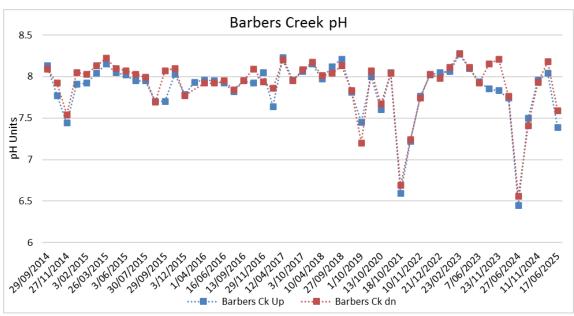
Graph 1- Barbers Creek upstream and downstream pH

All of the creeks being monitored are sourced within limestone bedrock systems. Although limestone is naturally alkaline, fast flowing surface water from high rainfall events would not allow sufficient time to raise the pH in normally neutral precipitation. Flow rate and duration of contact with limestone is the main factor affecting pH.

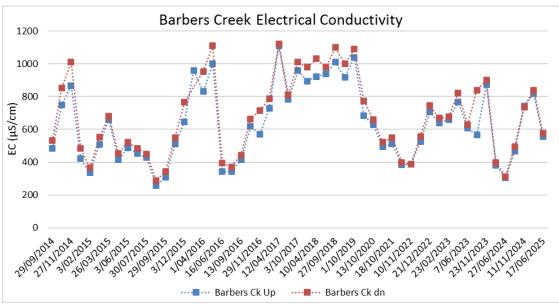
Graph 2- Barbers Creek upstream and downstream EC

The electrical conductivity levels in Barbers Creek have fluctuated from 257 μ S/cm to 1120 μ S/cm over the past 11 years as shown in Graph 2. The conductivity levels have remained similar at sites upstream and downstream during the same sampling periods. High levels of fluctuation were observed from 2014-2018 during drought conditions, which then plateaued at around 900 μ S/cm for two years until 2020. Following higher rainfall, there has been a continued drop in conductivity to levels below 400 μ S/cm which hadn't previously been recorded since late 2016.

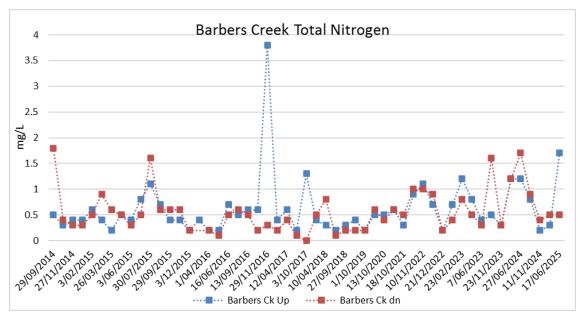
Graph 5- Barbers Creek upstream and downstream Total Nitrogen

Nitrogen levels can be arbitrarily high at any point in time, particularly in small ephemeral creeks where a single dead animal can cause spikes in either Nitrogen or Phosphorus or both. If a spike appears, a comparison is made with other analytes such as dissolved oxygen to determine if there are any potential ongoing issues of concern. In this case, dissolved oxygen has remained generally between 6 and 11 mg/L which is indicative of a normal healthy river system.

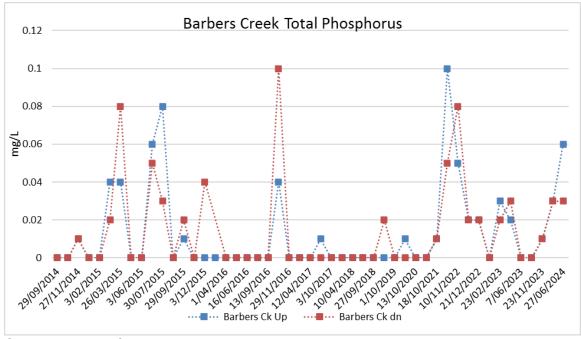
Graph 6- Barbers Creek upstream and downstream Total Phosphorus

Phosphorus is as an essential nutrient for all plant and animal life, commonly as phosphate in inorganic fertiliser. Natural levels of Phosphorus have a similar range of between 0.01 to 0.08 mg/L. ANZECC/ANZG 2018 guidelines place Phosphorus levels for natural rivers and streams at less than 0.1 mg/L. The levels found in Barbers Creek are within natural levels and do not indicate that there has been any contamination with fertilisers used in the rehabilitation work on the eastern emplacement and batter areas.

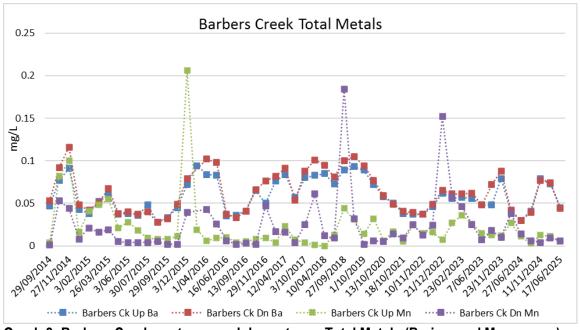
Graph 8- Barbers Creek upstream and downstream Total Metals (Barium and Manganese)

Barium and Manganese concentrations are shown on Graph 8. Both minerals are naturally occurring although can also be generated by anthropogenic processes. Manganese is also a common fertiliser additive. There is no specified level of Barium in the ANZG 2018 guidelines however Manganese has a 95% ecosystem protection goal of 1.9 mg/L. A Manganese spike occurred in December 2015 shortly after the spike in Aluminium which also indicates that the cause could have been fertiliser addition which was making its way down stream. In May 2019 and December 2022 similar spikes in Manganese occurred in the downstream site indicating the time taken for the fertilisers to move through the sediments. This timeframe would be expected with an ephemeral creek system which does not see regular water movement but only following rainfall.

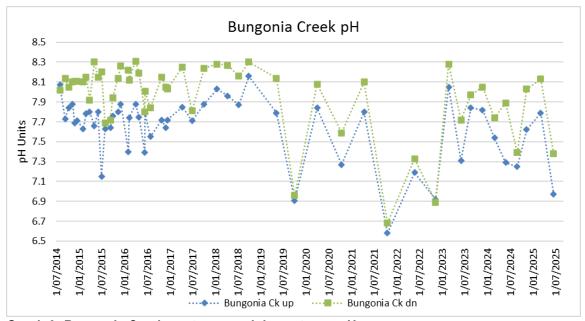
Graph 9- Bungonia Creek upstream and downstream pH

There is however an overall increase in alkalinity downstream of the mine with the Bungonia Down site having a long term average pH of 7.95 while the long term average for the upstream site being a pH of 7.63. Both values are reflective of the geology that the creek flows through.

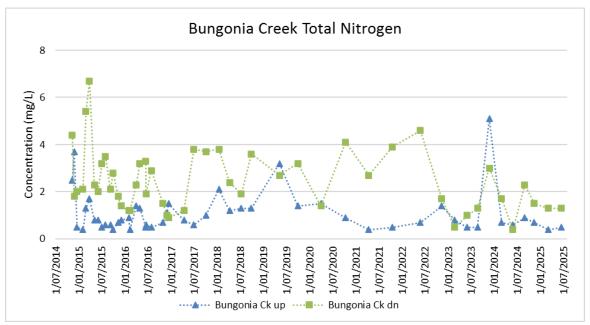
Graph 13- Bungonia Creek upstream and downstream Total Nitrogen

As the levels are relatively consistent, it is unlikely to be caused by flow. Changes in flow appears to have an influence on some metals and suspended solids, however the concentration of Nitrogen has been relatively consistent despite changes in flow conditions between above average rainfall periods and drought. These issues are discussed in the following section.

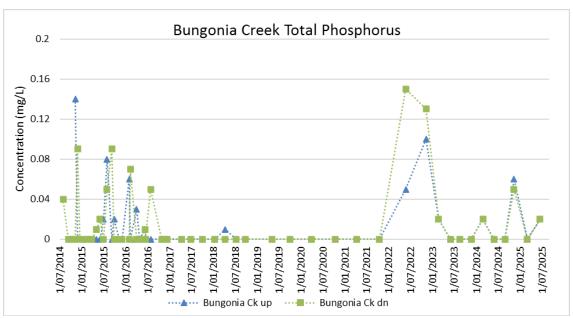
Graph 14- Bungonia Creek upstream and downstream Total Phosphorus

Phosphorus is also an indicator of nutrient levels. ANZECC 2000/2018 guidelines have a goal for Upland Rivers of 0.02 mg/L of Total Phosphorus. There are many occasions where the level of Phosphorus is above the environmental trigger. The monitoring program commenced in a period of higher flow conditions post Millennial Drought (2001-2009). This period was followed by dry conditions in 2017 to 2019 with subsequent above average rainfall in 2021-22.

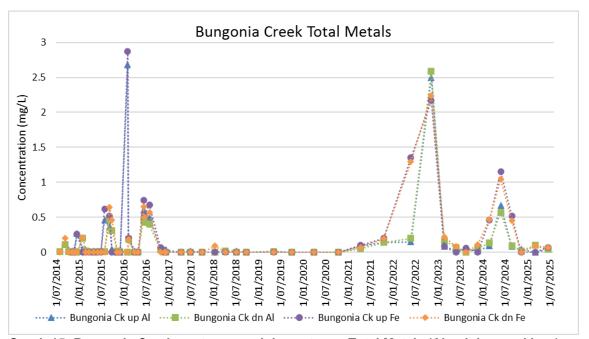
Graph 15- Bungonia Creek upstream and downstream Total Metals (Aluminium and Iron)

The pattern with Aluminium and Iron concentration is similar to that of Suspended Solids which appear to be influenced by flow conditions. Higher flow will tend to relocate minerals from higher in the catchment down towards the confluence with the Shoalhaven River. There was one elevated Iron level of 2.8 mg/L in February 2016 however there are no environmental goals specified for Iron concentration.

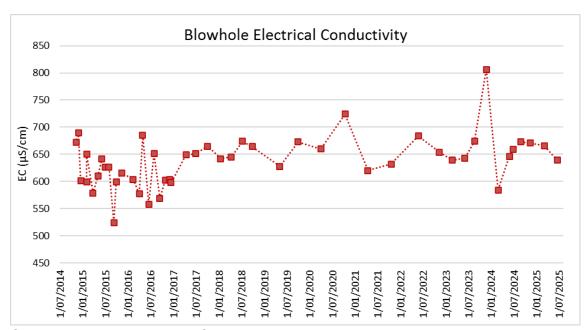
Graph 18- Blowhole Electrical Conductivity

Graph 18 below shows that the electrical conductivity concentration of the Blowhole has fluctuated from 524 μ S/cm to 806 μ S/cm with an average of 638 μ S/cm since 2014. The concentration has remained relatively stable over this period of time, with no obvious trends.

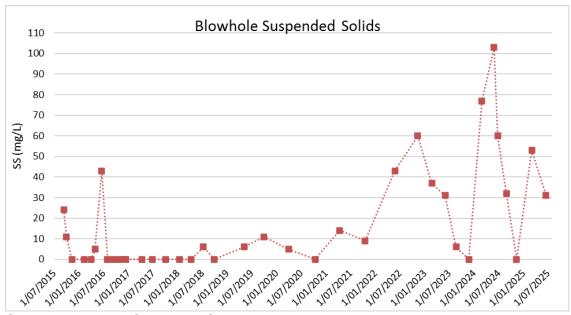
Graph 19- Blowhole Suspended Solids

The suspended solids generally remained below the detection limits (<5mg/L), with only a few outliers up until 2019 (Graph 19). Since that time, the levels have ranged between <5 mg/L to 103 mg/L, with an increasing trend since January 2022. Suspended Solids peaked in 2024 with levels as high as 103 mg/L. During periods of high solids loading, the discharge has been noted as brown to orange in colour. This indicates the presence of elevated minerals.

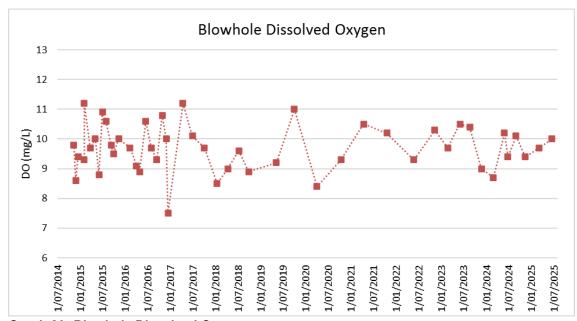
Graph 20- Blowhole Dissolved Oxygen

The dissolved oxygen concentrations within the Blowhole have remained relatively consistent, with an average of 9.70 mg/L and a range of 7.5 mg/L to 11.2 mg/L, as shown on Graph 20. Results show that the groundwater discharged from the Blowhole has sufficient dissolved oxygen levels to support aquatic life.

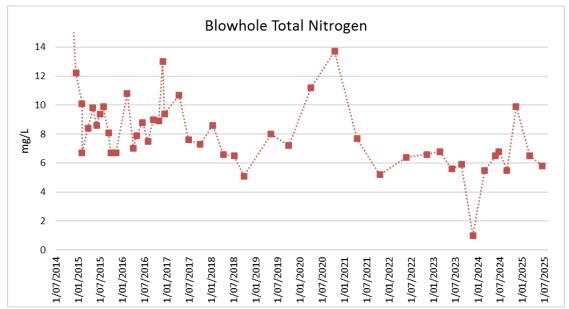
Graph 21- Blowhole Total Nitrogen

Nitrogen and Phosphorus occur naturally but the levels at the Blowhole are uncharacteristically high (Graph 21 and 22). For natural systems to yield Nitrogen at the measured levels would indicate the presence of high levels of organic matter. As the volume of the Blowhole discharge is relatively small, there is only a minor increase in Nitrogen levels downstream (refer Graph 13). However, the cause of the elevated Nitrogen is unknown. The long term average Total Nitrogen concentrations are 8.2 mg/L, with a range of 1.0 mg/L to 15.1 mg/L.

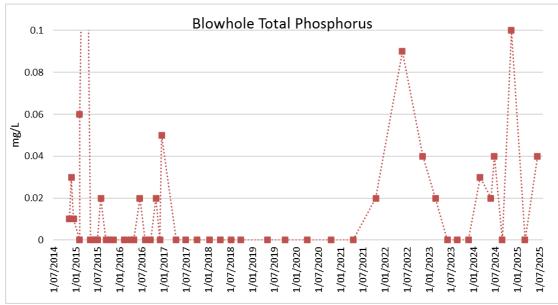
Graph 22- Blowhole Total Phosphorus

For a period of 4 years from 2017 to 2021, the phosphorus concentration remained below the detection limit of 0.001 mg/L. Levels of phosphorus spiked in June 2022, with a level of 0.09 mg/L during heavy rainfall and high flow events (Graph 22). The concentration of phosphorus dropped back below detection limits later in 2023. Phosphorus levels have been elevated throughout 2024 and 2025. During November 2024 the concentration increased to 0.1 mg/L.

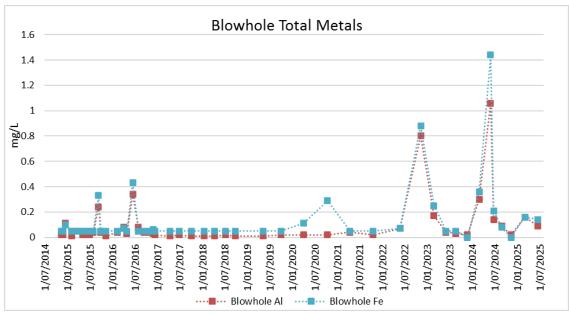
Graph 23- Blowhole Total Metals (Aluminium and Iron)

The total Aluminium and Iron concentrations mirror the trends observed for phosphorus above. The metals in Graph 23 show lowered concentrations, often below detection limits during the drought, with elevated levels peaking in November 2022, before dropping back to lowered concentrations in 2023. The highest were recorded in 2024, with Aluminium and Iron levels of 1.06 mg/L and 1.44 mg/L, with long terms averages of 0.09 mg/L and 0.14 mg/L respectively.

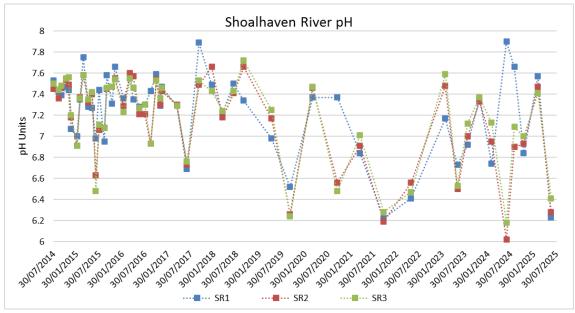
Graph 25- Shoalhaven River pH

There is generally very good correlation between all three sample sites within the Shoalhaven River indicating that the Marulan Limestone Mine is not influencing natural variability.

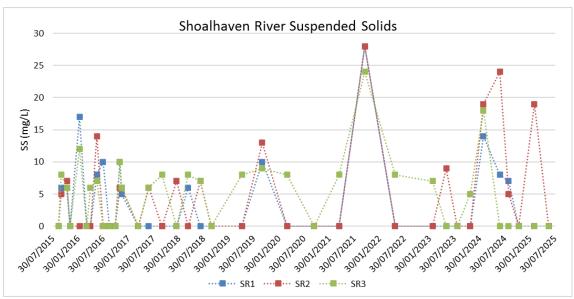
Graph 27- Shoalhaven River Suspended Solids

Suspended solids is a measure of fine particle movement within a waterway. It can indicate erosion caused by high rainfall events or poor quality water being discharged from a mine site. As there is very good correlation between all three sample sites within the Shoalhaven River, the Marulan Mine is not contributing to the solids loading of the Shoalhaven River.

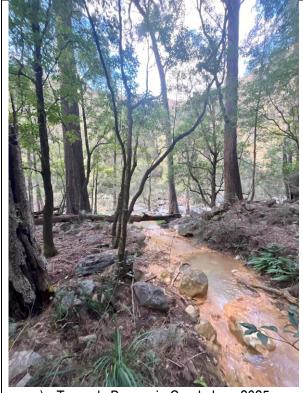
Plate 5- Blowhole

- □ The Blowhole site is located above the confluence of Main Gully and Bungonia Creek. It is a natural spring which is sourced from the limestone deposit below the extraction area. It is a point where groundwater discharges to surface water and joins Bungonia Creek between the upstream and downstream sampling sites. Being groundwater derived, the water quality is significantly different from the surface water of Bungonia Creek and has often been observed with an orange sediment present (Plate 5 in Appendix 1).

b) Looking across flow path March 2020

Located downstream of Main Gully is a notable hydrogeological feature referred to as the "Blowhole" (Plate 5, Appendix A). This feature represents a perennial groundwater seep or spring, emerging below the elevation of the South Pit and independent of surface runoff processes. The Blowhole's discharge is exclusively groundwater-derived and is therefore not considered representative of surface water quality conditions. Nonetheless, it contributes to baseflow within Bungonia Creek and can influence downstream water quality. Water quality samples are routinely collected at the lower extent of the Blowhole, immediately prior to its confluence with Bungonia Creek, to assess its influence on the receiving environment.

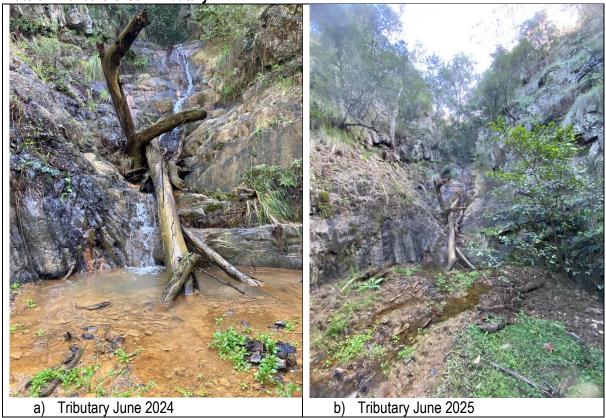
Plate 9 - Barbers Creek Tributary

A tributary originating from the Eastern Batters flows into Barbers Creek and is currently being monitored (see Plate 9). This site is located between the upstream and downstream monitoring points on Barbers Creek. An additional water sample is also collected directly upstream of the tributary for comparison. Since monitoring began in December 2022, there has been no observed change in Barbers Creek's water flow, quality or sediment characteristics. The tributary exhibits higher salinity and lower redox potential, while dissolved oxygen (DO) and pH levels remain similar to those of Barbers Creek (see Section 2.3.1).

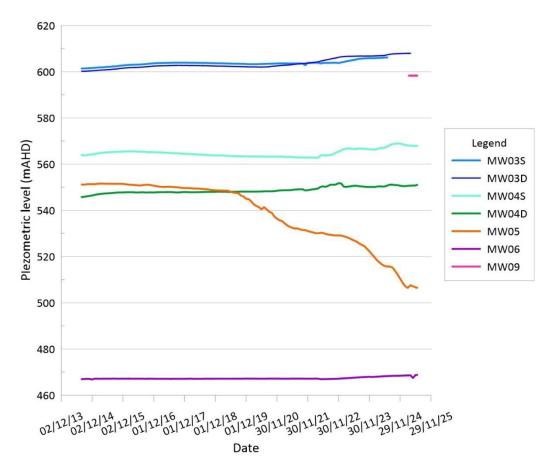
Figure 8 Historical hydrographs for monitoring bores

Groundwater level data for 2024/2025 has been compared to trigger levels (**Table 5**). MW06 was the only bore which recorded levels below 5th % trigger level. However, this occurred in April 2025 only, therefore, trigger level event did not occur. Groundwater levels have recovered in MW06 after April 2025.
