Annual Review

Marulan South Limestone Mine Continued Operations Project Boral Cement Limited

This Annual Review has been prepared in accordance with Condition D11 of SSD 7009 and covers the operation over the 2024-2025 period. This review has been structured in accordance with the Department of Planning and Environment guidelines for the preparation of Annual Reviews.

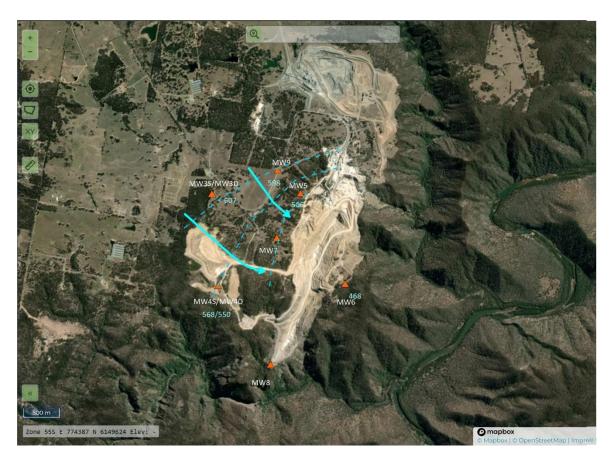
Figure 10 Map with piezometric levels (2025), interpreted contours (blue dotted) and flow direction (blue arrows)

Based on the groundwater levels within the weathered and fractured granite/granodiorite and interpreted groundwater contours, it appears that groundwater flow direction is to the east and south-east (**Figure 10**). This is consistent with the baseline readings as reported in GWMP (AGE, 2021).

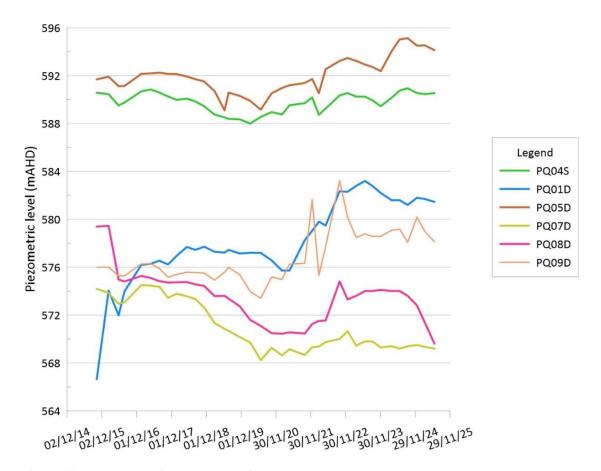
Figure 11 Hydrographs for Peppertree Quarry bores

In summary, groundwater levels in Peppertree quarry continue to respond to long term weather events. Groundwater levels are within the historically measured data and groundwater flow direction is towards the pit, which is in agreement with historical data.

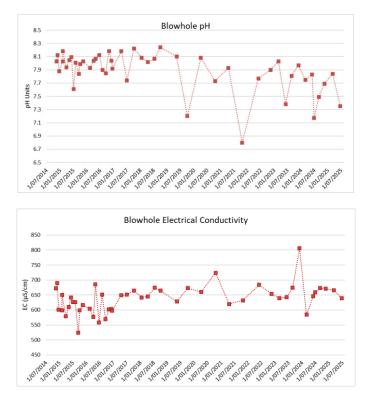
Figure 15 Time series – Groundwater seepage and GDEs as observed in Blowhole basic water quality parameters

The surface water management plan provides trigger parameters for observed spring flow and is reported in annual report. Groundwater seepage is monitored via spring flow at "Blow hole" and any significant changes reported here.
