Dunmore Quarry

Annual Review

2016-2017

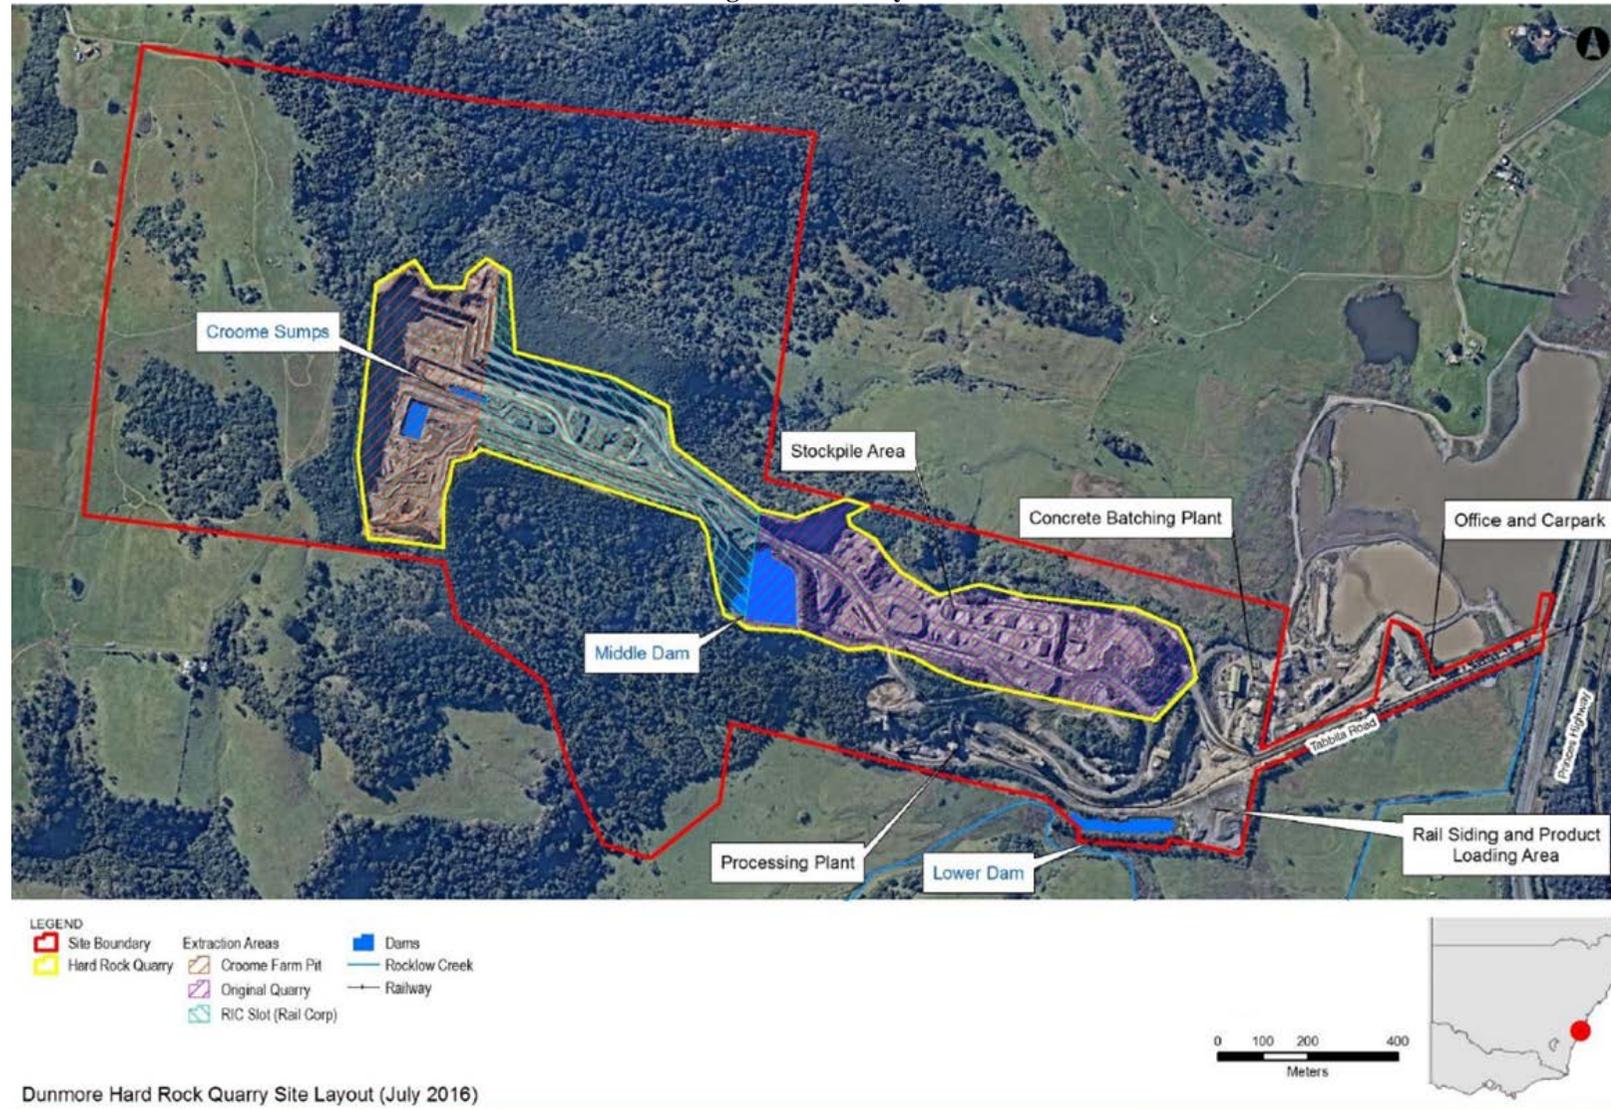
Figure 1: Site Layout

Dunmore Hard Rock Quarry Site Layout (July 2016)

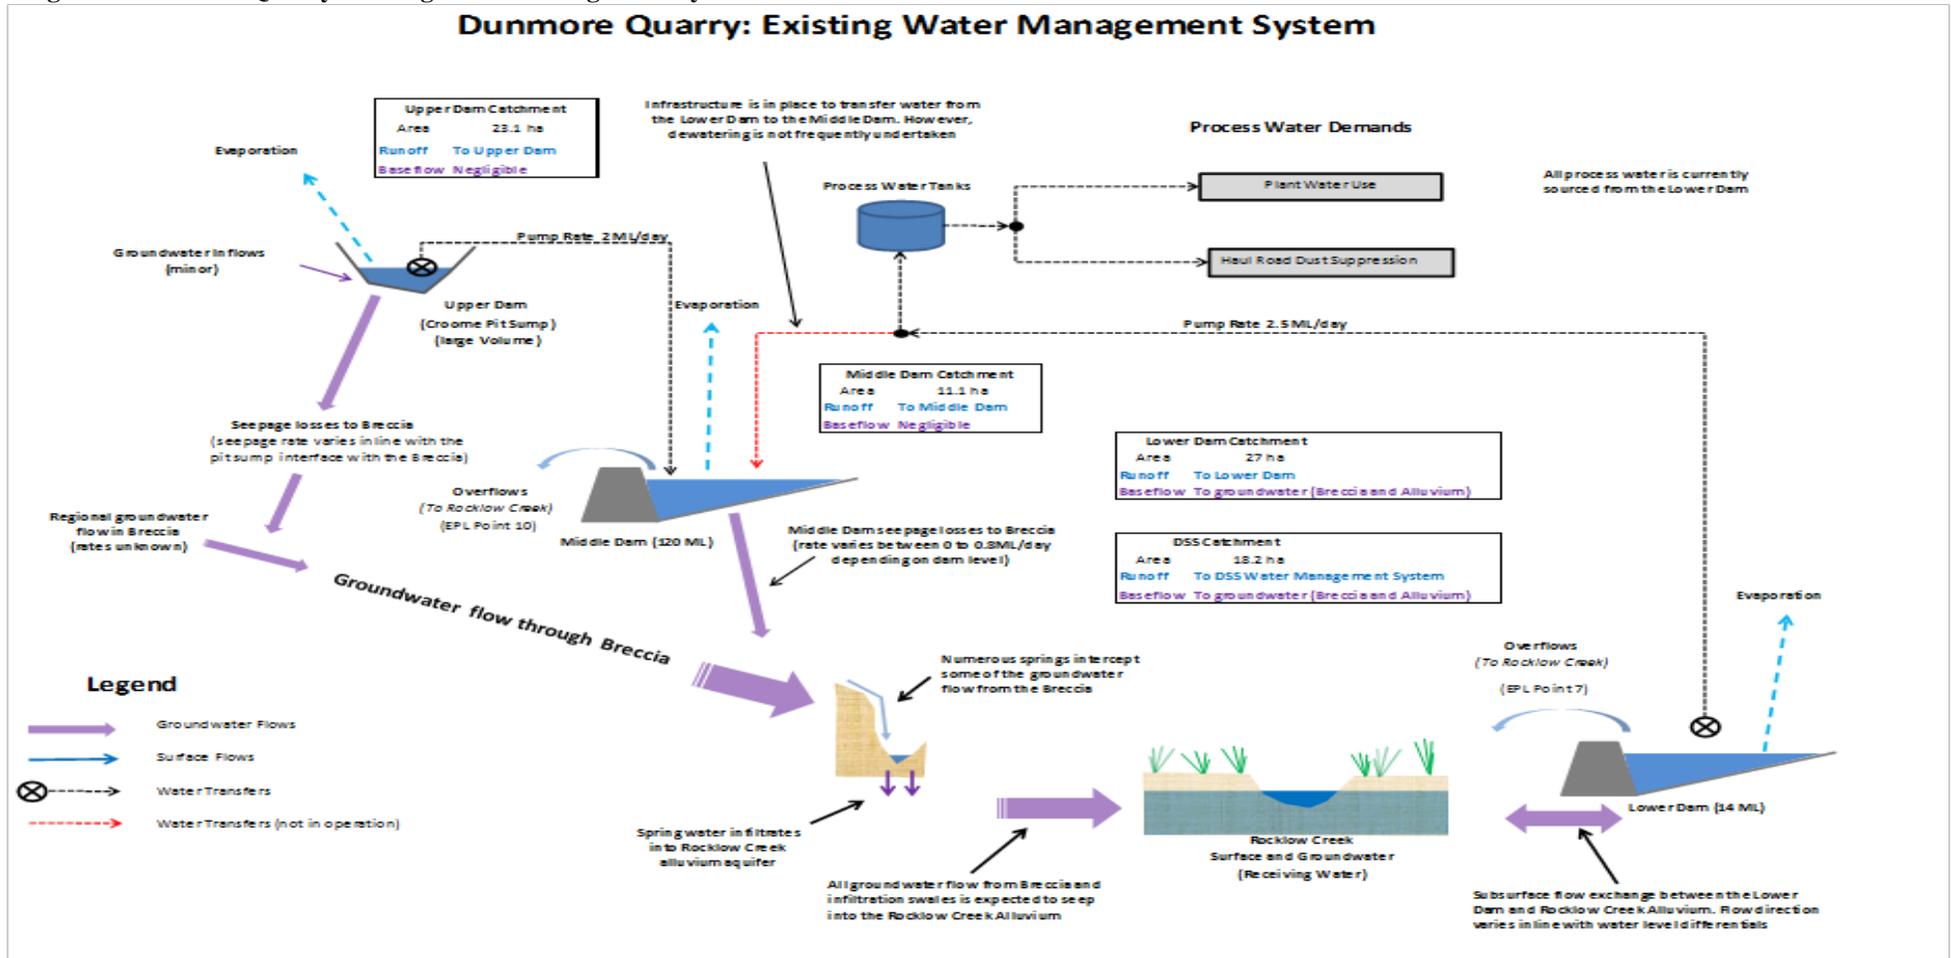
Figure 2: Dunmore Quarry Existing Water Management System

The site water balance is currently under review by consultants Royal Haskoning DHV and is being prepared as part of Condition 30 of Schedule 4 of the development consent. Figure 2 outlines the existing water management system, dam capacities and water transfers. The site water demands are presented in Table 5 below.

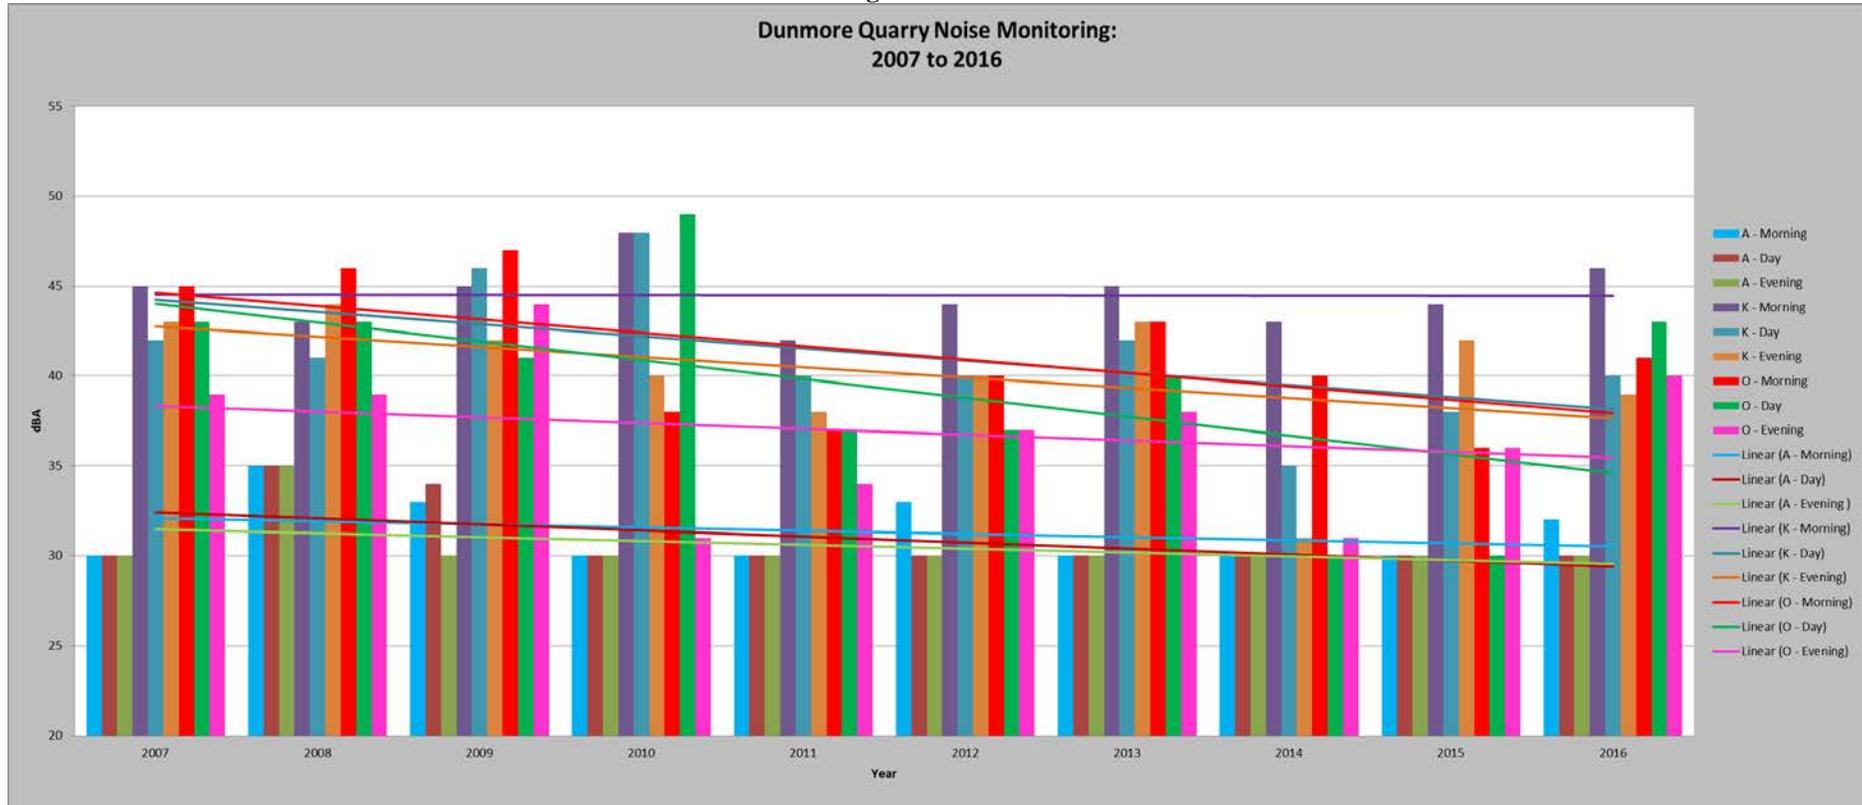
The report found that the quarry achieved compliance with the licence noise limits at all locations during all monitoring periods. This is in line with previous reporting periods. The noise levels monitored are consistent with the majority of EIS predictions, with only Location O noise levels slightly higher than predicted. It should be noted however the Annual Noise Compliance assessment reports that noise generated from road traffic was the dominant noise source at this residential location. Quarry operations were only observed to be audible during the morning shoulder and evening noise monitoring periods. A copy of the Noise Compliance Assessment Report is attached as Appendix 6 of this report.

Dunmore Quarry Noise Monitoring:
2007 to 2016

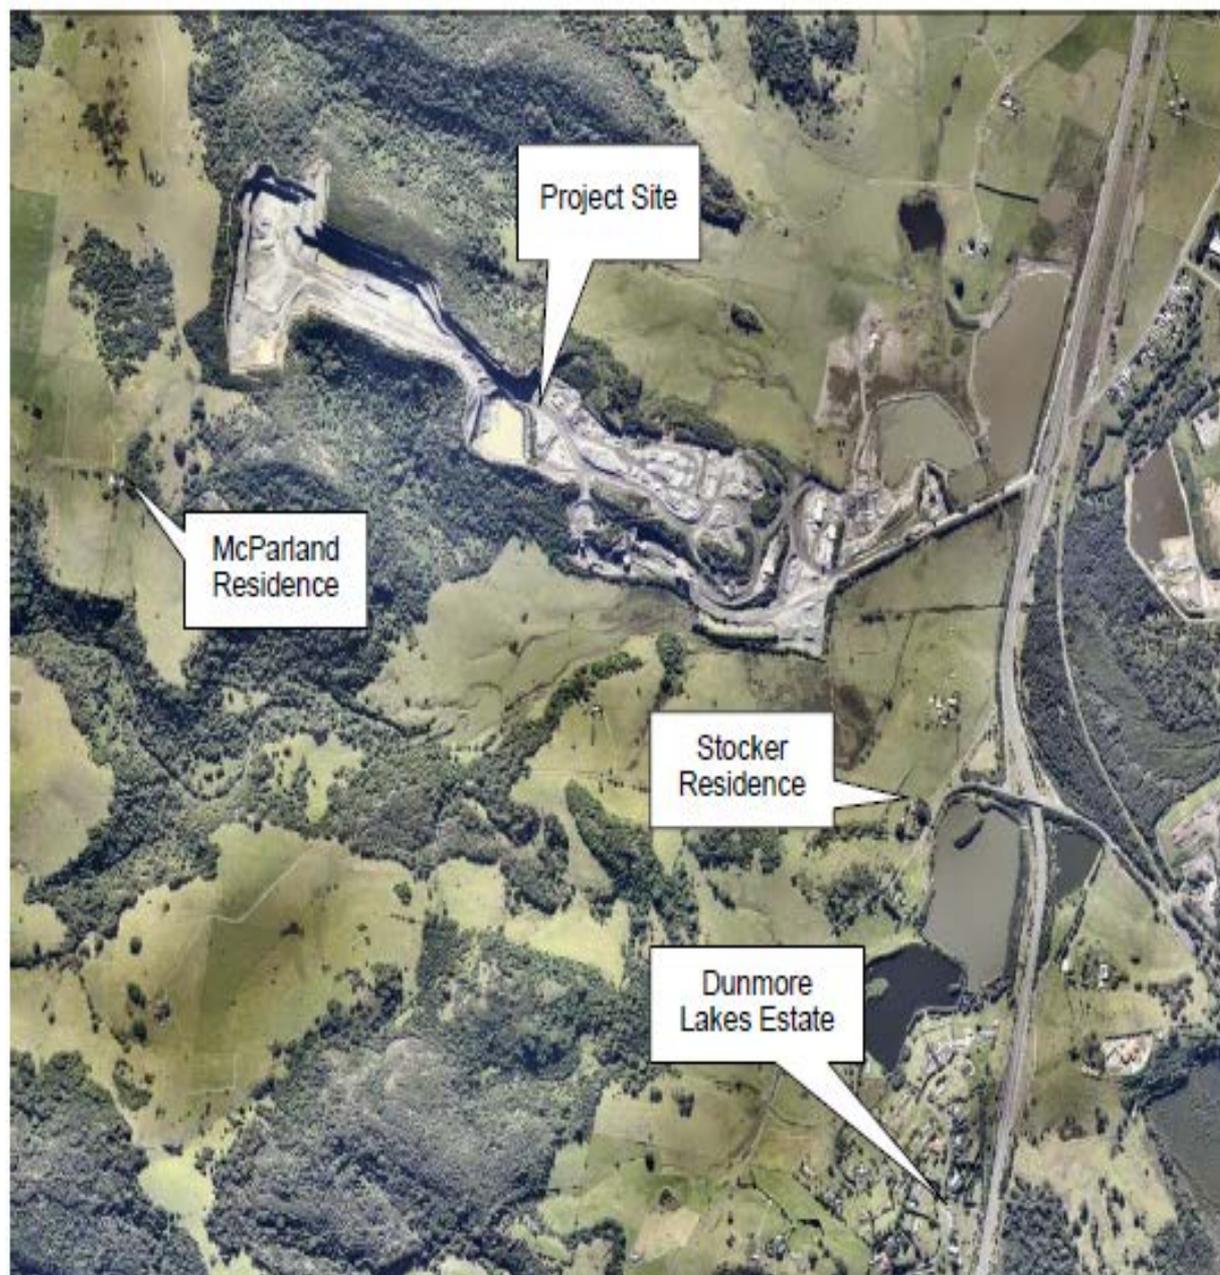
Figure 1 Noise Monitoring Locations

A noise monitoring program was prepared in recognition of Condition 4(14) to monitor noise at the three receiver locations specified in the consent and EPL. These locations are displayed in Appendix 1. The noise monitoring program includes:

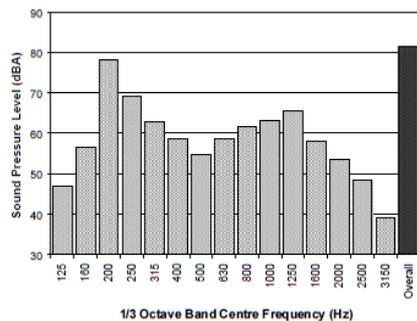
The following figure shows a 1/3 octave band frequency analysis where the noise is dominated by the 200 Hz band. Note that the indicated level of each individual band is less than the overall level, which is the logarithmic sum of the bands.

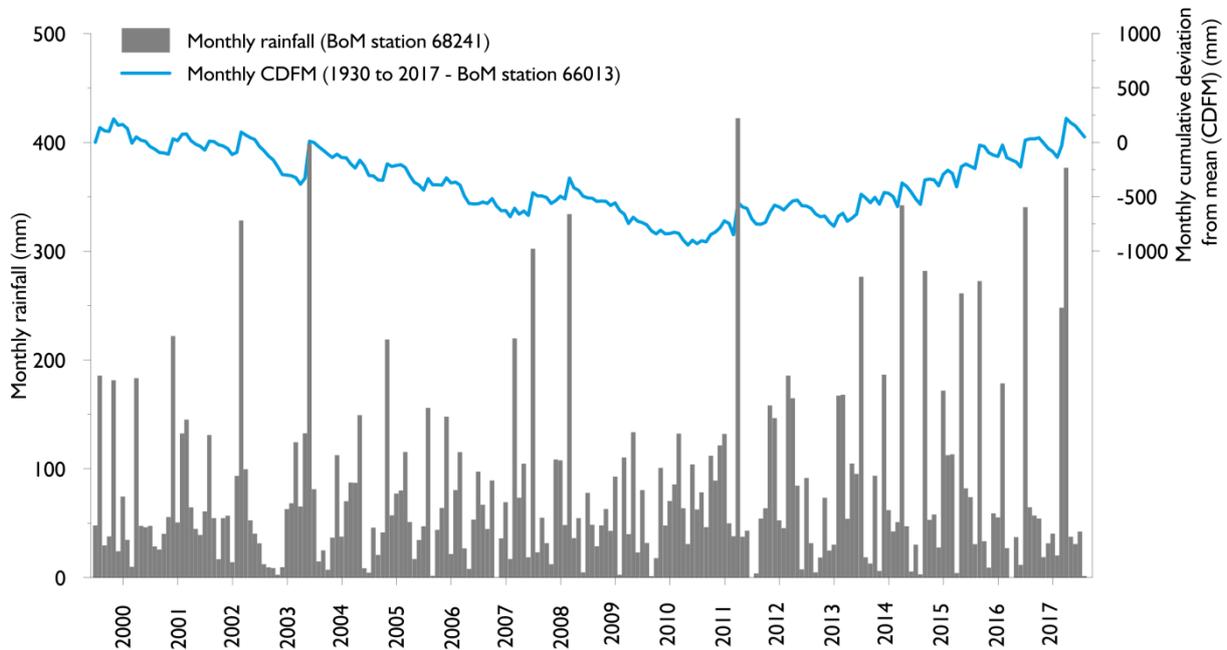
Figure 2.1 Cumulative deviation from long term monthly mean rainfall

The cumulative deviation plot for Albion Park shows a period of predominantly below average or average rainfall from 1999 until late 2007, followed by a brief above average rainfall period. Since 2010 rainfall has been mostly above average (Figure 2.1).

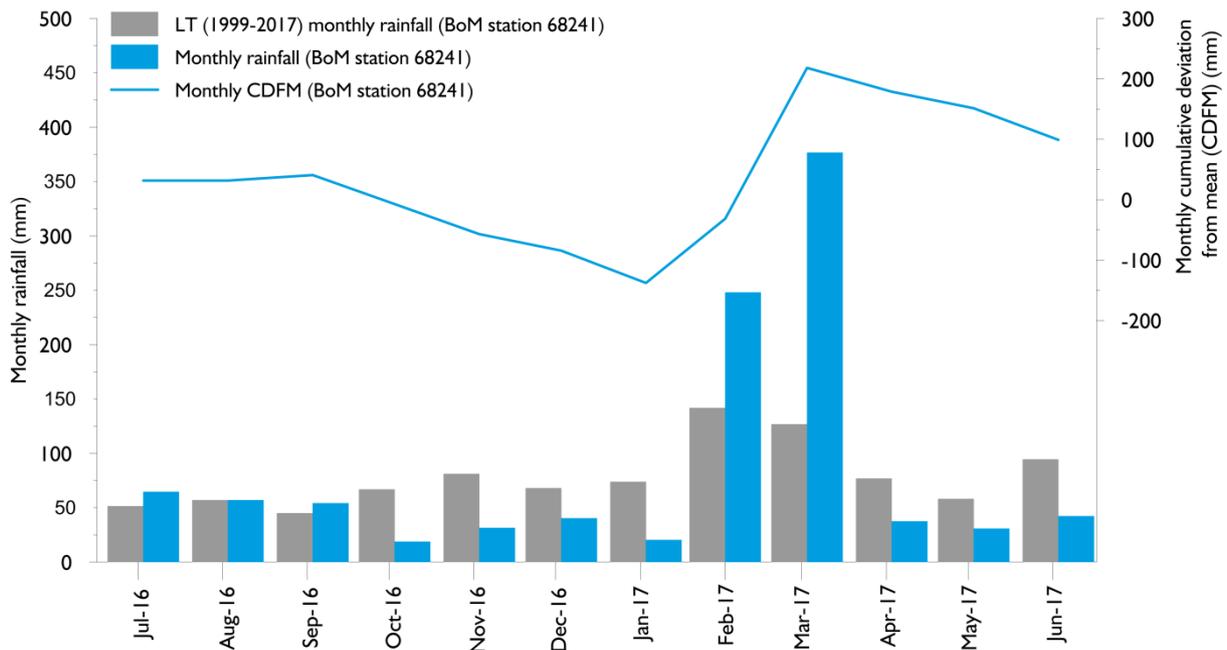
Figure 2.2 Monthly rainfall for the 2016/17 monitoring year (June 2016 to May 2017)

Total monthly rainfall for the 2016/17 monitoring year differed from the long-term average, with a period of below average rainfall observed from July 2016 to January 2017, followed by a period of above average rainfall in February and March 2017, after which rainfall returned to be below average (Figure 2.2).

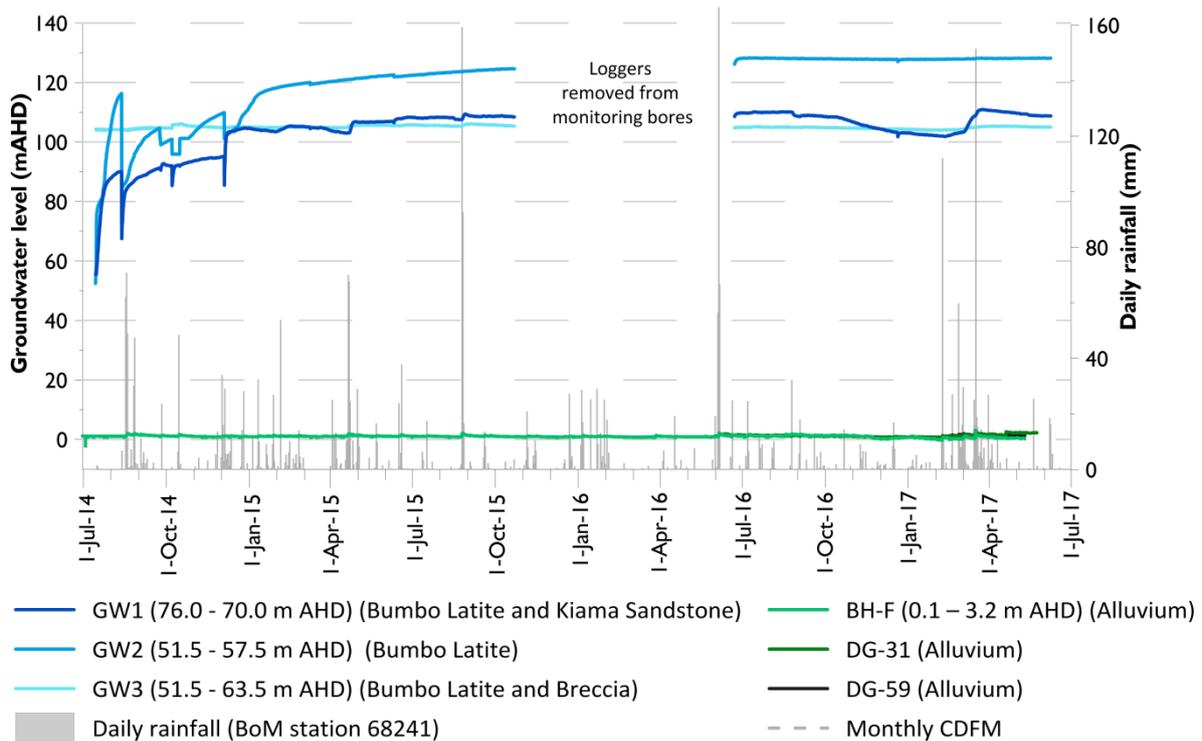
Figure 4.1 Groundwater levels

Hydrographs showing groundwater levels and rainfall from the start of monitoring until June 2017 are presented in Figure 4.1. Individual hydrographs for each monitoring bore are included in Appendix A.

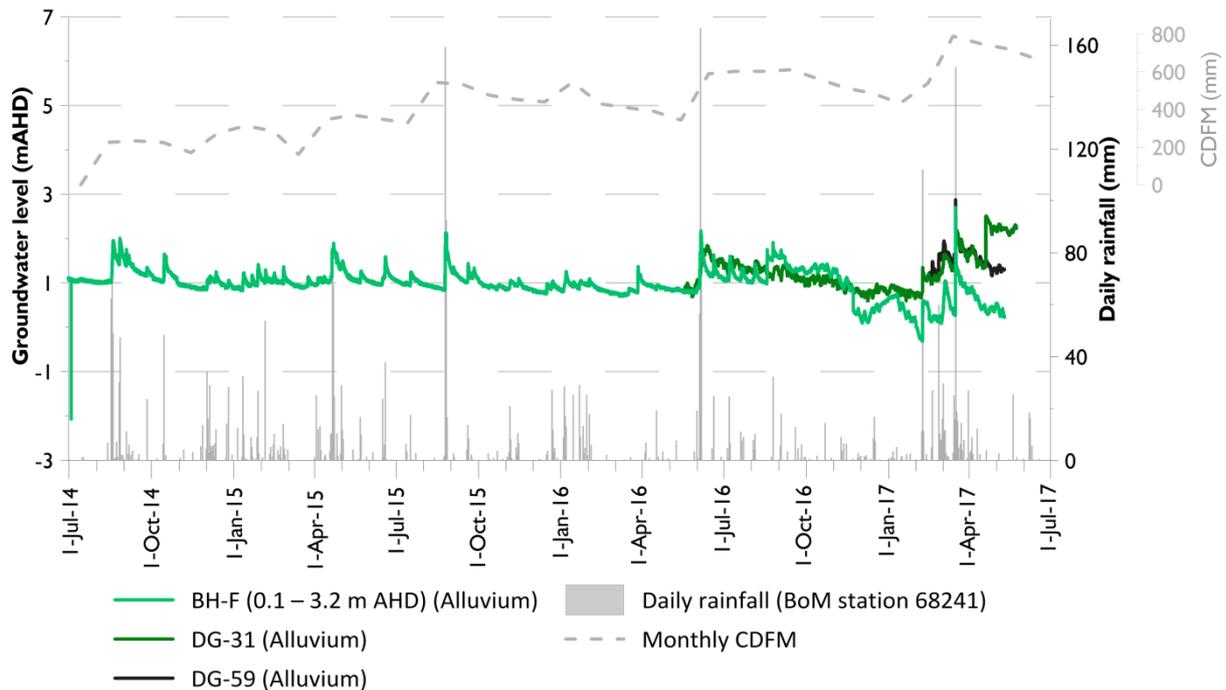
Figure 4.2 Groundwater levels in the alluvium

During the monitoring year, groundwater levels increased in response to the high rainfall events in March 2017, after which they receded to pre-rainfall levels. The water levels receded to pre-rainfall levels in less than a month at BH-F and DG-59 and over a period of up to two months at DG-31 (Figure 4.2).

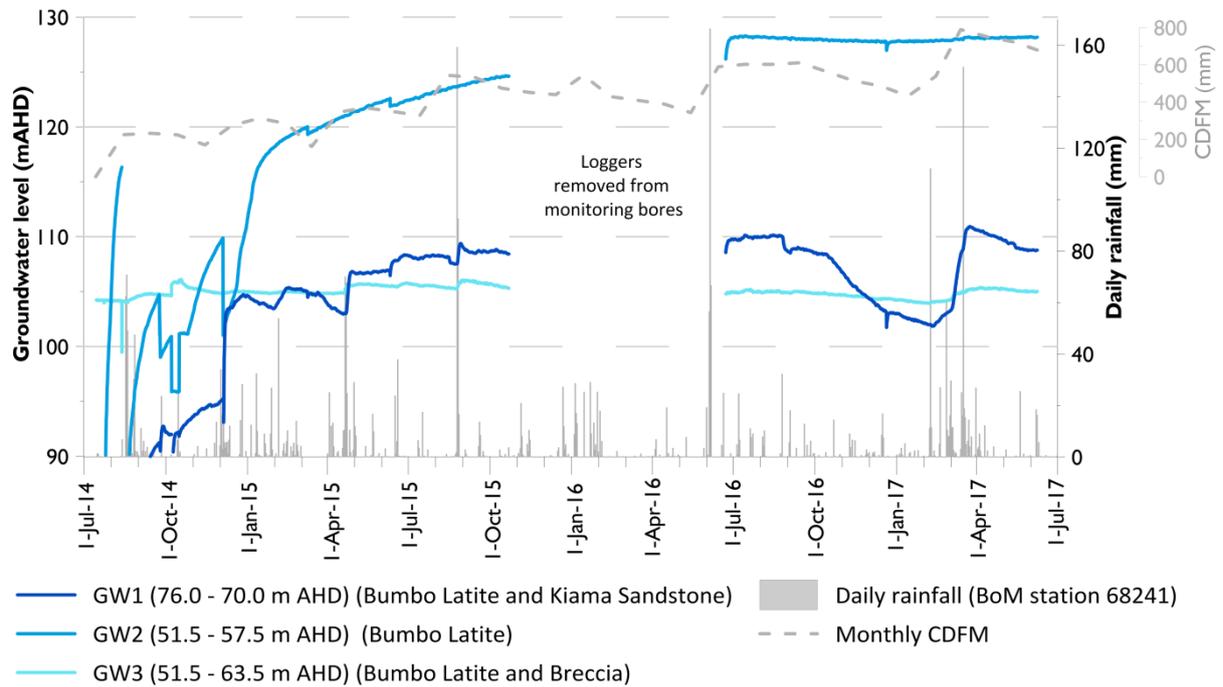
Figure 4.3 Groundwater levels in the Bubmo Latite

Monitoring bore GW2 shows little apparent response to individual rainfall events (approximately 0.4 m increase).

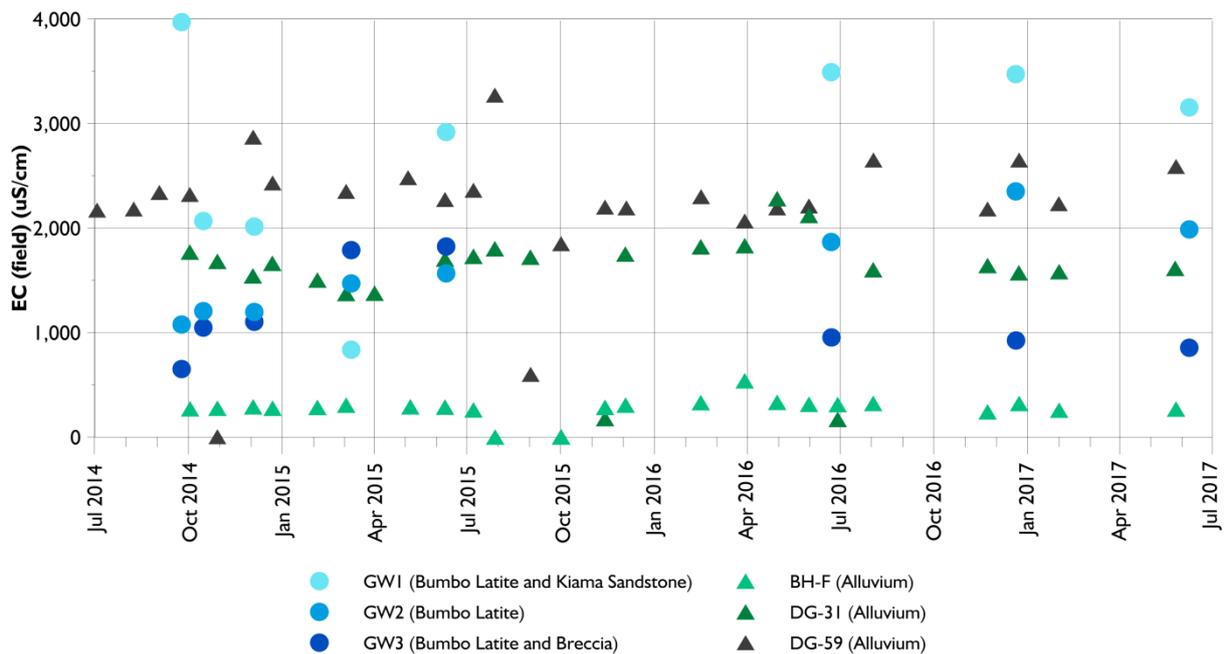
Figure 5.1 EC time series for the alluvium and Bumbo Latite monitoring bores

Groundwater EC and pH were overall comparable to previous monitoring years.

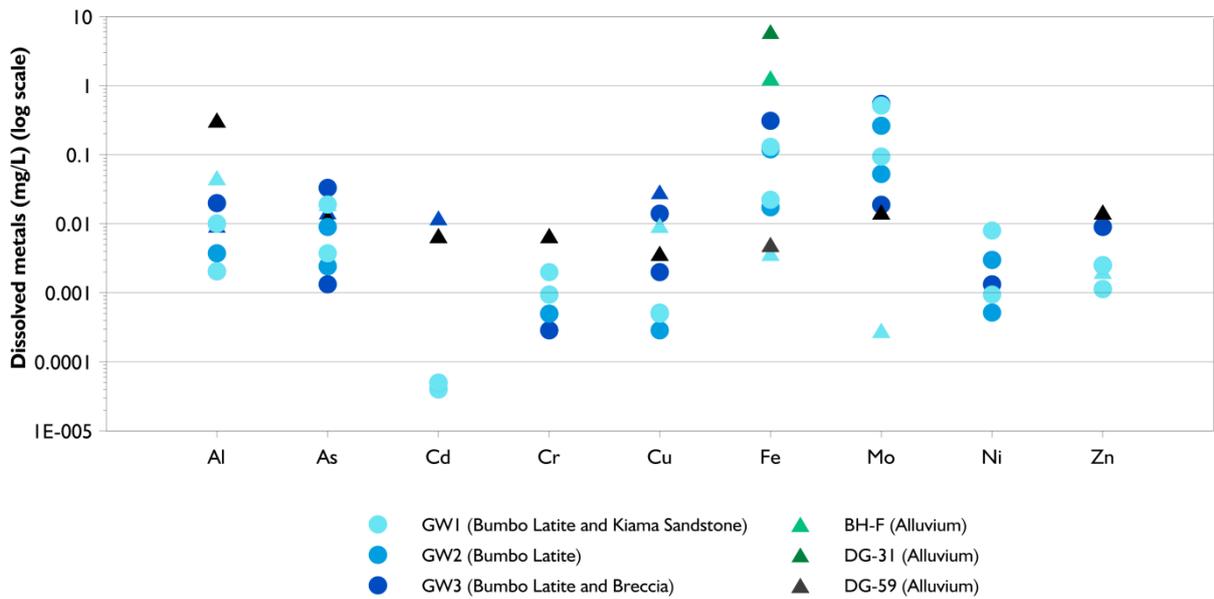
Figure 5.4 Dissolved metal concentrations for the alluvium and Bumbo Latite monitoring bores (2016/17 monitoring year)

- dissolved metal concentrations in the alluvium were comparable to previous years and are generally the highest at monitoring bores BH-F and DG-31; and
- dissolved metal concentrations in the Bumbo Latite were comparable to previous monitoring years and overall comparable amongst the three monitoring bores.

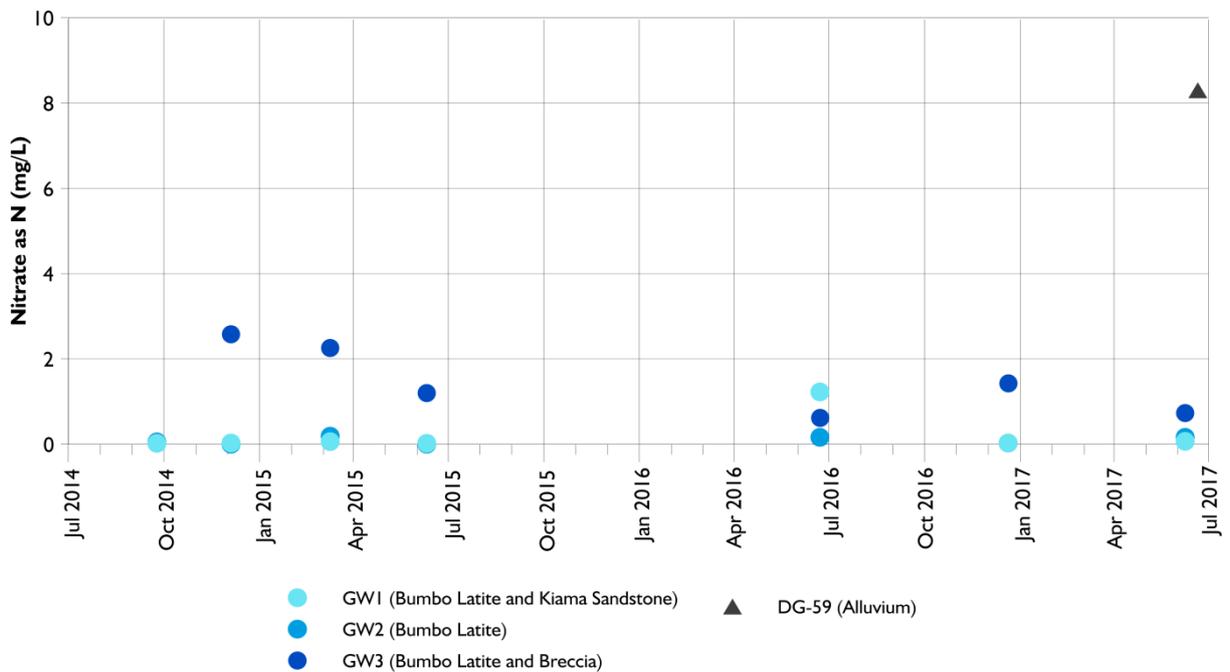
Figure 5.5 Nitrate time series for alluvial monitoring bore DG-59 and Bumbo Latite monitoring bores

Time series of nitrate and total phosphorous concentrations are presented in Figure 5.5 and Figure 5.6 respectively.

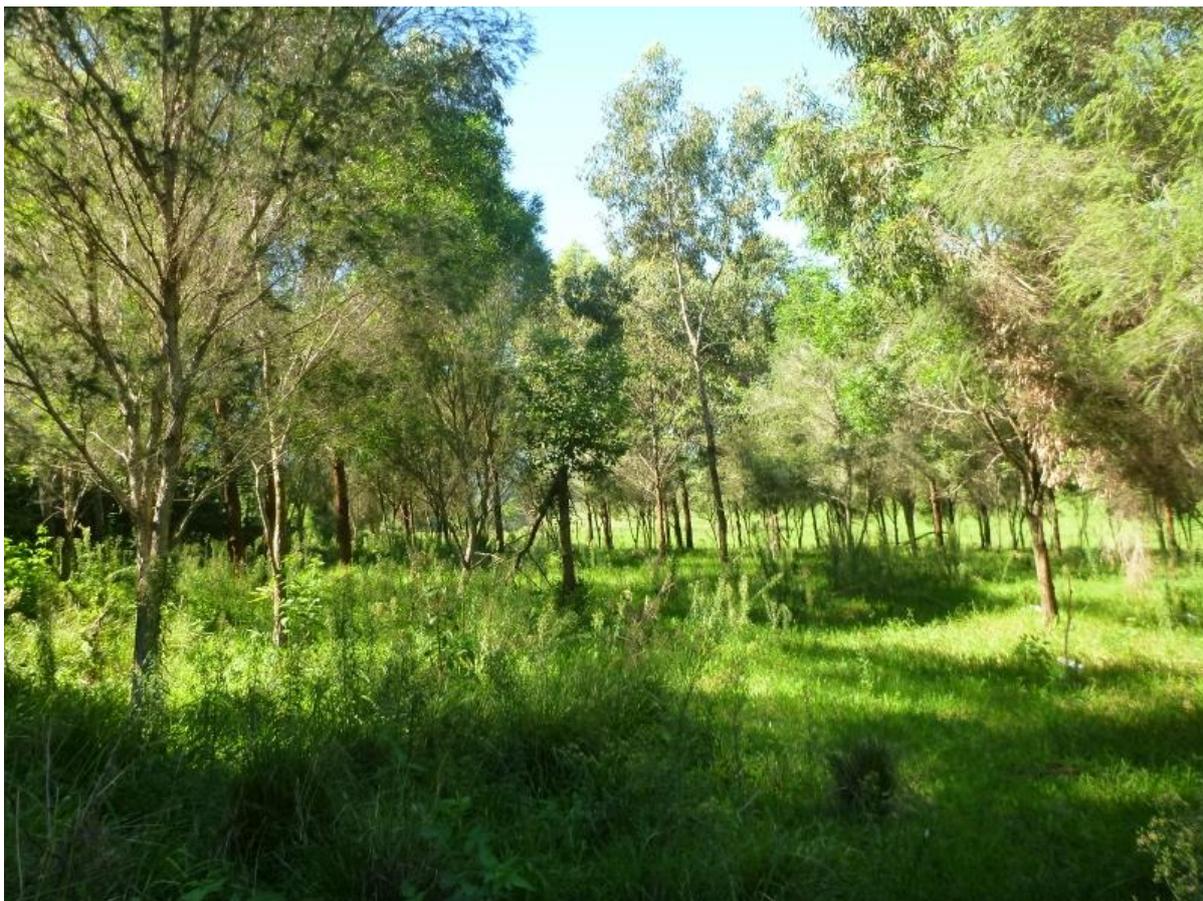
Revegetated area at the lower end of the gully showing sparse plantings of woodland species. Infill planting of rainforest pioneer species will create a closed canopy to assist weed suppression

Regeneration of weed species within the planted areas	Weed control will be required within the planted areas to reduce competition and assist plant establishment
Use of inappropriate tree species in the planting program	Planting species specific to the site conditions. (See appendix 1 for suitable species planting list)
Several of the species used within the planting areas have been heavily grazed by stock	Exclusion of stock using fencing and ensuring gates are closed

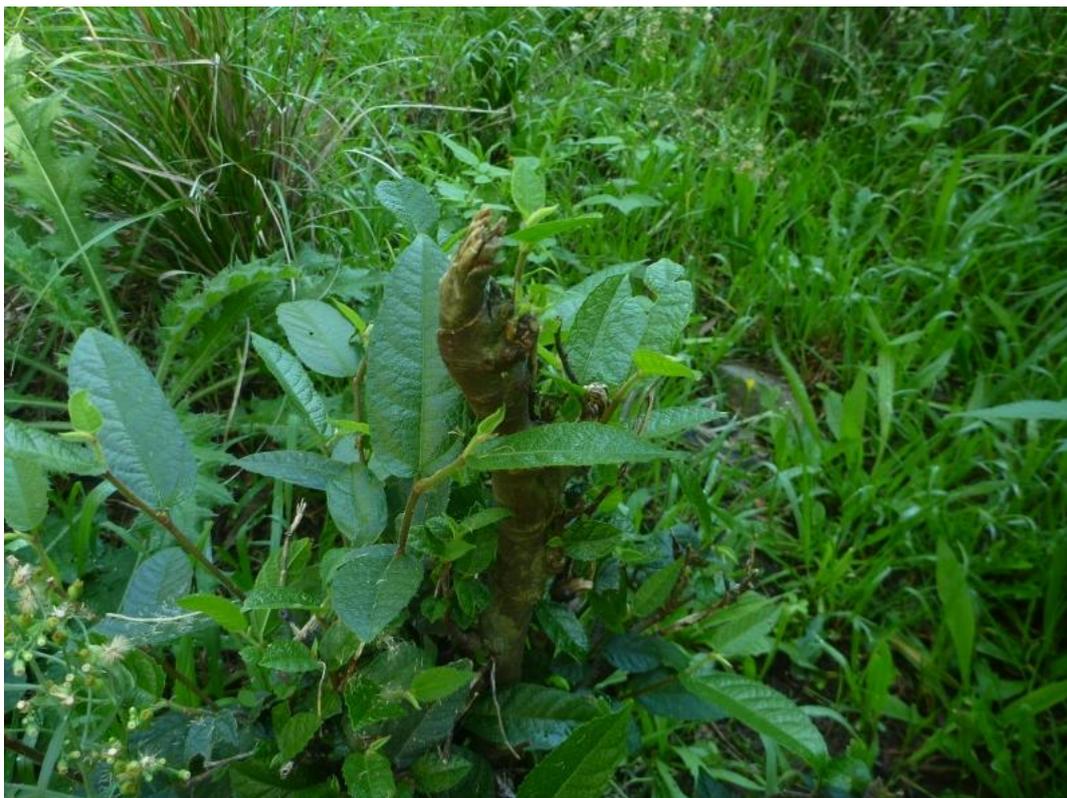
Sandpaper Fig (*Ficus coronata*) suffering from heavy grazing

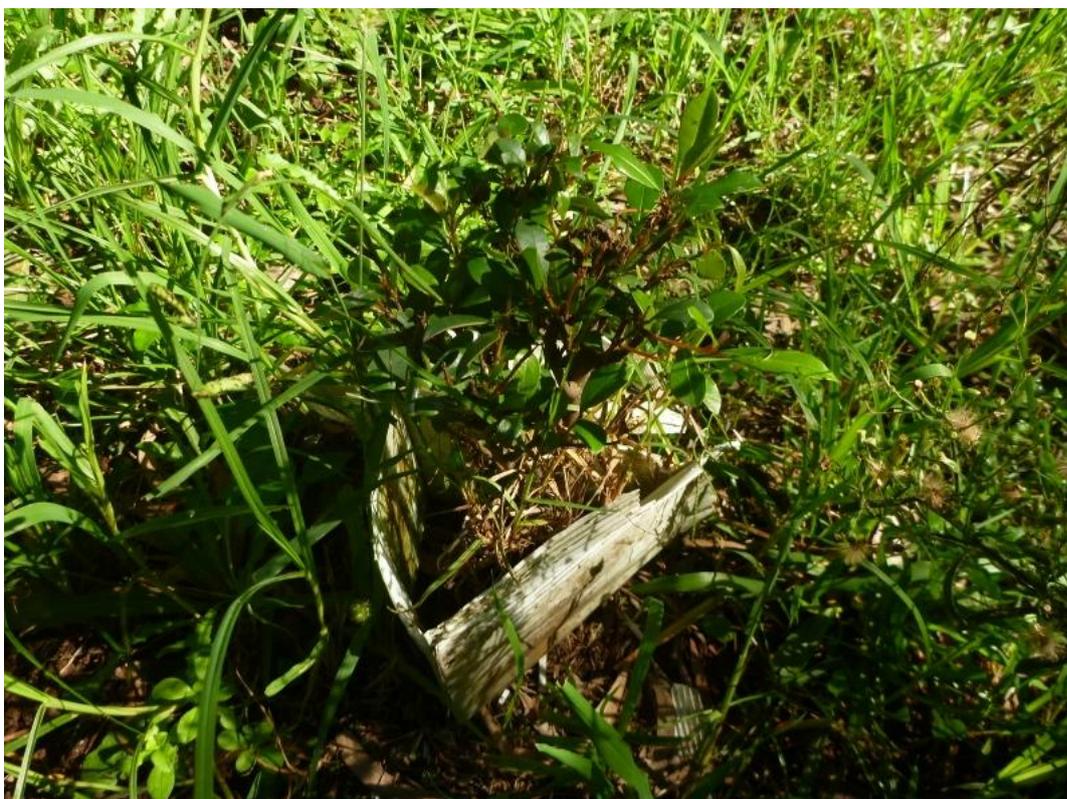
Brush Cherry (*Syzygium australe*) suffering from heavy grazing and with old worn plant guard still intact

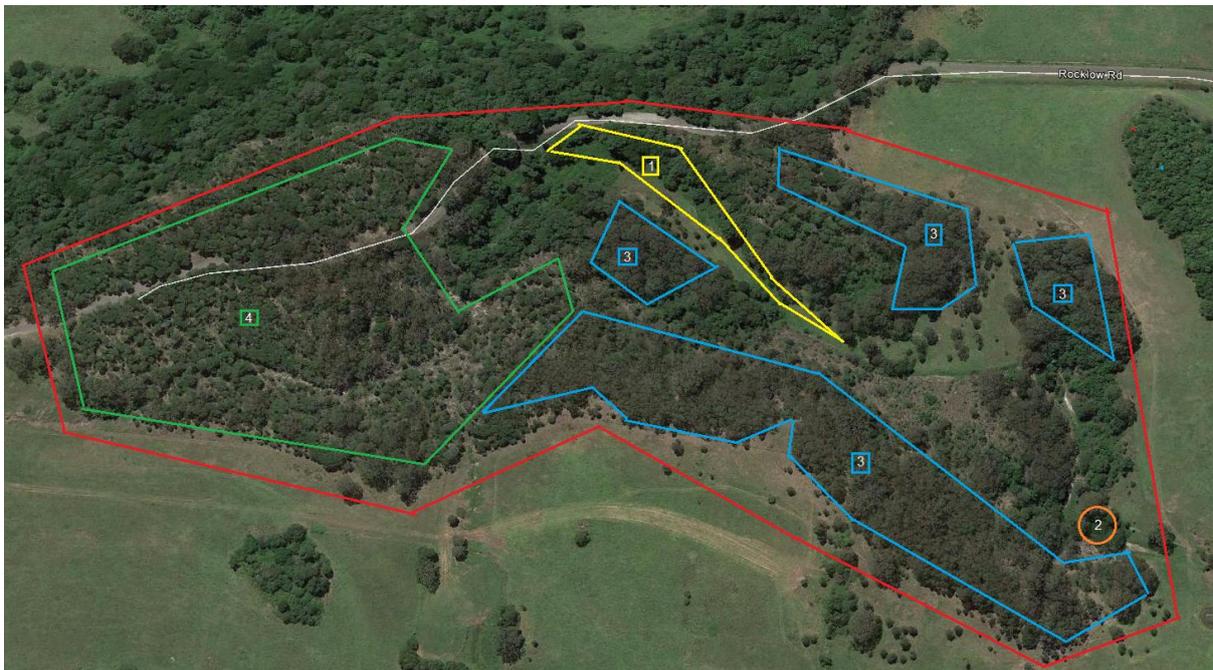
1. Madiera vine (*Anredera cordifolia*) population covering approximately 1,500m²
2. Coral Tree (*Erythrina x sykesii*) stand comprising approximately 30 individual stems
3. Grassy Woodland remnant with a dense Lantana understory covering approximately 26,500m²
4. Melaleuca armillaris Tall Shrubland area with many mature individual African Olive (*Olea europa subsp. cuspidata*) plants. The ground layer within this entire community has become infested with annual grassy weeds and planting and assisted regeneration of native groundcovers will be beneficial to help out compete these weeds
