Dunmore Hard Rock Quarry Annual Review

1 July 2020 – 30 June 2021

| Name of operation | Boral Dunmore Hard Rock Quarry |
| Development consent | DA-470-11-2003 |

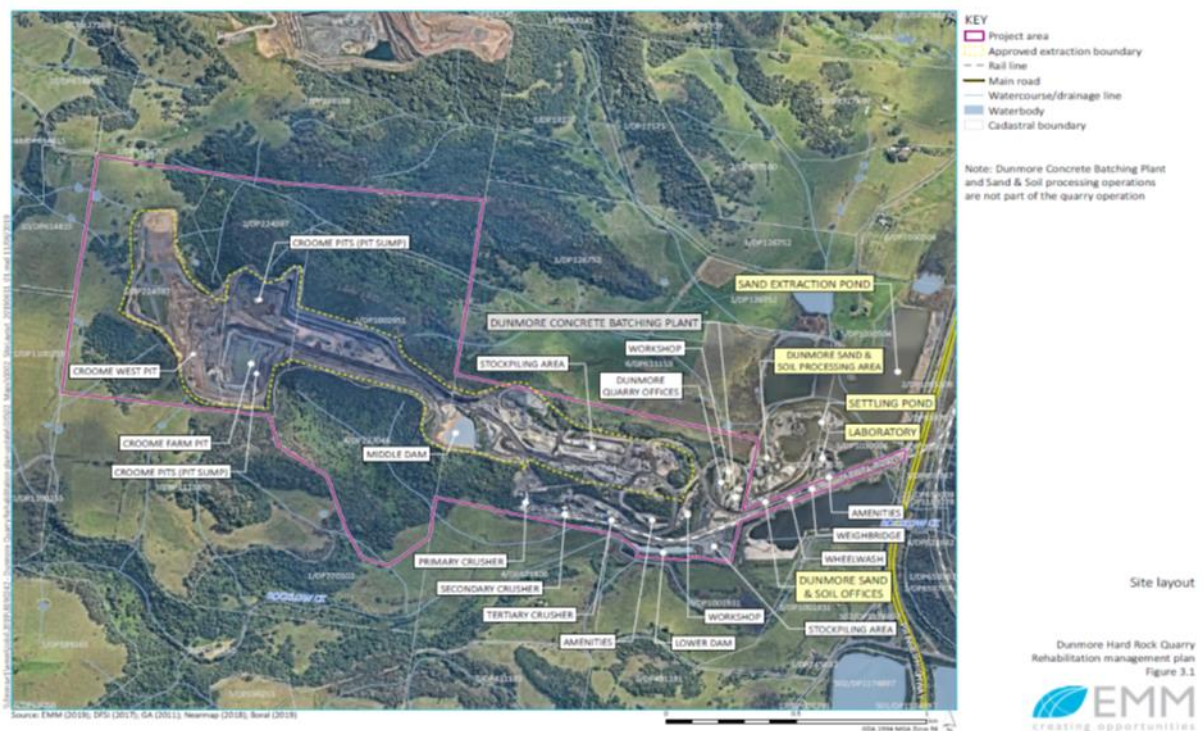
Figure 1 Dunmore Site Layout

During the reporting period extraction has occurred in the area known as the Croome West Pit. Approval of the most recent modification, MOD 11, was granted in March 2019. The site layout is shown below in Figure 1.

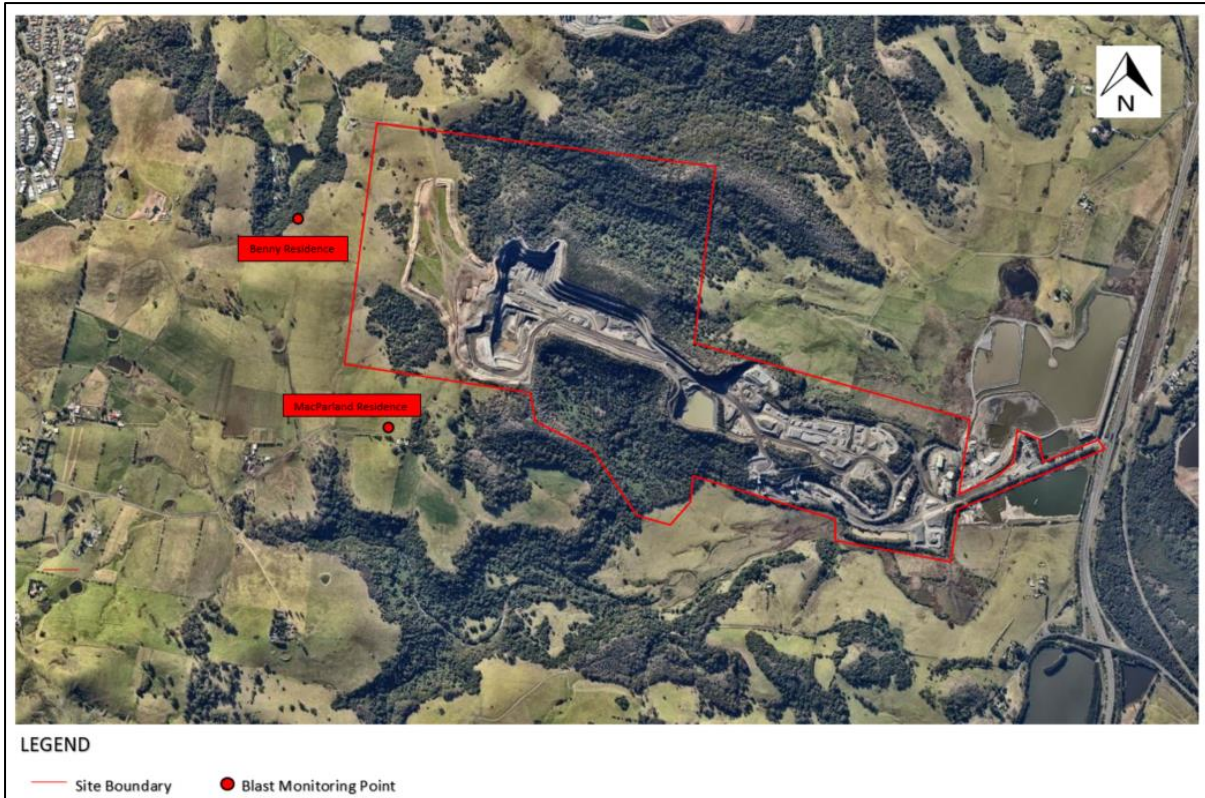
Figure 10 Blast Monitoring Locations

S4C16 and S4.C17 outline the blast monitoring parameters which are assessed at the nearest receiver, the Benny Residence. Monitoring at the Benny residence indicated compliance with all relevant blast parameters during the reporting period. Monitoring Points are shown in Figure 10.

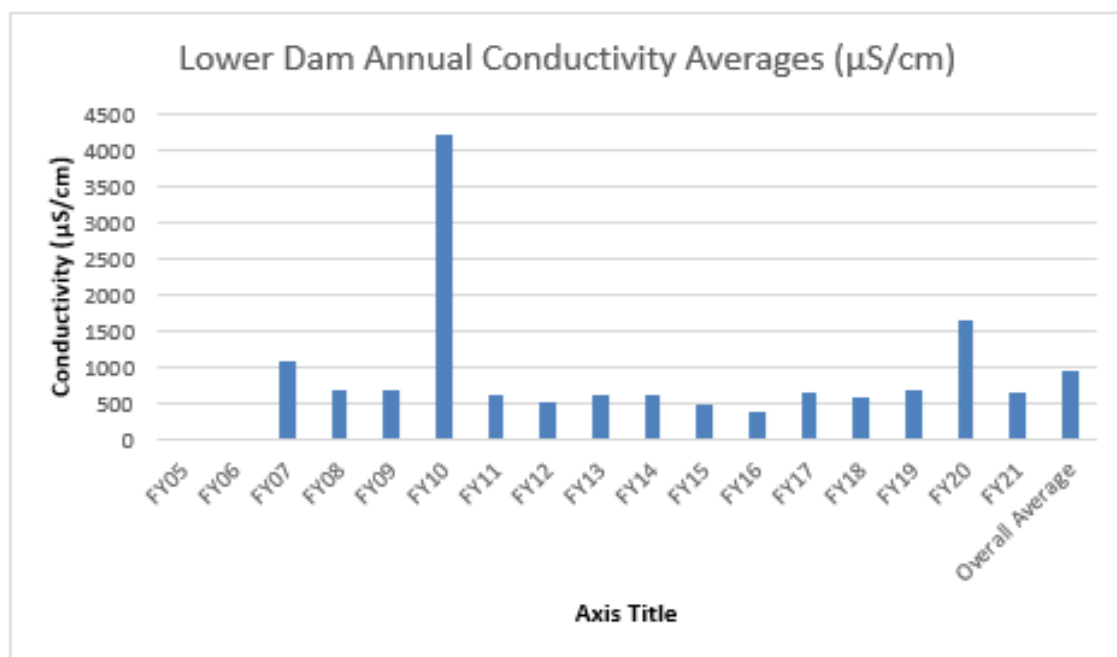
The Lower Dam (GS-4/EPL#8) ambient water quality for FY21 was below average for TSS and turbidity and relatively consistent for pH. Conductivity was slightly higher for FY21 than the overall average. The increase in conductivity is likely due to the dry conditions experienced throughout the year where evaporation was typically greater than rainfall. These trends are visible in Figures 23 to Figure 26 below.

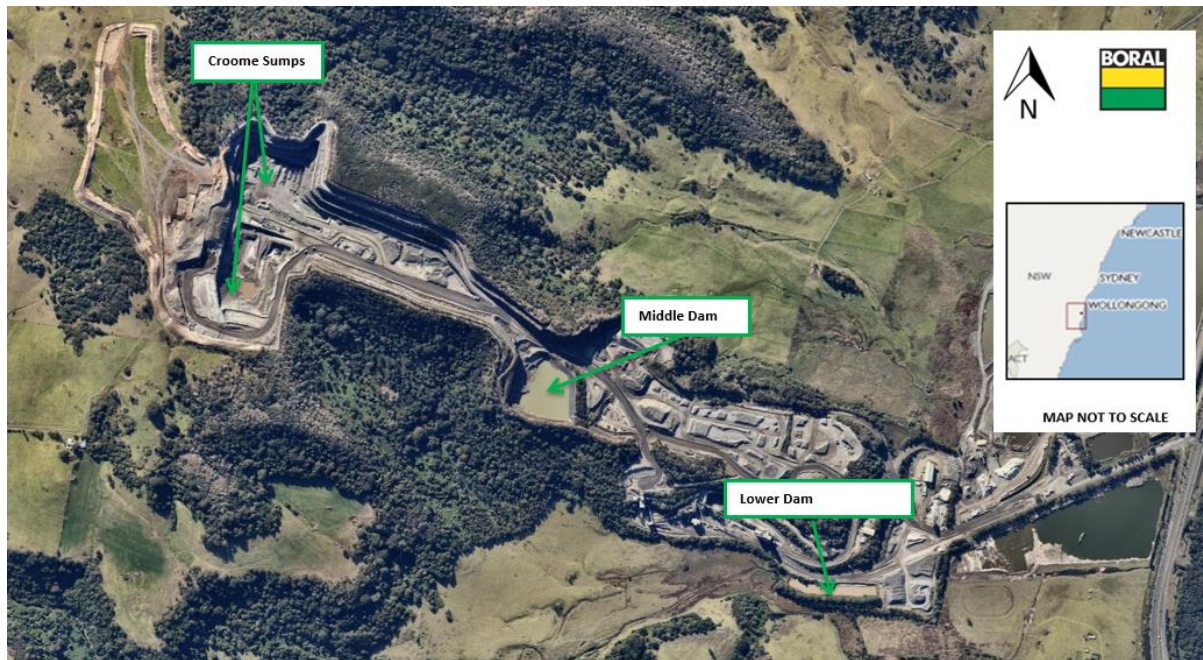
Figure 27 Water Storage Locations

All process water was sourced by either the Lower Dam, Middle Dam or Croome Sumps, which are offline from Rocklow Creek as per water management upgrades undertaken in 2008 under MOD 4. The Location of water storage infrastructure is shown below in Figure 27.

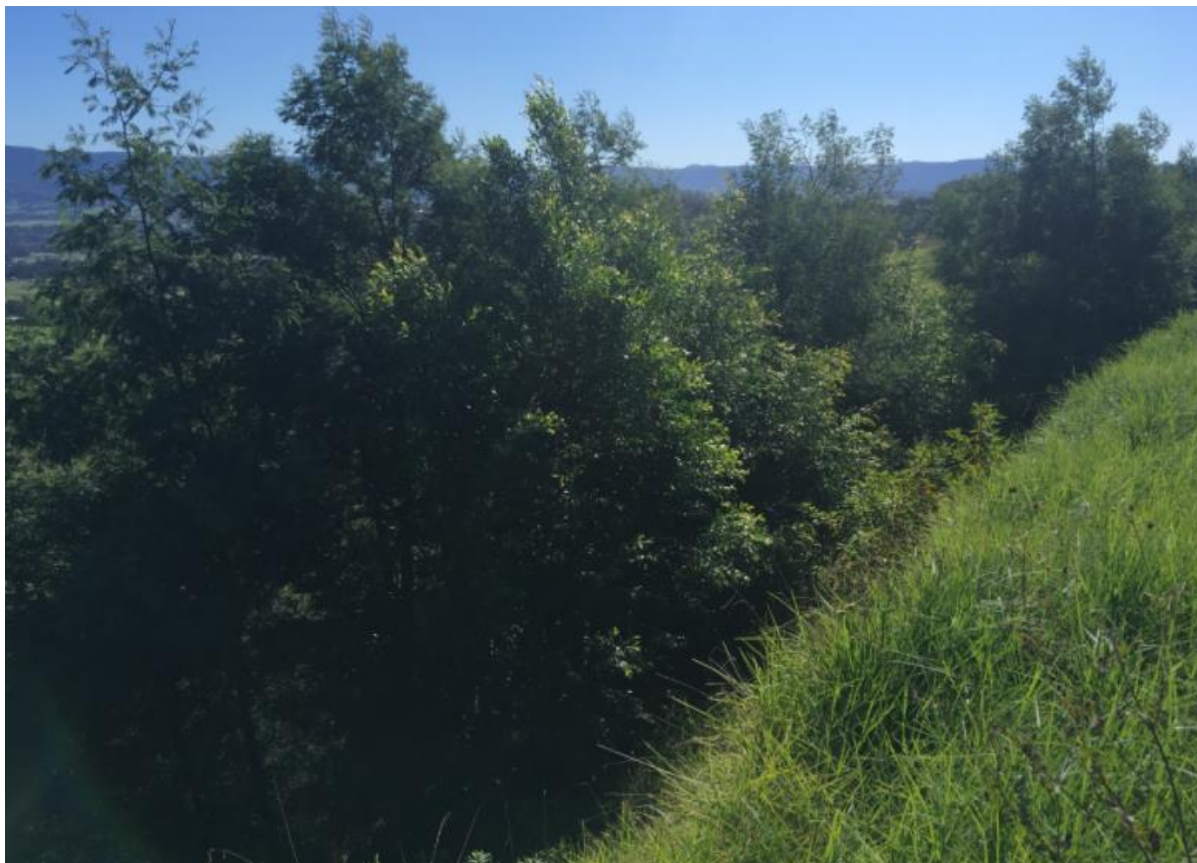
Figure 30 Hydroseeding cover and trees over Croome West Bund

Most areas of the site are currently operational and as such rehabilitation is not able to commence on the majority of areas within the quarry until the completion of extraction activities. When practical, progressive rehabilitation of the site will be undertaken in conjunction with on-going quarrying works. Hydroseeding of the Croome West Bund is now well established with trees as shown below in Figure 30.

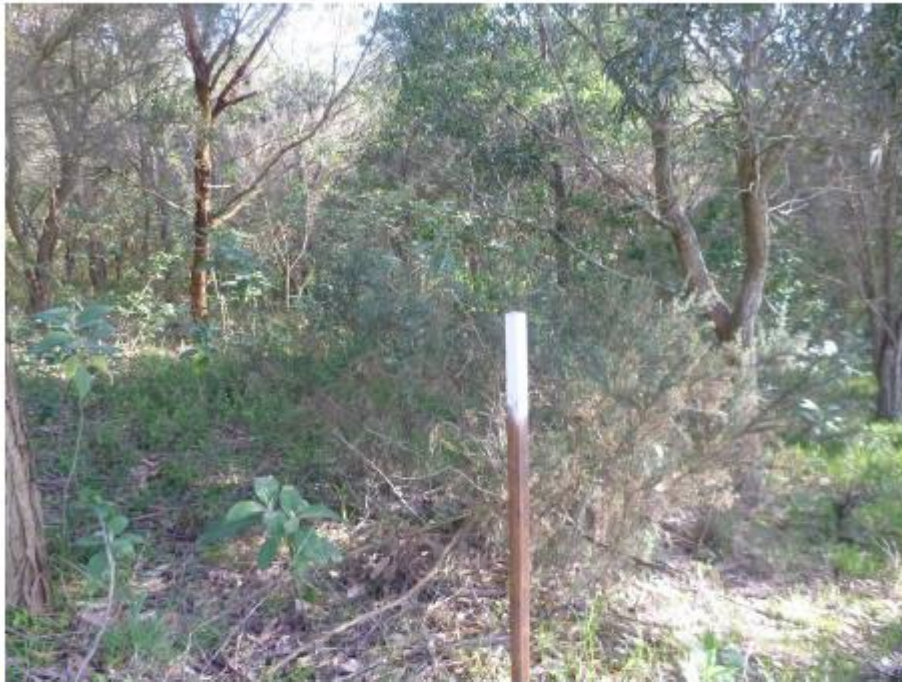
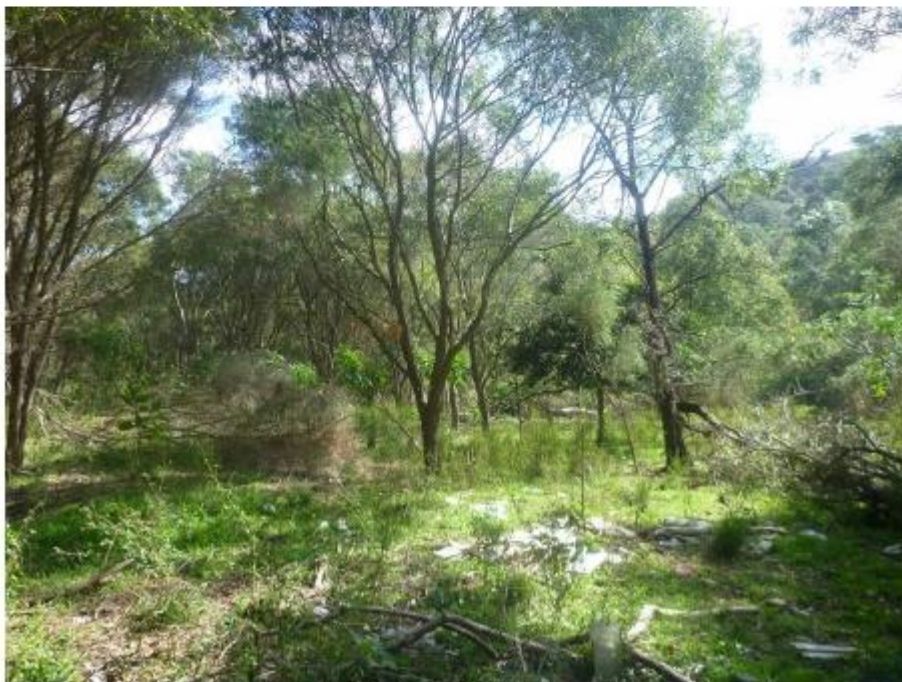
Figure 32 Photomontage of vegetation condition at RVCA1

RVCA1 Photo point prior to primary weed control November 2019 (photo point marker was removed)

Similar area after primary weed control, September 2020

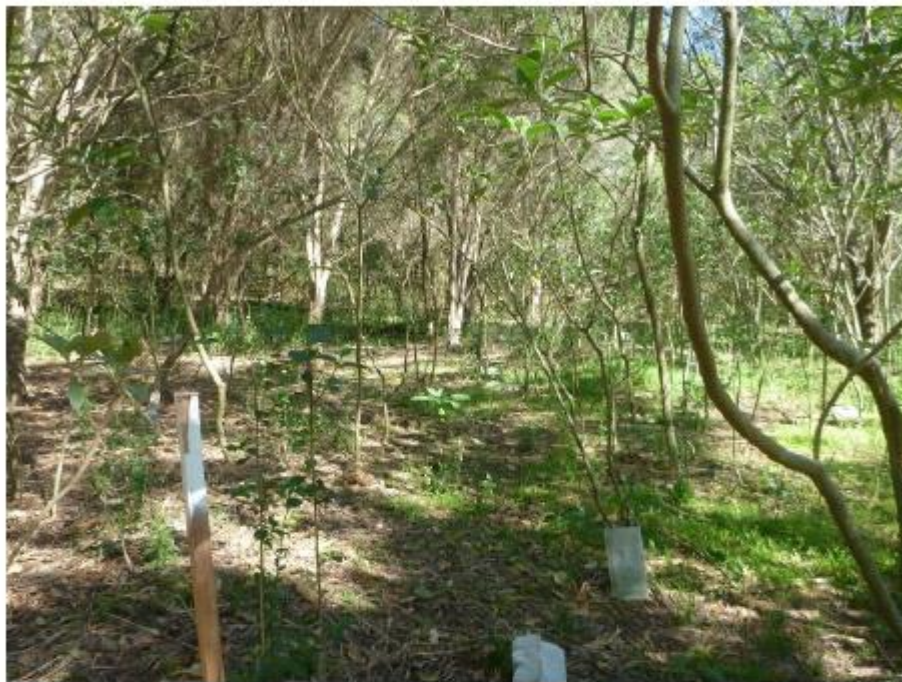
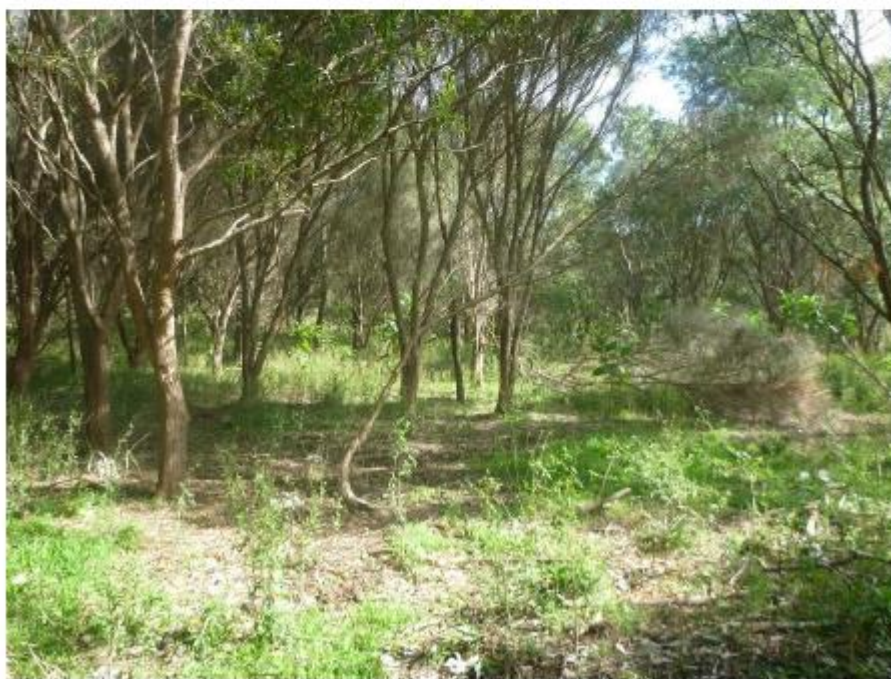
Figure 33 Photomontage of vegetation condition at RVCA2

RVCA2 Photo point prior to primary weed control November 2019 (photo point marker was removed)

Similar area after primary weed control, September 2021

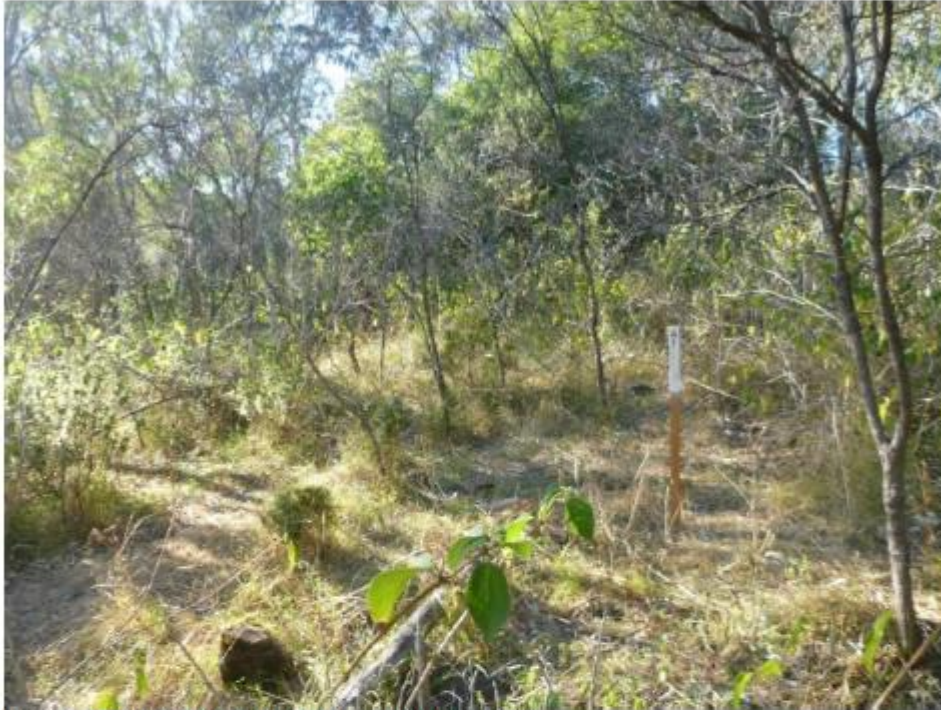
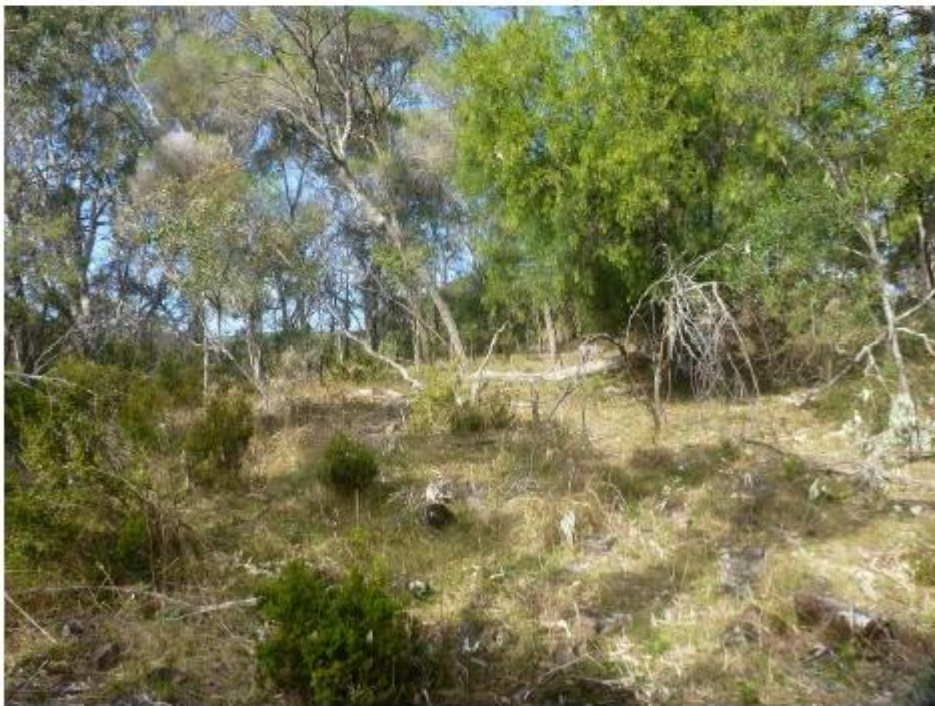
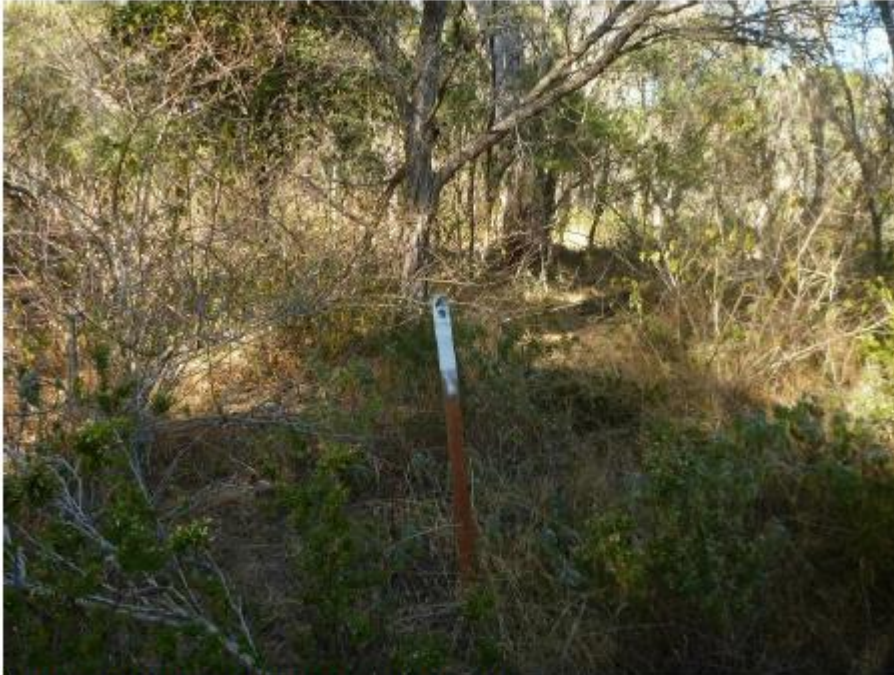
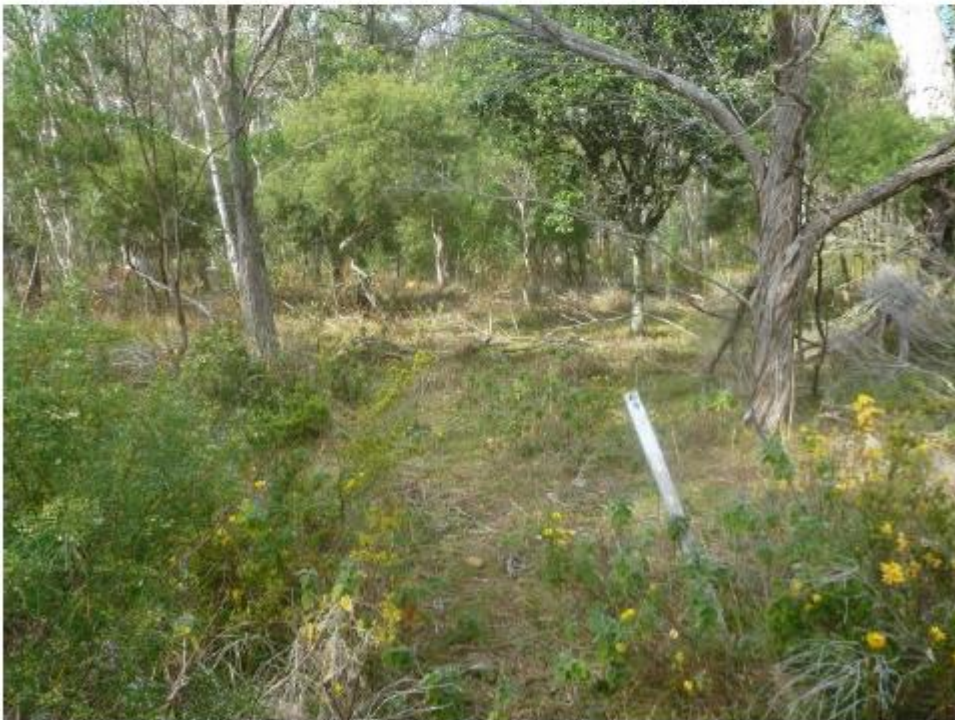
Figure 34 Photomontage of vegetation condition at Zone 2a

A1 Photo point prior to commencement of works in 2017

A1 Photo point after primary weed control and maintenance, September 2021

A3 Photo point prior to commencement of works in 2017

A3 Photo point after primary weed control and maintenance, September 2021

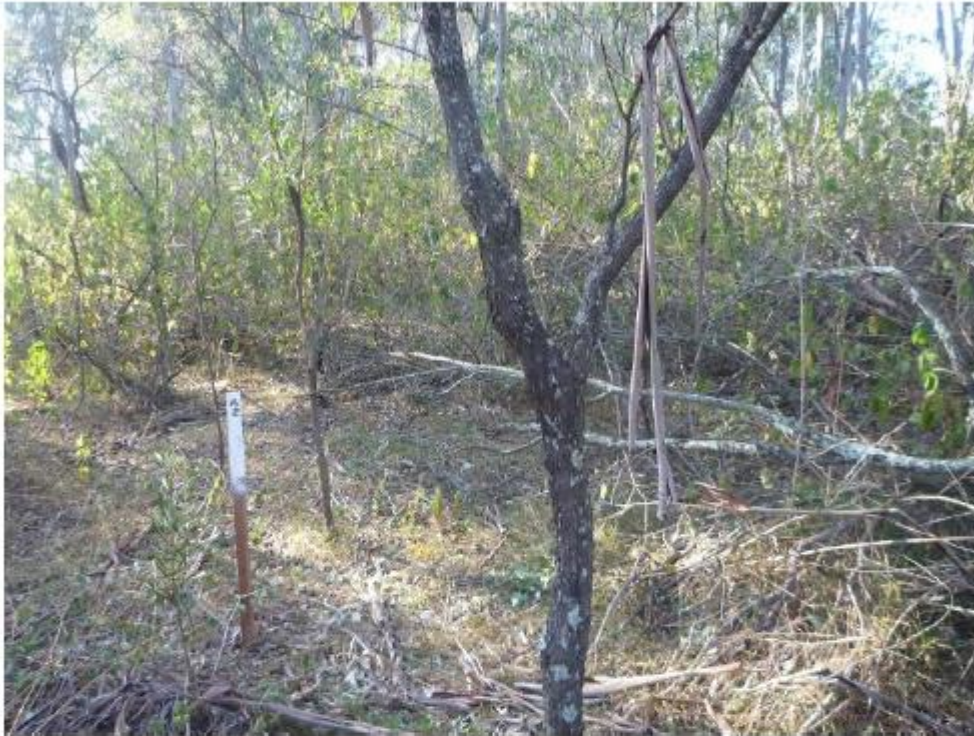
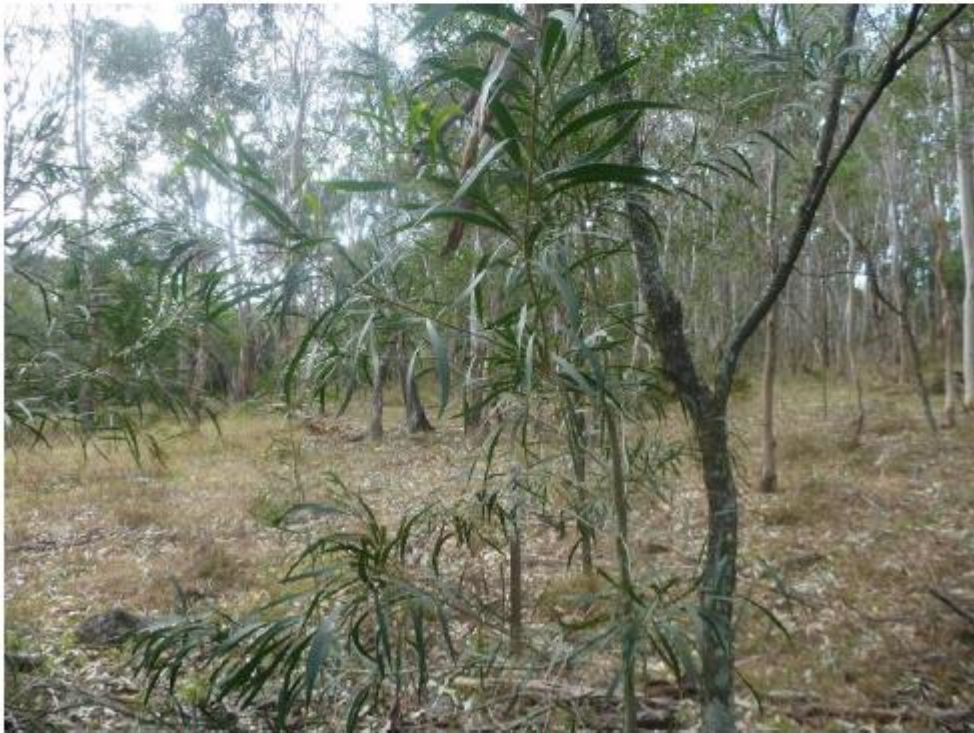
Figure 35 Photomontage of vegetation condition at Zone 2c

A2 Photo point prior to commencement of works in 2017

A2 Photo point after primary weed control and maintenance, September 2021

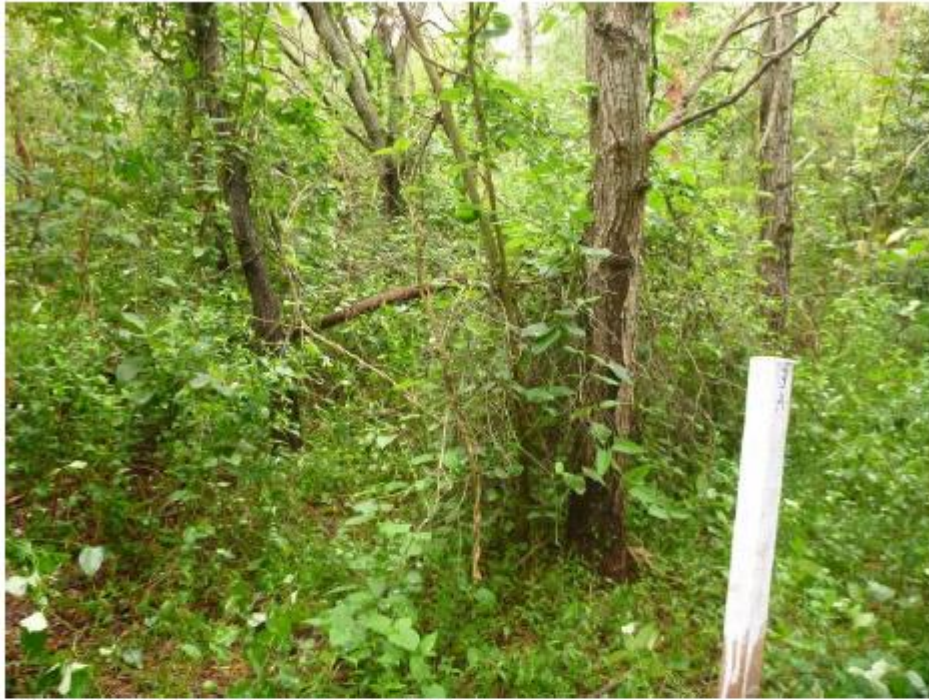
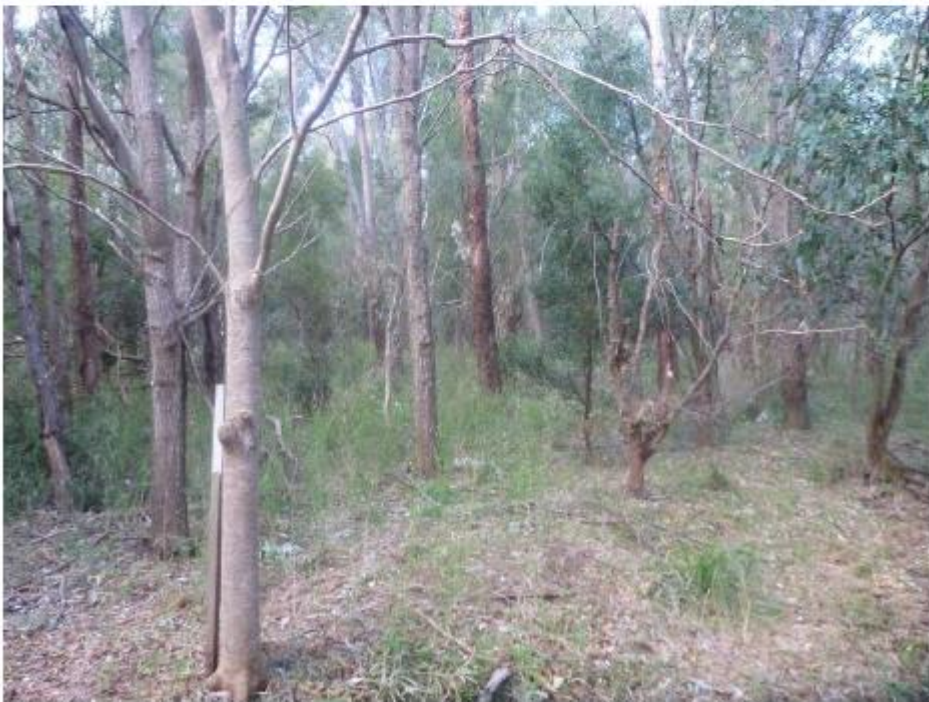
Figure 36 Photomontage of vegetation condition at Zone 3a

3A Photo point prior to commencement of works

The same view after primary and secondary weed control works, September 2021

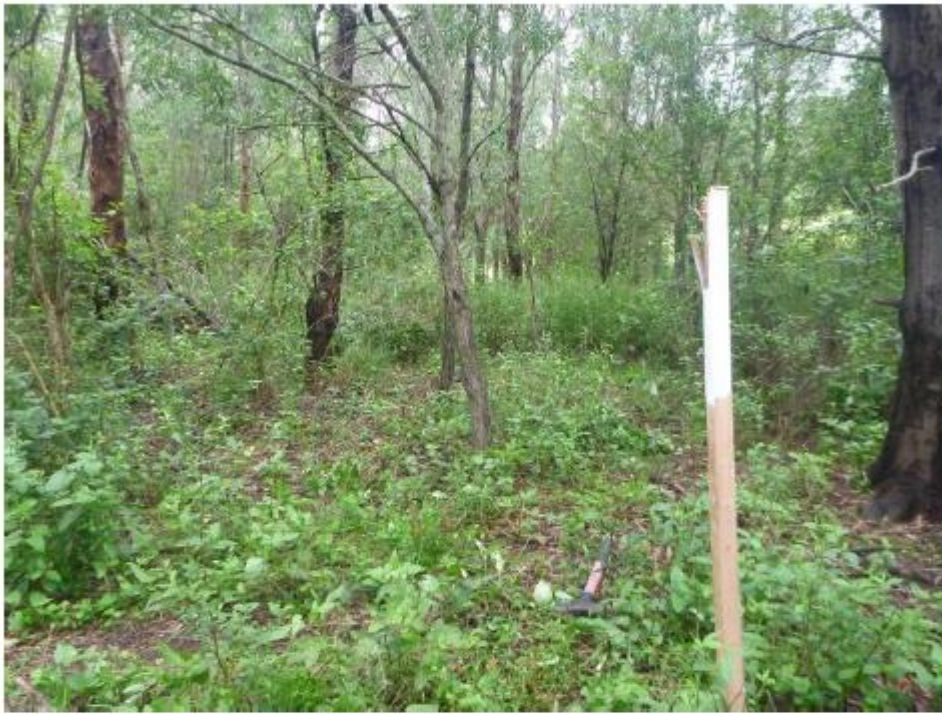
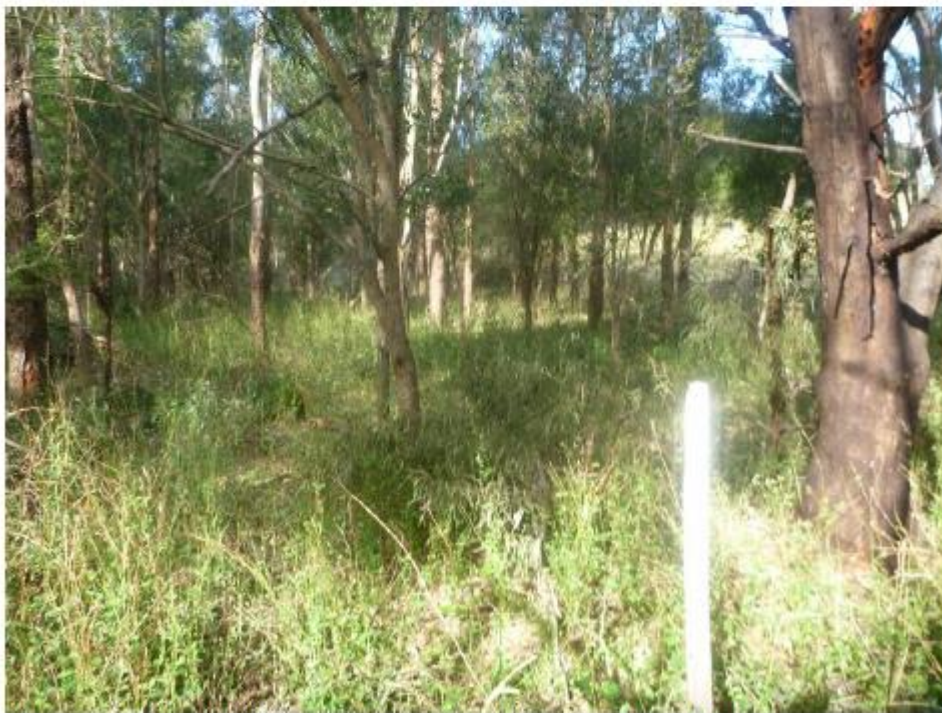
Figure 37 Photomontage of vegetation condition at Zone 3b

3B Photo point prior to commencement of works

The same view after primary and secondary weed control works, September 2021

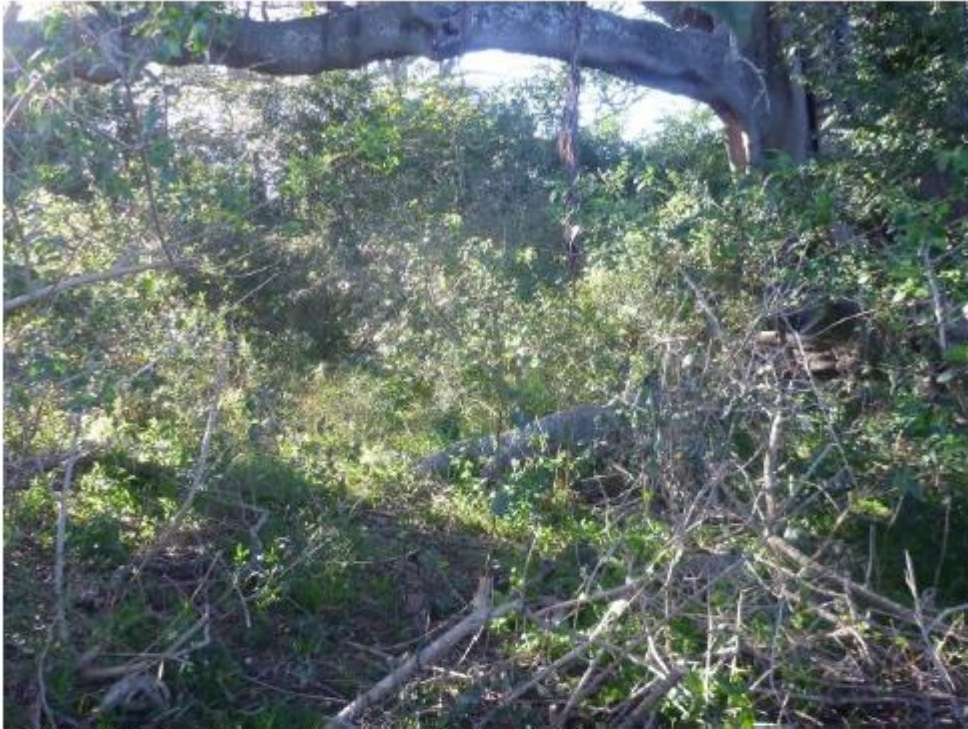
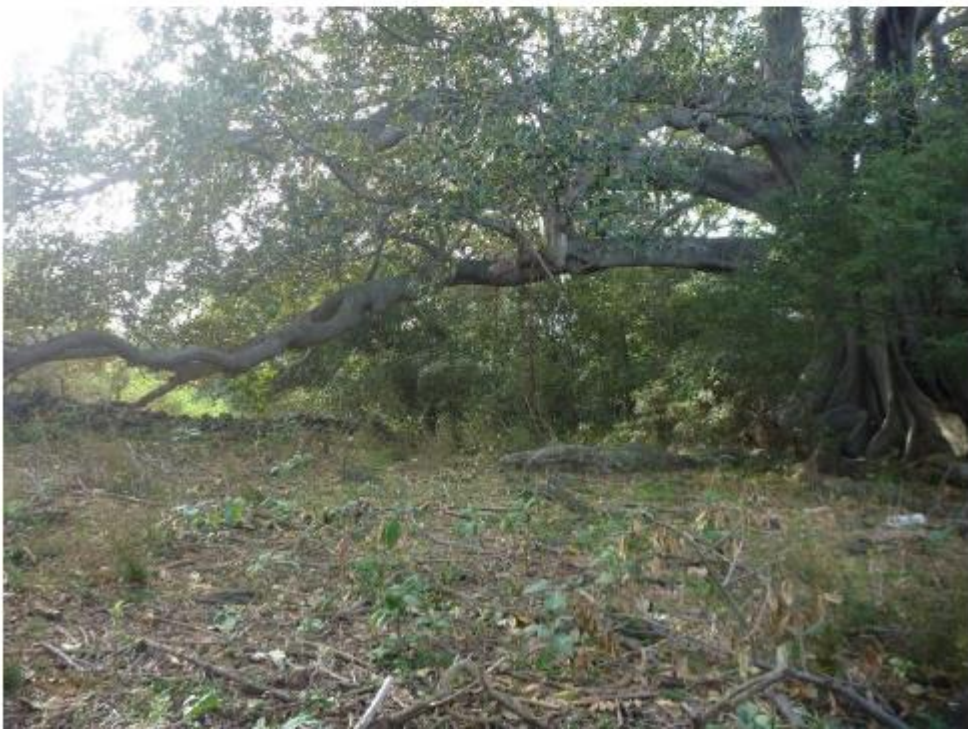
Figure 38 Photomontage of vegetation condition at Zone 3d

3D Photo point prior to commencement of works August 2020

3D Photo after primary weed control September 2021

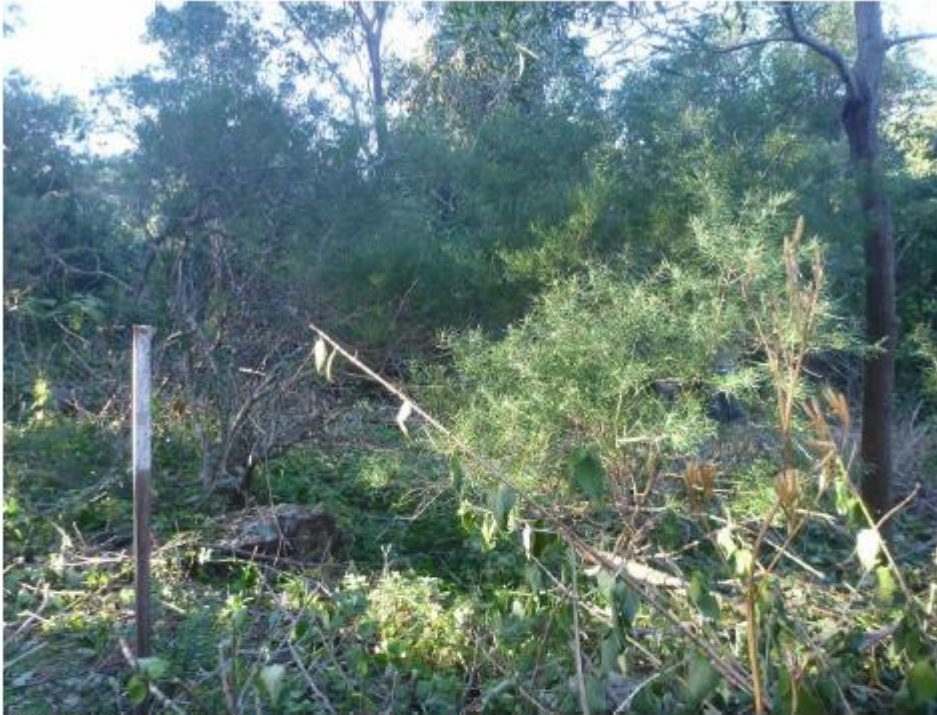
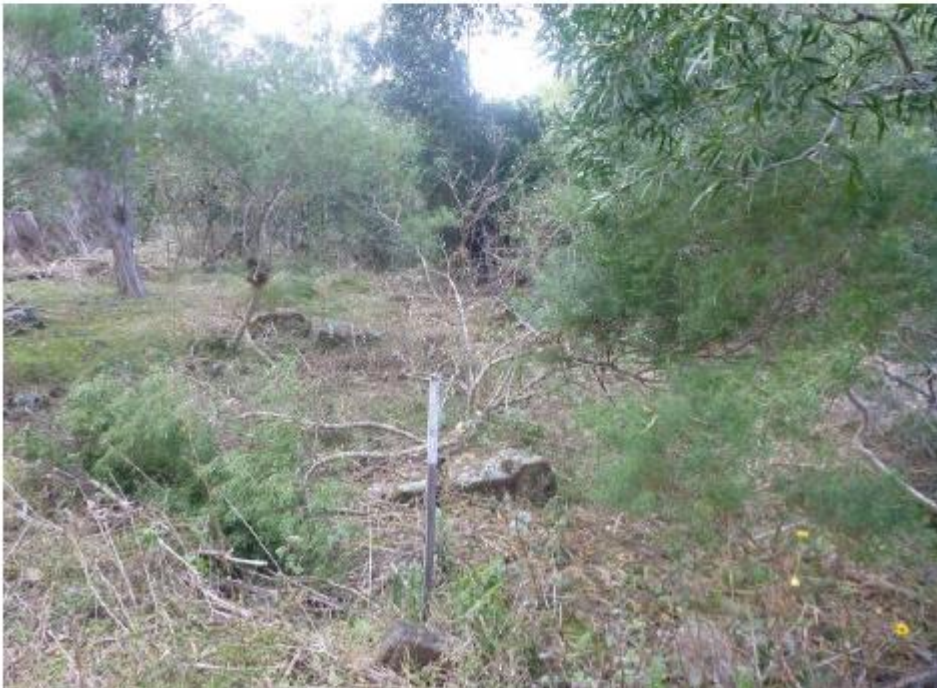
Figure 39 Photomontage of vegetation condition at Zone 3c

3C Photo Point before primary weed control August 2020

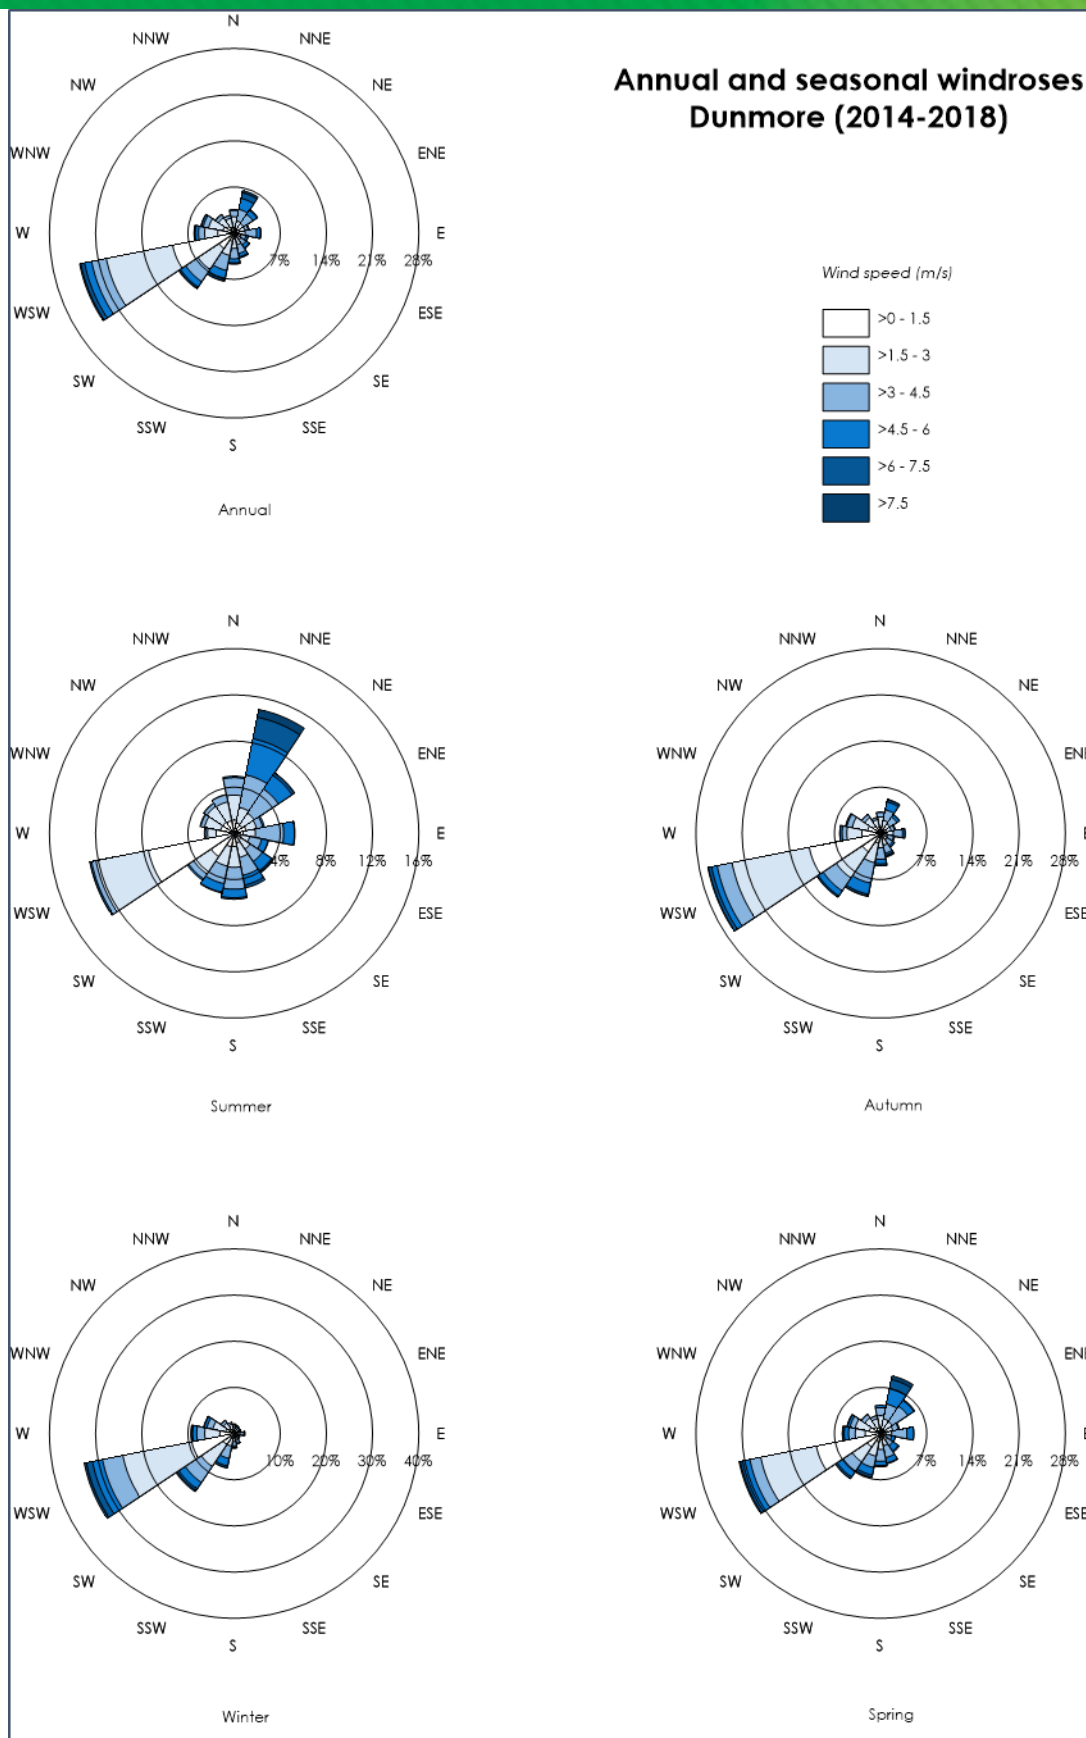
Figure 54 Dunmore Seasonal Wind Rose Data

Monthly wind roses and seasonal wind roses are shown in Figure 42 to Figure 53. Please note calm is defined as winds averaging less than 0.3m/s over the averaging period.
