Dunmore Hard Rock Quarry Annual Review

1 July 2022 – 30 June 2023

Dunmore Hard Rock Quarry Annual Review Title Block

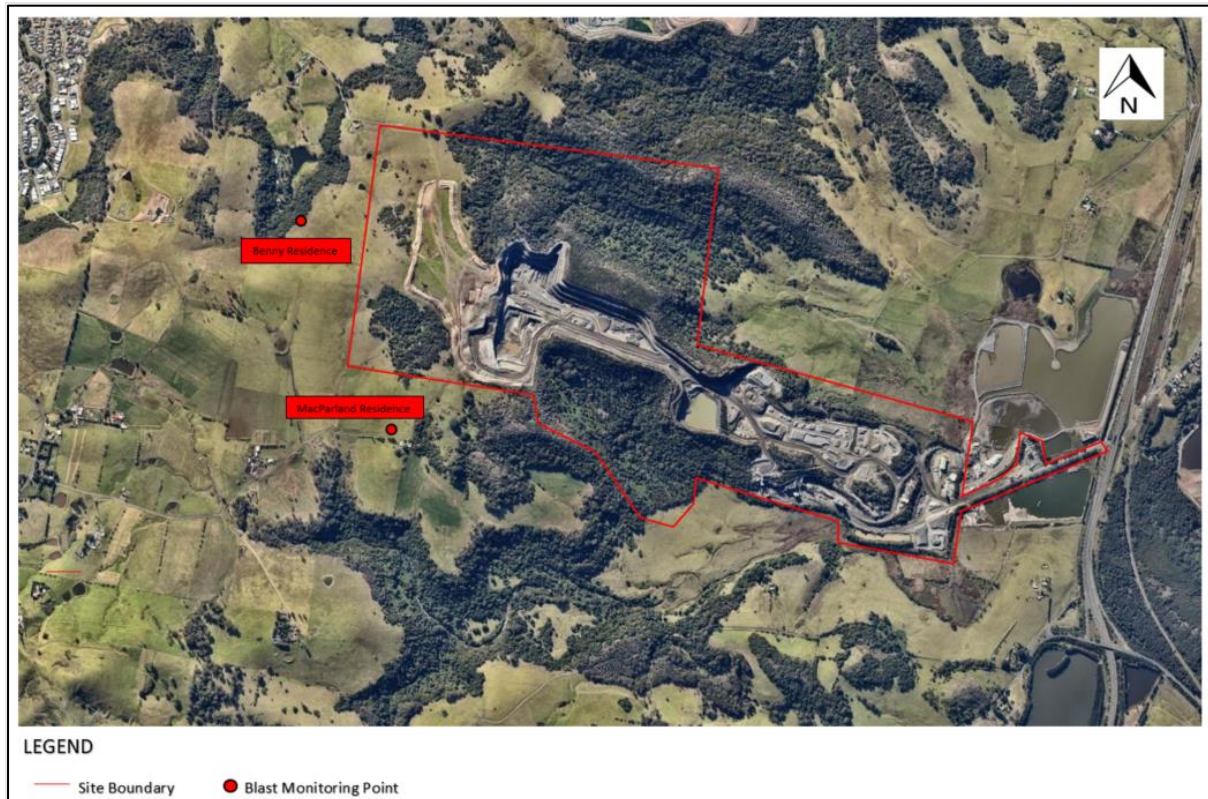
Figure 10 Blast Monitoring Locations

S4C16 and S4.C17 outline the blast monitoring parameters which are assessed at the nearest receiver, the Benny Residence. Monitoring at the Benny residence indicated compliance with all relevant blast parameters during the reporting period. Monitoring Points are shown in Figure 10.

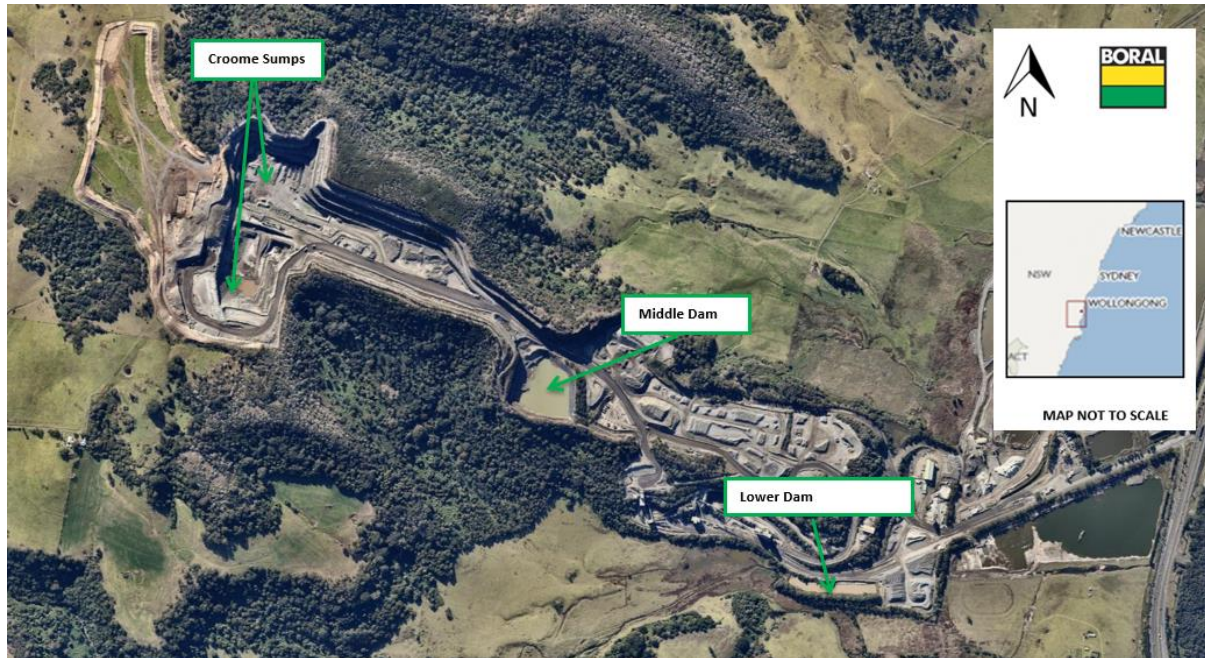
Figure 27 Water Storage Locations

All process water was sourced by either the Lower Dam, Middle Dam or Croome Sumps, which are offline from Rocklow Creek as per water management upgrades undertaken in 2008 under MOD 4. The Location of water storage infrastructure is shown below in Figure 27.

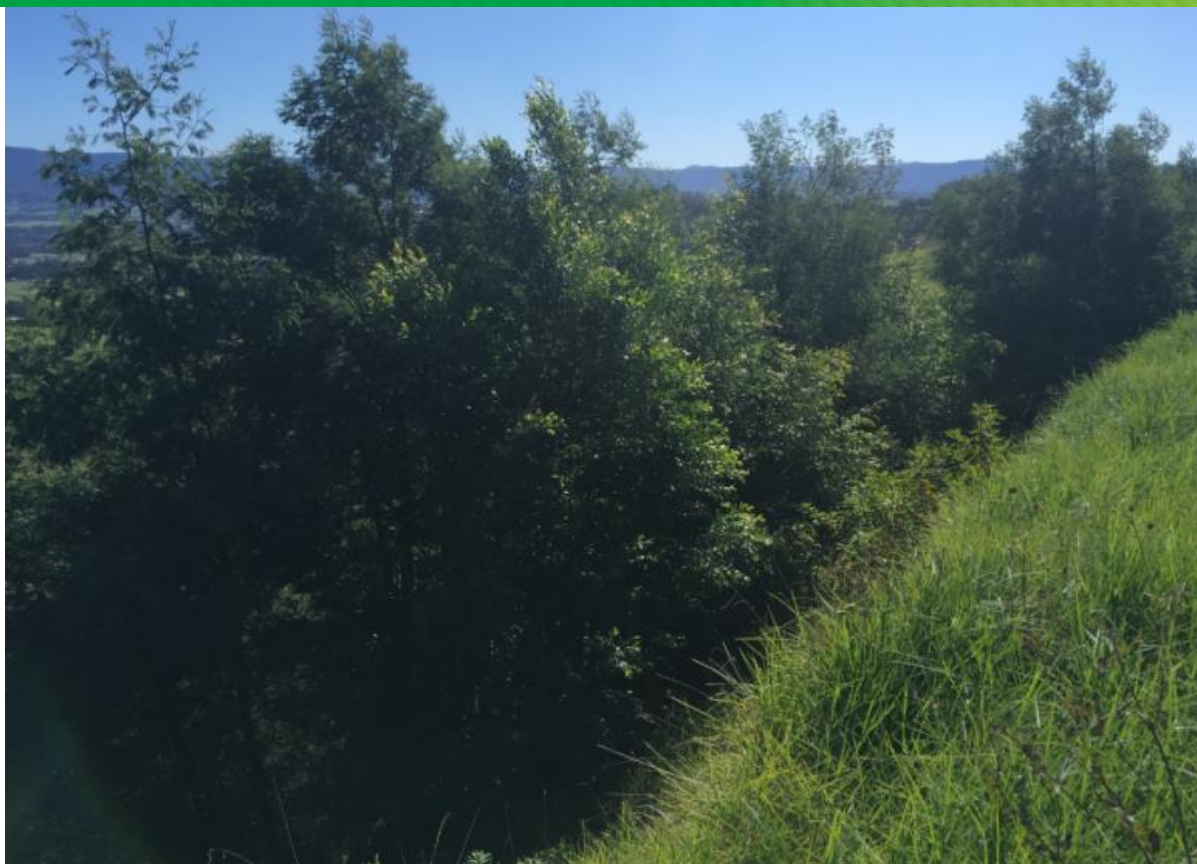
Figure 30 Hydroseeding cover and trees over Croome West Bund

Most areas of the site are currently operational and as such rehabilitation is not able to commence on the majority of areas within the quarry until the completion of extraction activities. When practical, progressive rehabilitation of the site will be undertaken in conjunction with on-going quarrying works. Hydroseeding of the Croome West Bund is now well established with trees as shown below in Figure 30.

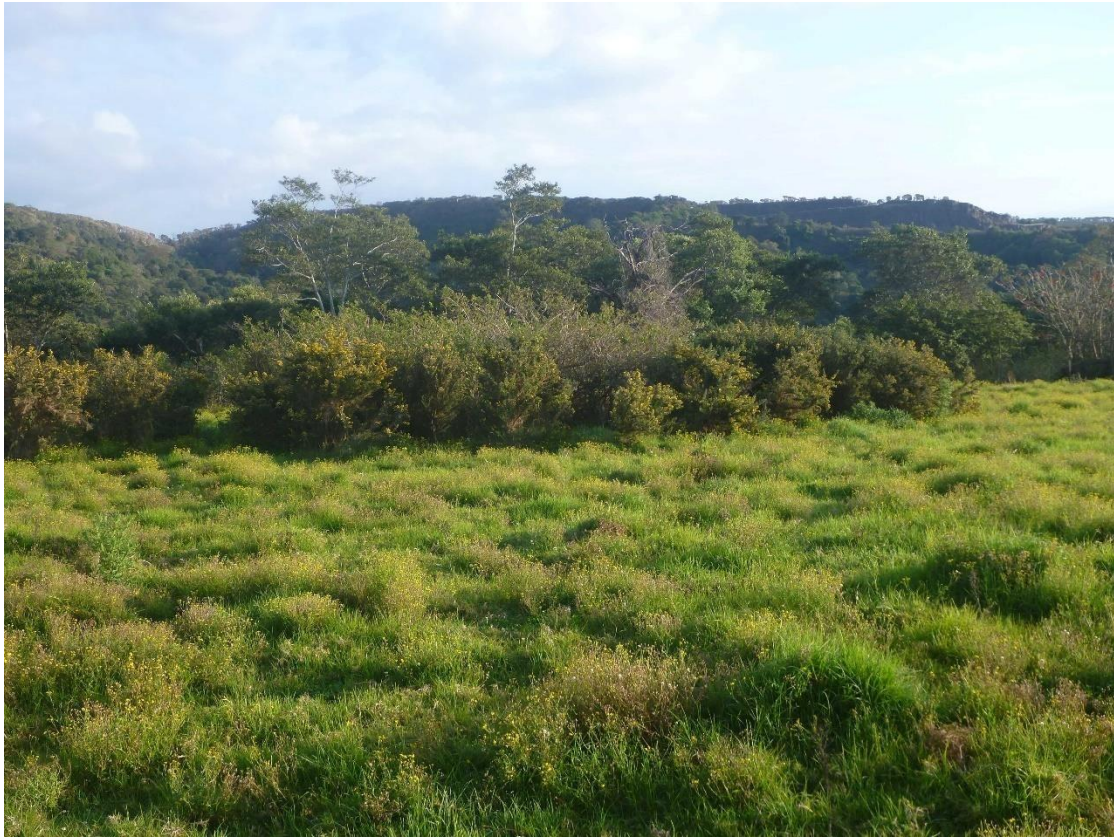
Gorse infestation off Rocklow Road prior to treatment

Treatment of Gorse using the cut and paint method

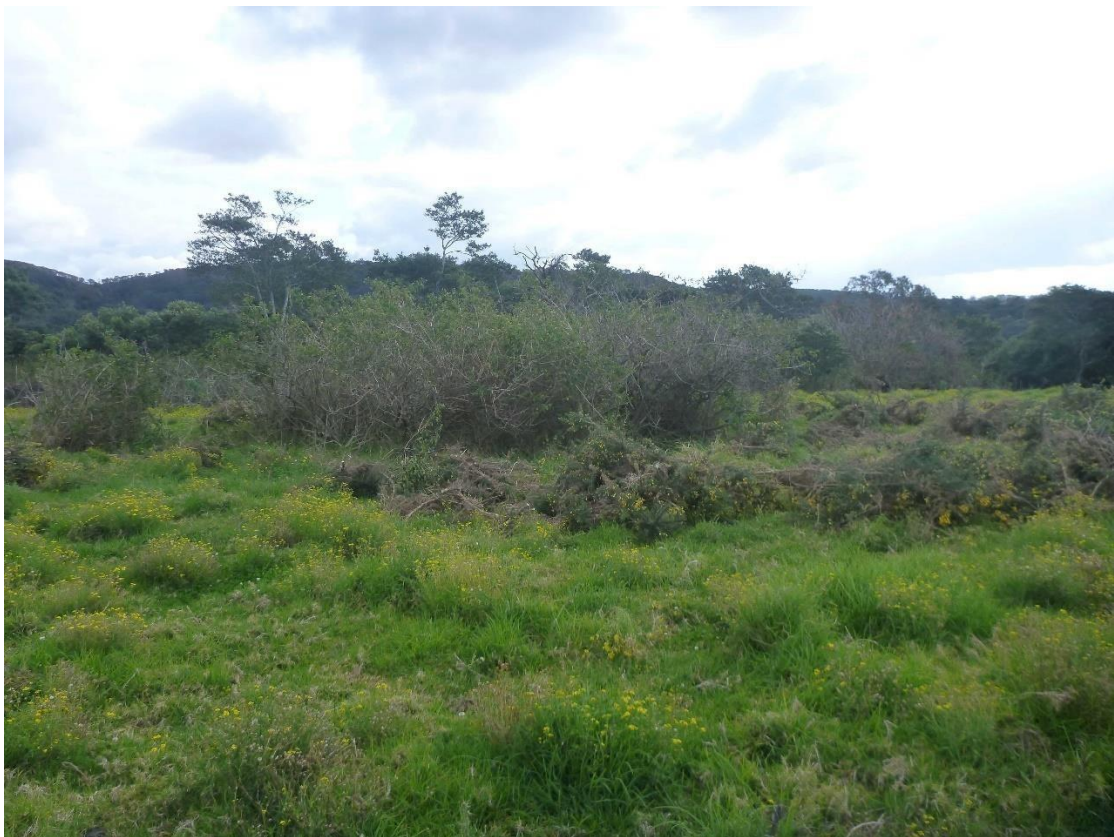
Gorse infestation off Rocklow Road after treatment using the cut and paint method
