Marulan South Limestone Mine

Boral Cement Limited

Annual Environmental Management Review

1 July 2021 to 30 June 2022

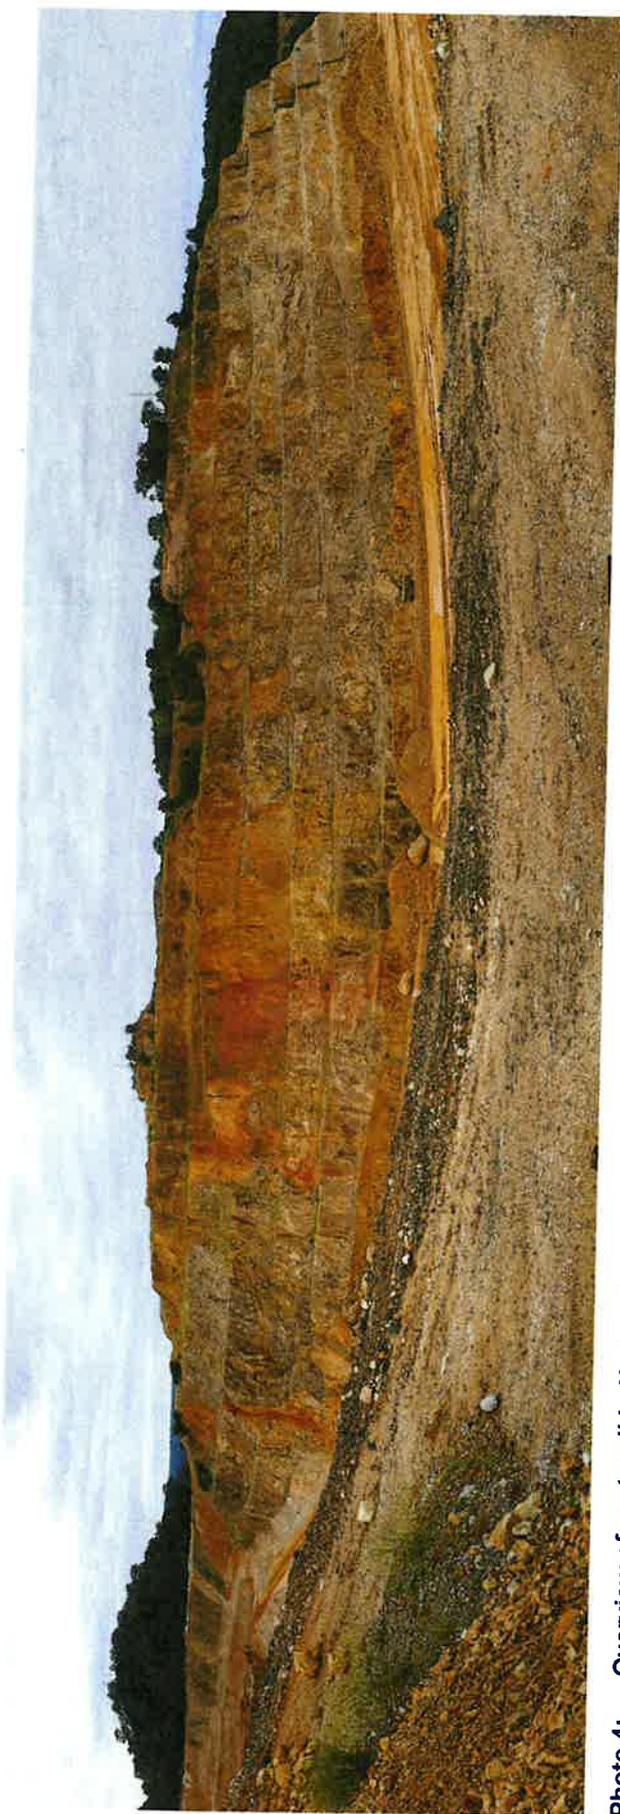
Photos 4 and 5 provide an overview of the east wall in the North pit. Of note has been the remobilisation of an existing failure at the northern end, Photo 5, and which had been initially recognised in 2008. It is understood the recent significant rainfall events contributed to triggering the failure, albeit the recent failure was gradual. PSM recommend the windrow at the toe of the area be slightly raised to limit the risk of future rock falls reporting to the haulroad.

Photo 4: Overview of east wall in North pit.

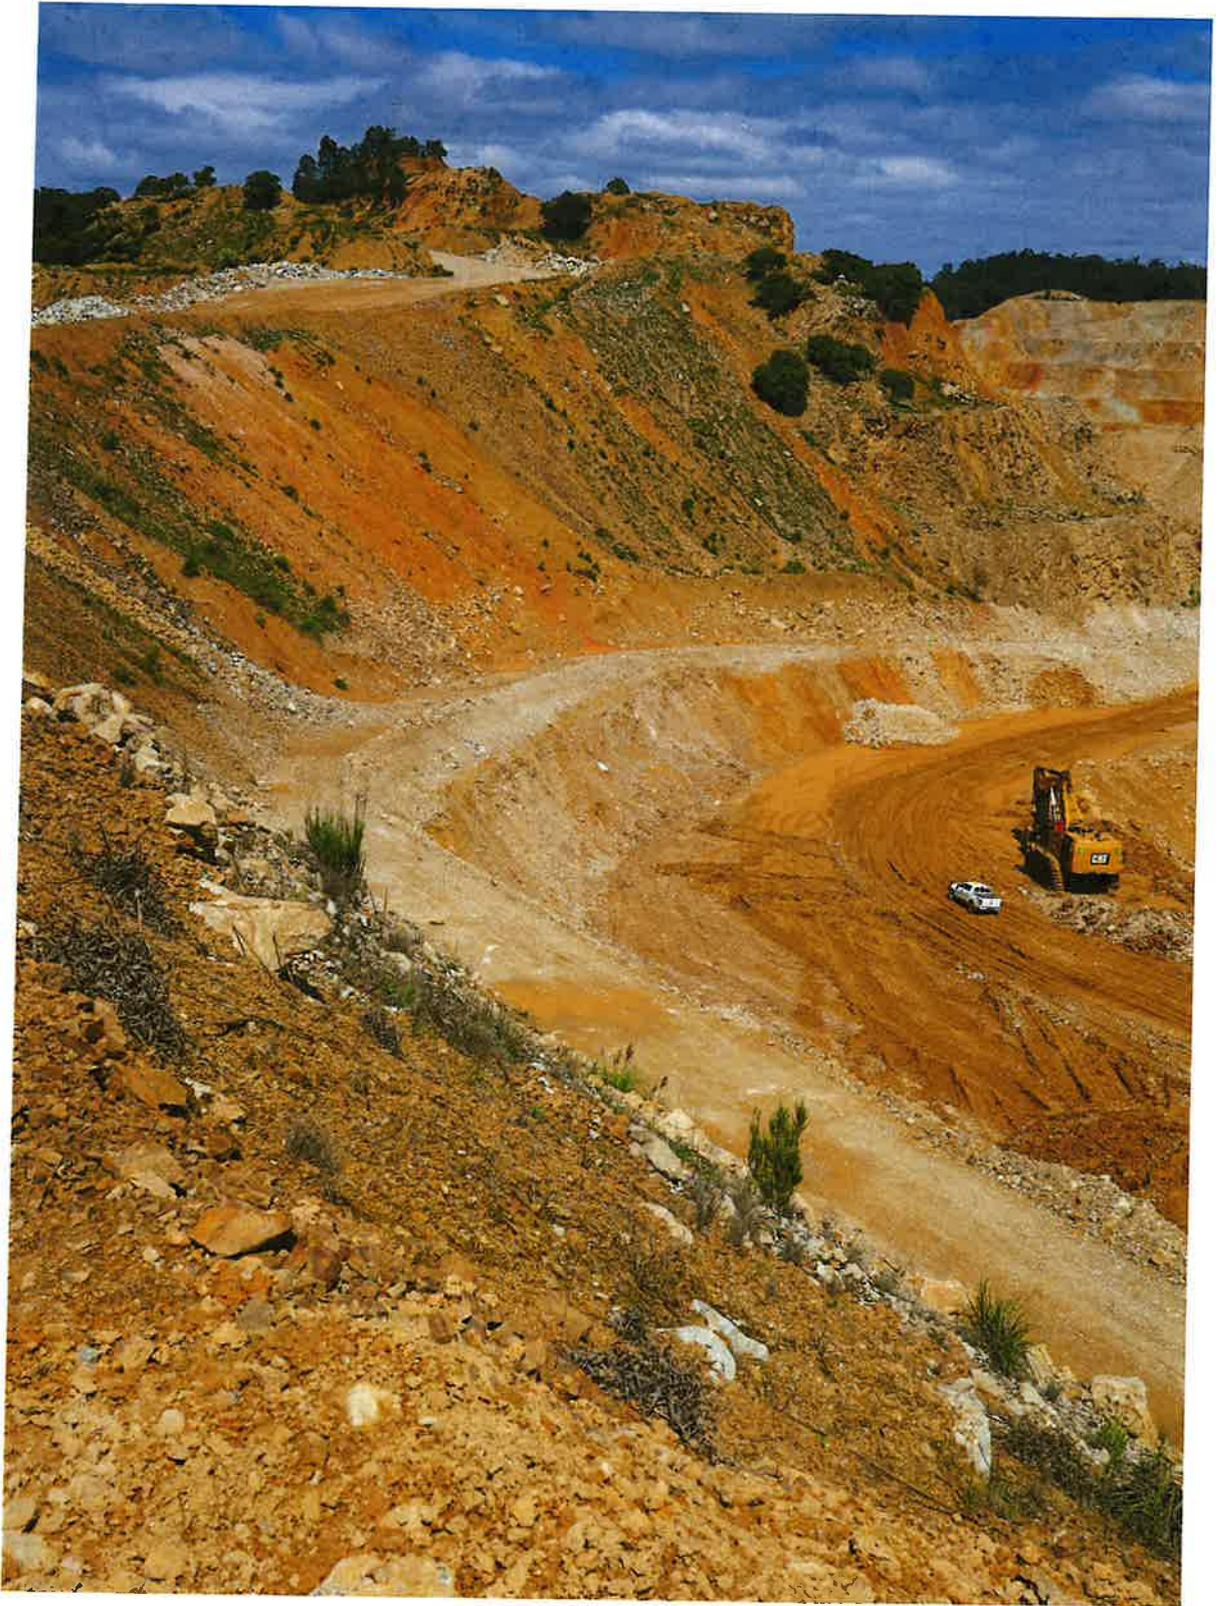
The area of re-mined backfill, Photos 3, 6, 10, 11 and 12 was discussed with BCL. It is understood the backfill extends to nominally RL400 and through a gully in the original topography. As such the backfill which was largely tipped towards the east, has been cut with batters facing to the west. The batter development, largely cross cutting any layering introduced in the initial placement and therefore is favourable. The critical control in such slopes is avoiding erosion formed by water flowing over the batters. PSM note there is a wide berm through the backfill, Photos 11 and 12, and with limited evidence of ponding which is favourable. However, it is critical that surface water from the road above be appropriately managed to avoid ponding and with no-cut throughs allowed in the windrow which would allow gulleying to quickly develop.

Photo 10: View from road on east wall and looking into northern end of North pit. The nominal extent of backfill annotated. Berm present is wide and in good condition in view of recent rainfall.

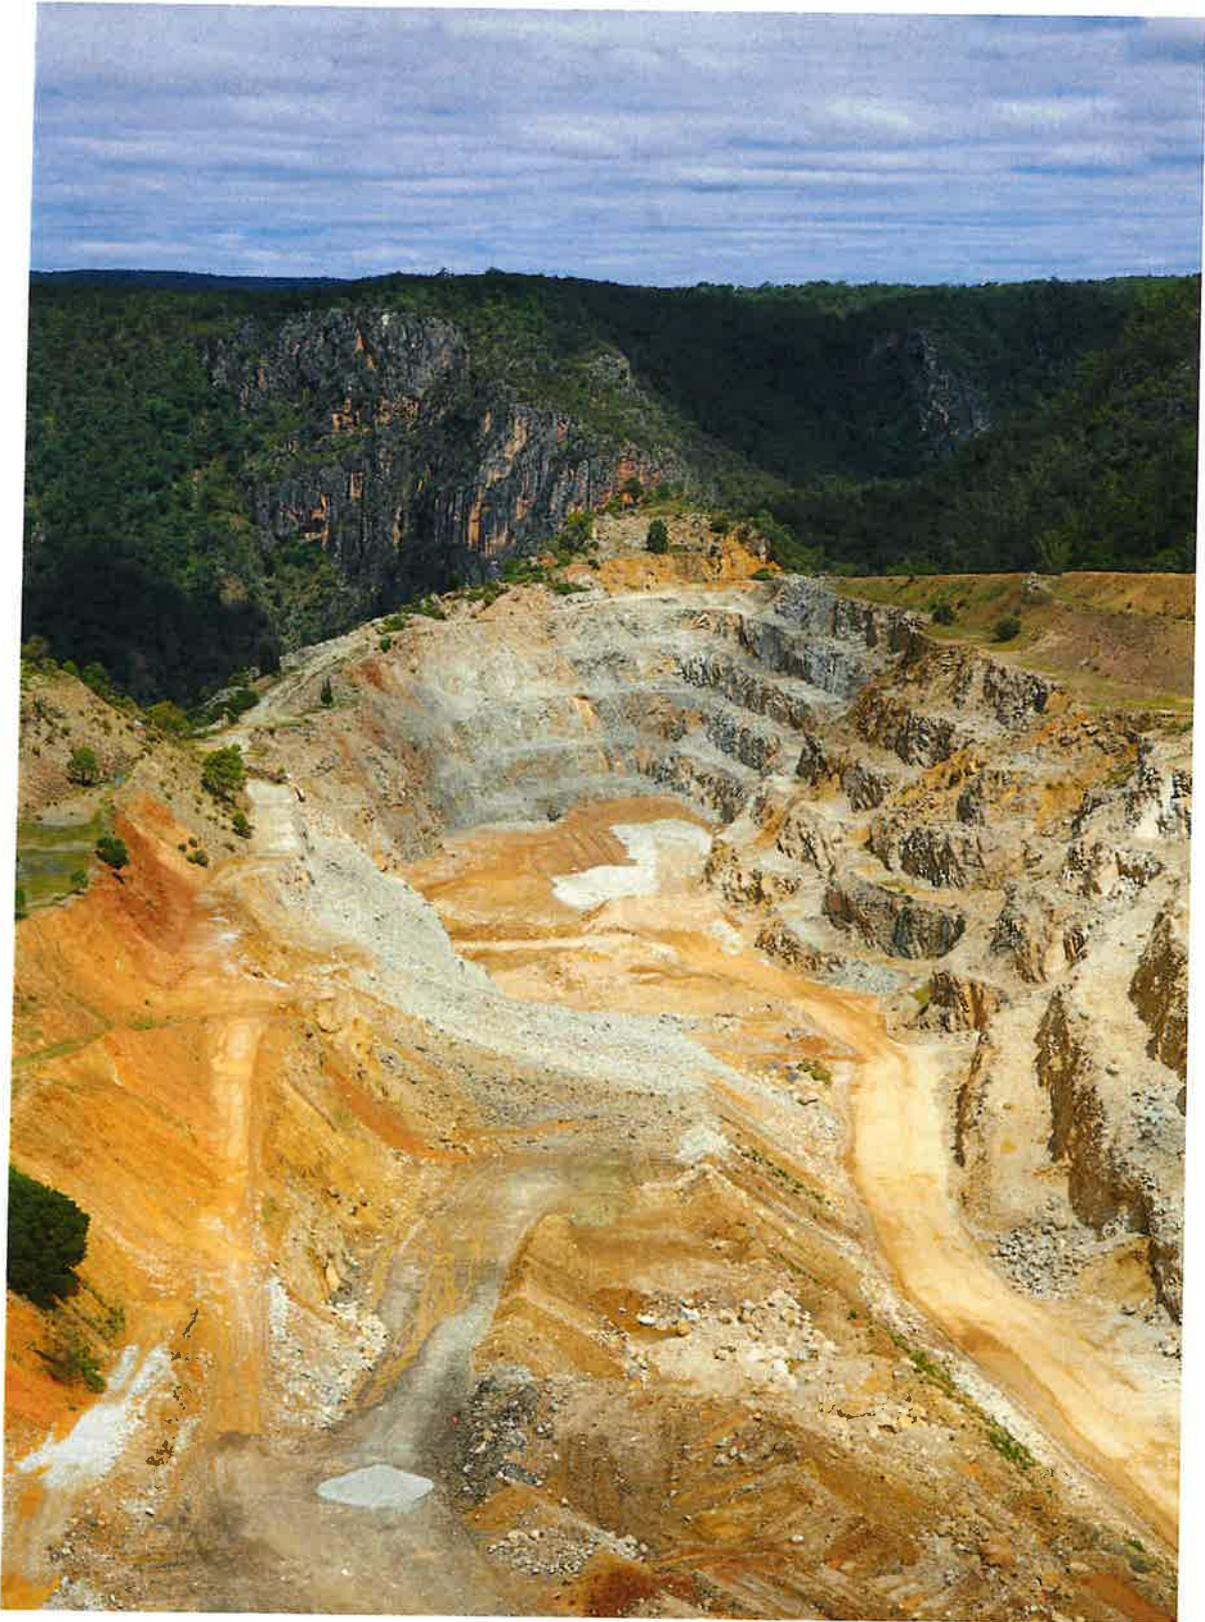
Photo 17 highlight an area in the upper part of the west wall and developed to mine the Middle Limestone. This area had significant ponded water and which was actively being pumped away by BCL. This approach is commended by PSM to actively reduce pore pressures which may impact on the lower part of the west wall.

Photo 17: Upper west wall in North pit, with mining of Middle limestone. Area has ponded during recent rainfall and is actively being pumped dry to limit pressures developed on lower part of west wall.

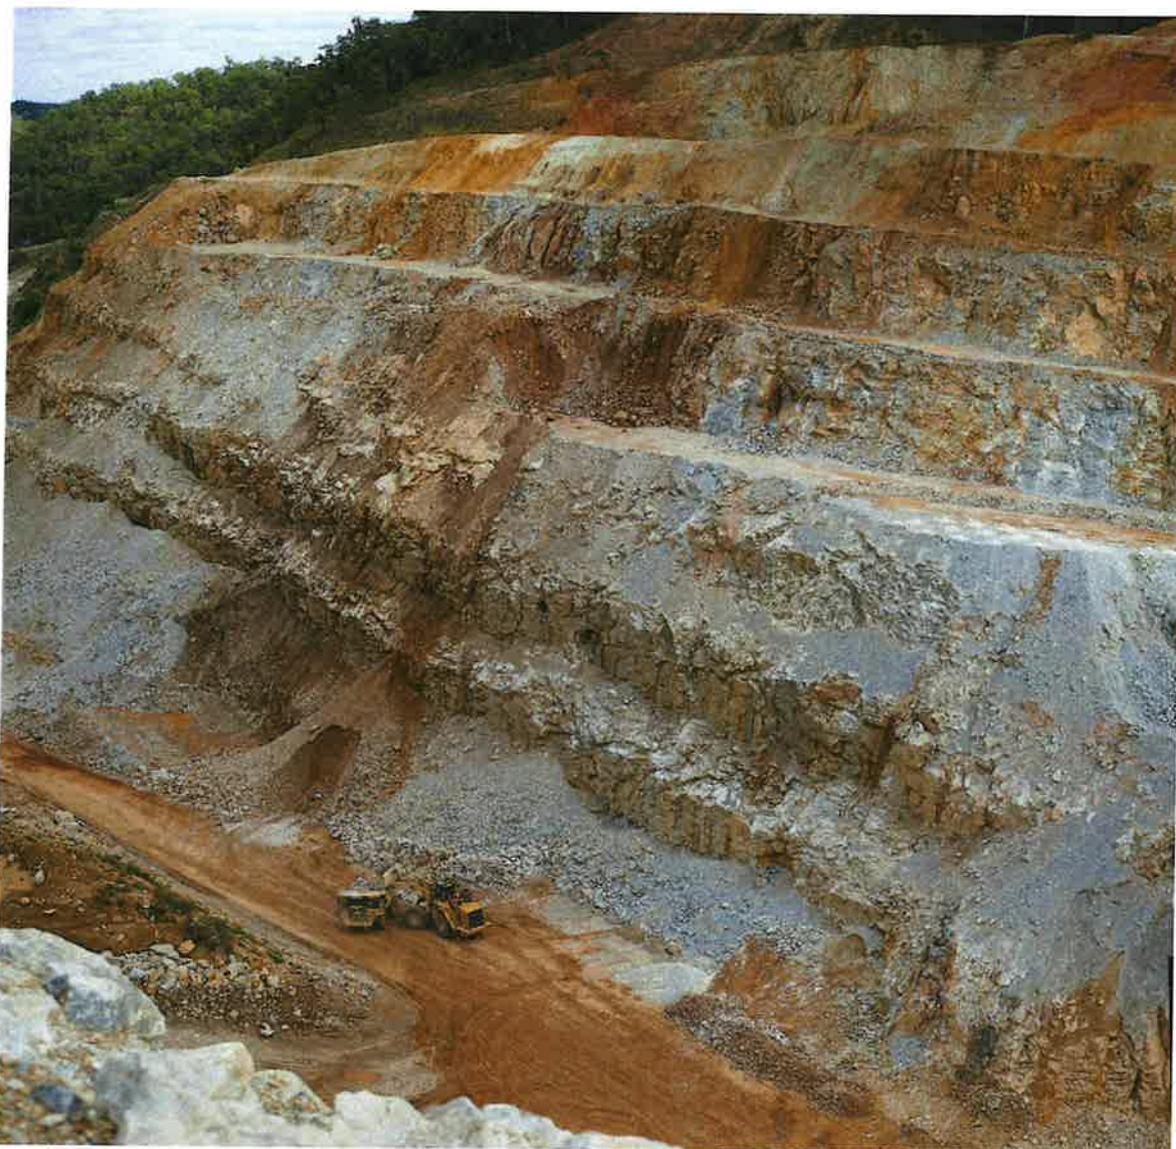
Photos 19 and 20 provide an overview of the west wall cutback. PSM note the operation was proceeding well and following the appropriate controls as outlined in PSM645-038L dated 29 April 2021.

Photo 19: West wall in transition area between North and South pits and with cutback of upper slopes of west wall in progress.

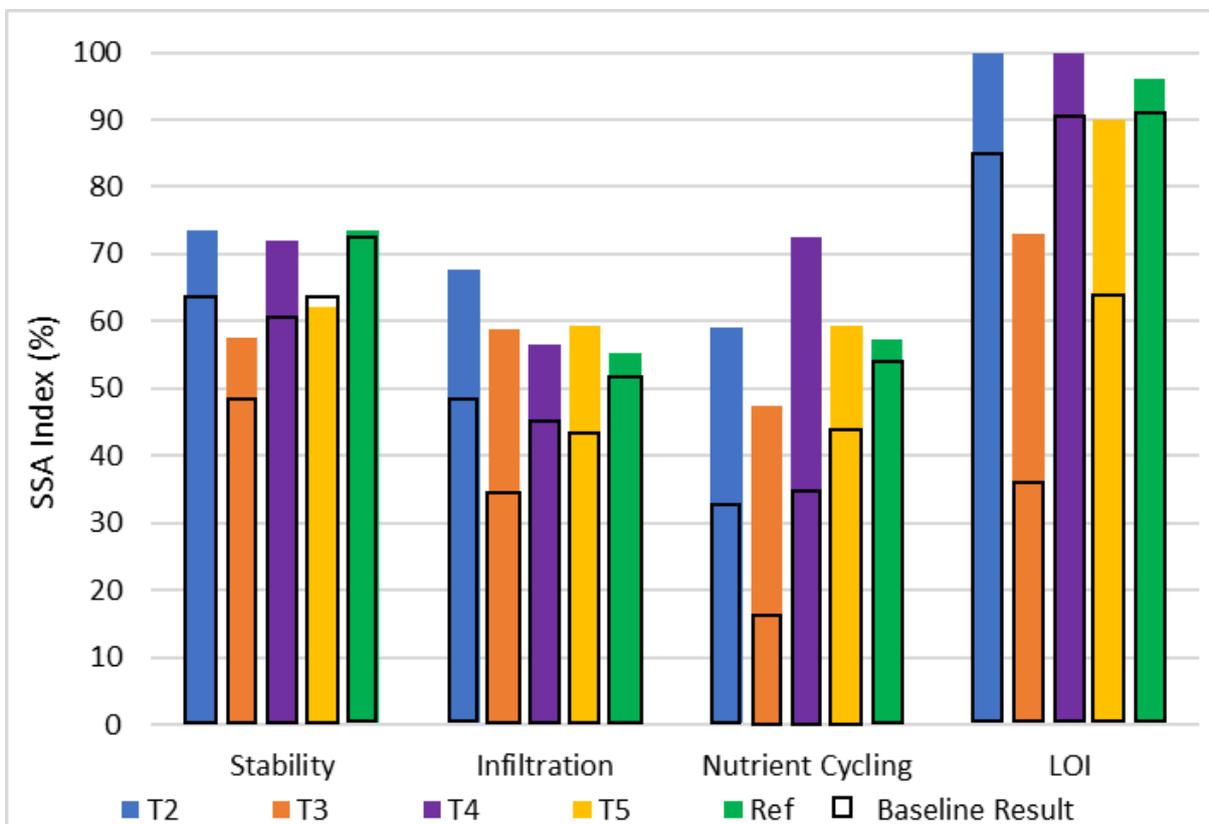
Graph 3- Soil Surface Assessment Index (%) Baseline result= July 2020 (April 21 for T5)

The highest nutrient cycling SSA indices were achieved by vegetated patches including grasses, shrubs, weeds, moss and litter, which will contribute to soil surface nutrients when broken down. Localised litter cover with a high decomposition improved the score because nutrients are effectively being returned to the soil. Low basal cover including bare ground and rock allows for resources to be lost in contrary to being filtered into the substrate. Nutrient cycling indices rose considerably during December 2021 and rose slightly higher in May 2022, with scores ranging from 47.4% at Site 3 (a 12% increase) to 72.4% at Site 4 (Graph 3).

The LOI is a good indication of vegetation cover and is related to the SSA parameters. It is recommended that the LOI is improved at Sites 3 and 5 to reach a similar score to the reference site (Graph 3). This can be done by minimising the proportion of bare ground on the site by increasing vegetation cover through planting and seeding methods.

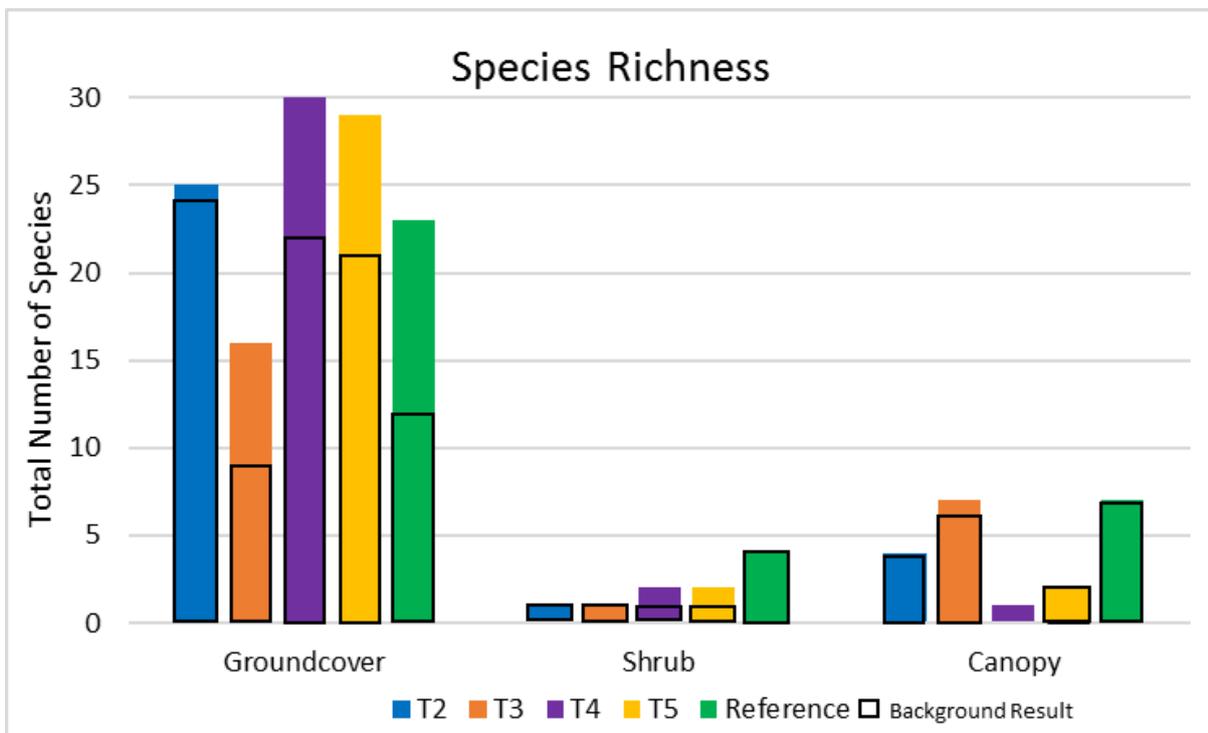
Graph 4- Species Richness at three levels of vegetation strata Baseline result= July 2020 (April 21 for T5)

The upper canopy at the reference site is characterised by mature *Eucalyptus mannifera* and *E. bosistoana* with the emergence of few juvenile *Acacia* and *Casuarina*. Meanwhile, Site 2 is comprised of a dense canopy of *A. decurrens* and *A. mearsii*, with the emergence of *E. cinerea*. Transect 3 and 5 are comprised of the same species, however rehabilitation work in these sites was more recent and all species are still at a juvenile stage. The dense monoculture of *Acacia* trees does not reflect the natural reference site, and more care should be taken with species selection. It could be suggested that planting of Eucalypt tubestock in these areas would improve diversity and species richness of canopy species to represent the reference site.

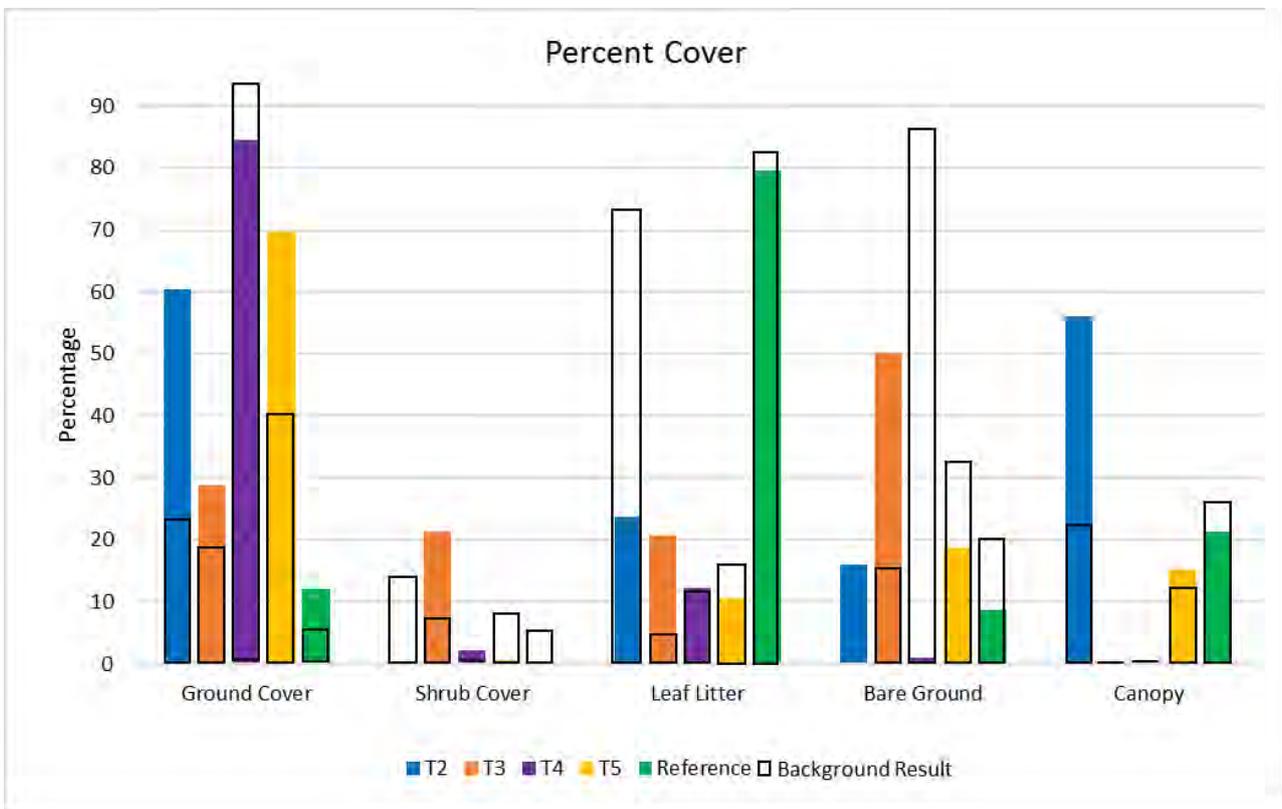
Graph 5- Average ground, shrub, litter and bare cover percentages **Baseline result= July 2020 (April 21 for T5)**

As shown on Graph 5, the reference site has a high canopy cover, but less ground and shrub cover and includes a significant proportion of leaf litter. Site 4 however, is predominantly ground cover, with vegetation increasing into the shrub layer, and has minimal tree layer at this stage. Over time as trees emerge, the groundcover will reduce, and the leaf litter layer will increase. Conversely, Site 3 is in the early stage of rehabilitation and shows little ground cover and leaf litter cover. Site 2 is an older rehabilitated area and has a higher canopy and leaf litter approaching the proportions observed in the reference site. It is evident that the timing of rehabilitation of Site 5 lies between Site 3 and Site 2, with a fair amount of bare ground gradually being covered by lower storey species and litter, while the middle and upper storeys are still somewhat lacking. It appears that over the past 6 months there has been a reduction in bare ground across all the rehabilitated sites, as ground cover species emerge and the leaf litter layer develops further.
