Table 3.1: Boral Cement Berrima - 2016 Annual Noise Assessment - Site Sound Levels for Kiln 6 Upgrade

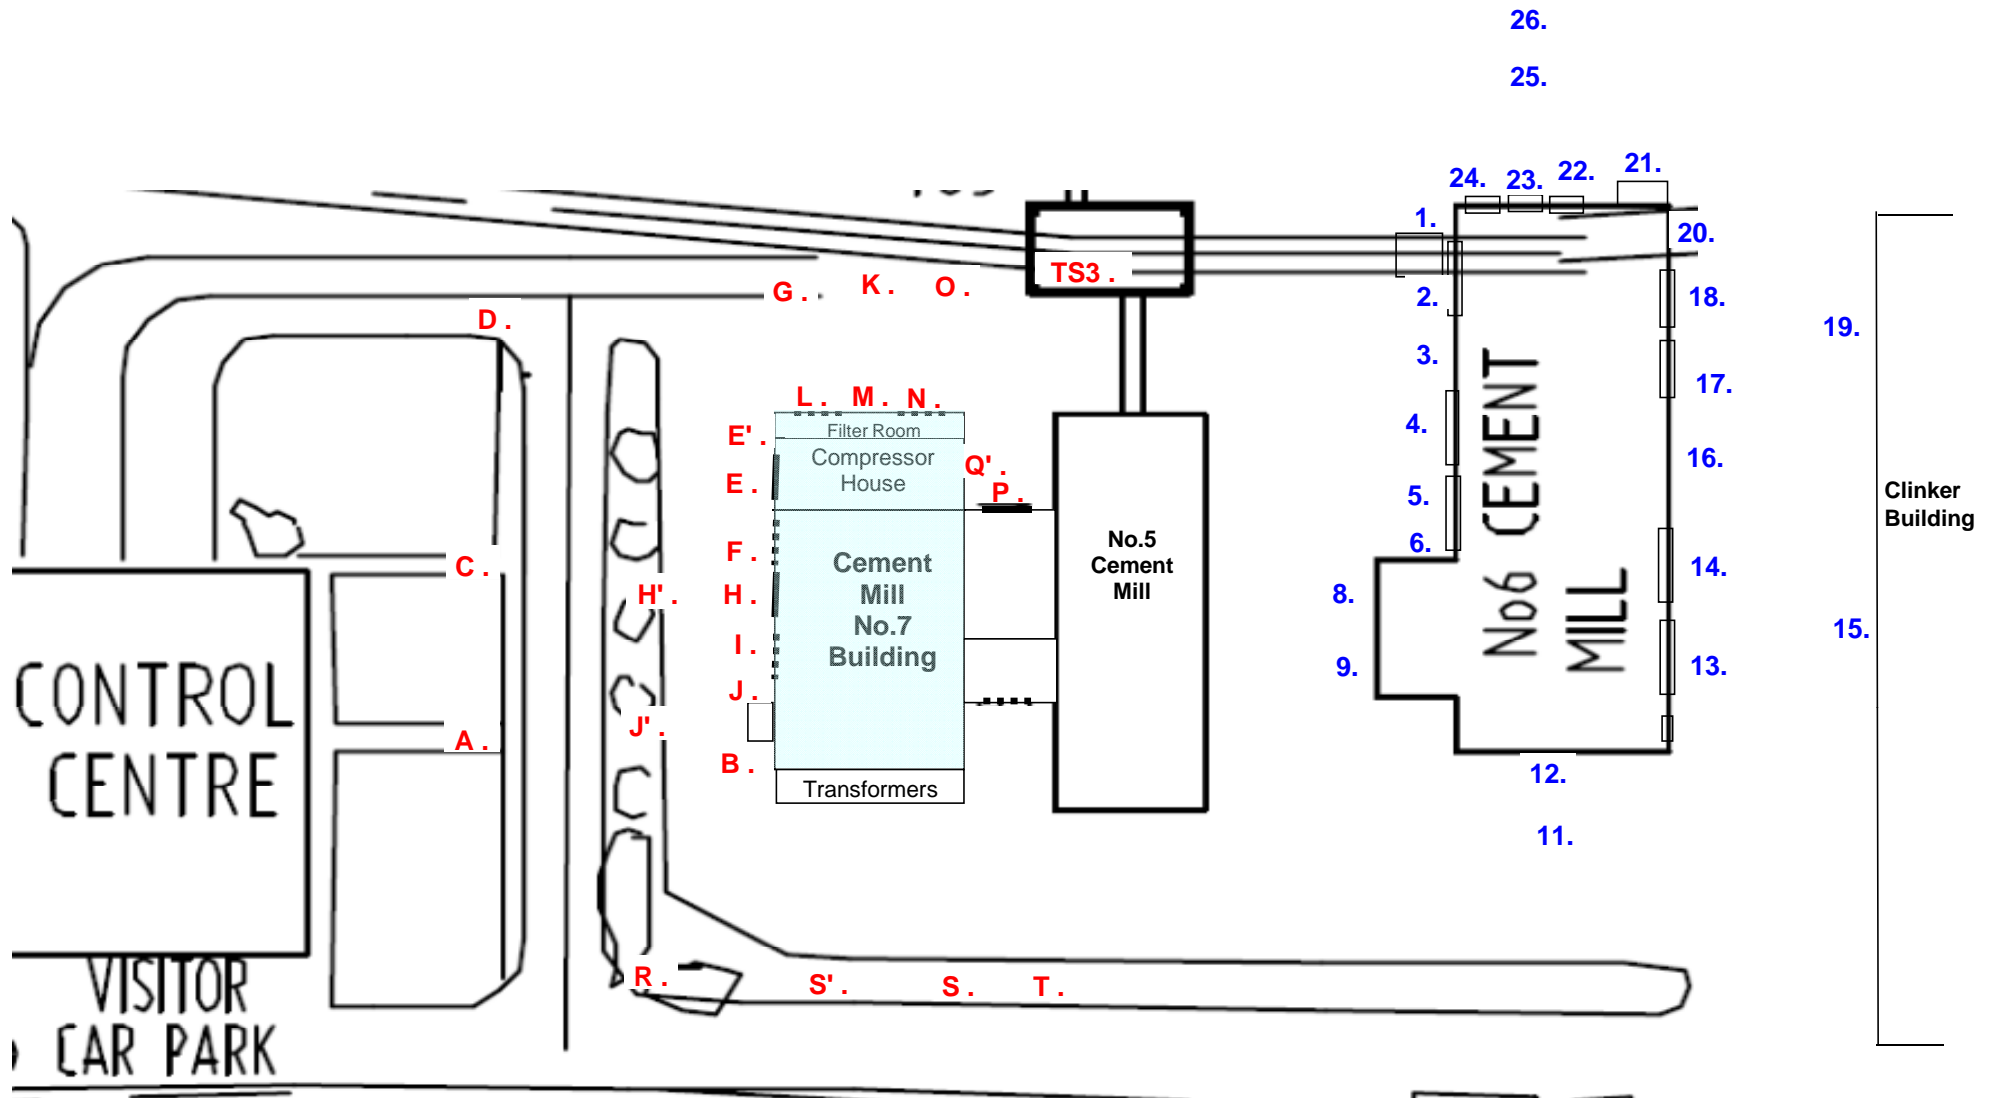
Figure 3.7: Blue Circle Southern Cement Berrima CM7 Noise Assessment - Plan view of external measurement locations around Cement Mill No.7 and Cement Mill No.6

Location D, on the north-western corner some 25m distance from the building northern and western side, had sound levels that were 5 dB higher than in 2010. The sound levels were the same as in 2015 and 2014 and lower than in 2006 and 2009. This was considered to be caused by other process fans (western wall fans of CM6 and CM5, and Kiln 6) and train movements north of the site at the rail dump station and locomotives. Similar effects occurred at most of the locations on the northern side of the mill building with increases ranging from 3 to 7 dBA. These were **locations G, K, K', M and O**.

Sound levels at location K', 6.9m from the compressor house, were also 72 dBA, the same as at Location D which is more than double this distance from the compressor building and CM7. This indicates that the sound levels at Location D and other locations north of the CM7 building and its compressor house are caused by other sources – if CM7 was the cause the levels would be up to 11dB lower at Location D than Location K'. The contributions from CM7 are therefore considered to be below the objectives for the measurement locations D, G, K, O, and K'.

Location H, 1m outside the main western roller door of CM7 building. Sound levels were 4 dB higher than in 2011. This may have been caused by the bottom of the door being open less than 80mm. The calculated contribution for this sound level at the receivers was 25 to 30 dB below the contribution objectives.

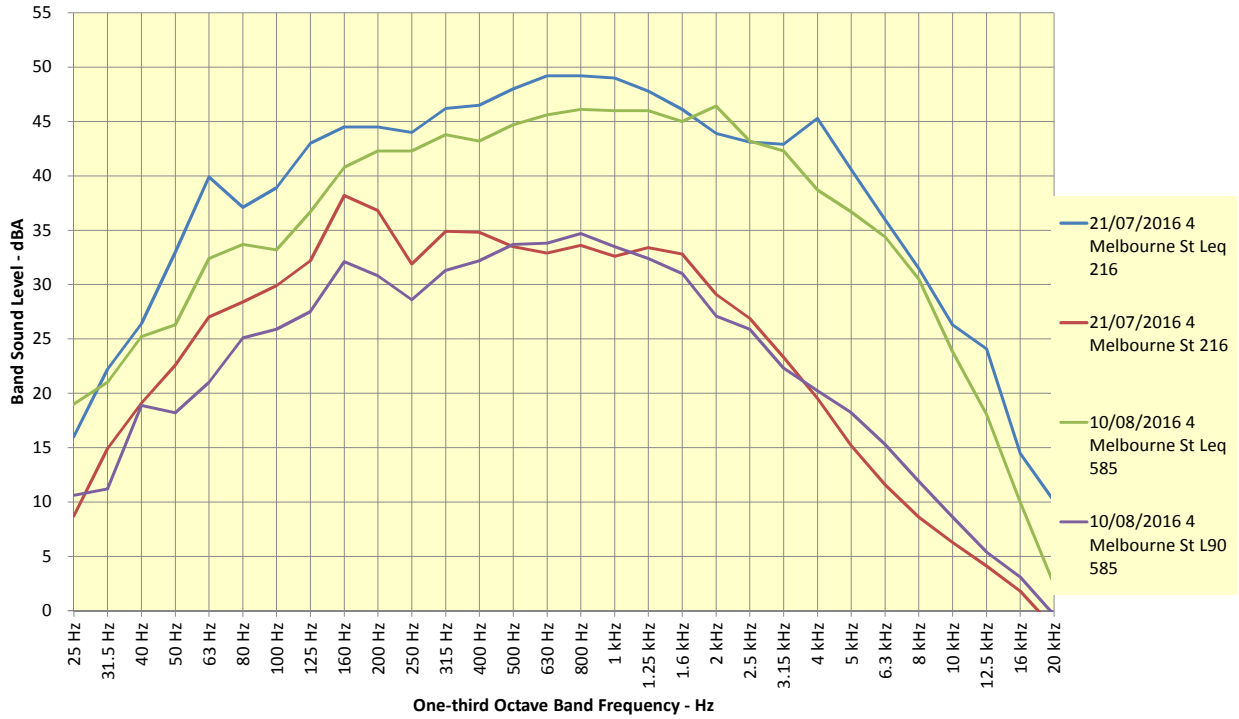
Figure 4.14: Boral Cement Berrima Annual Environmental Noise Assessment 2016 Residential Receiver & Boundary Spectra - 4 Melbourne St

One-third octave band spectra are shown in Figure 4.14. There is a peak in the 160 Hz band in both measurements and this is likely to be related to a harmonic of truck exhaust noise or the stack discharge but none were tonal.

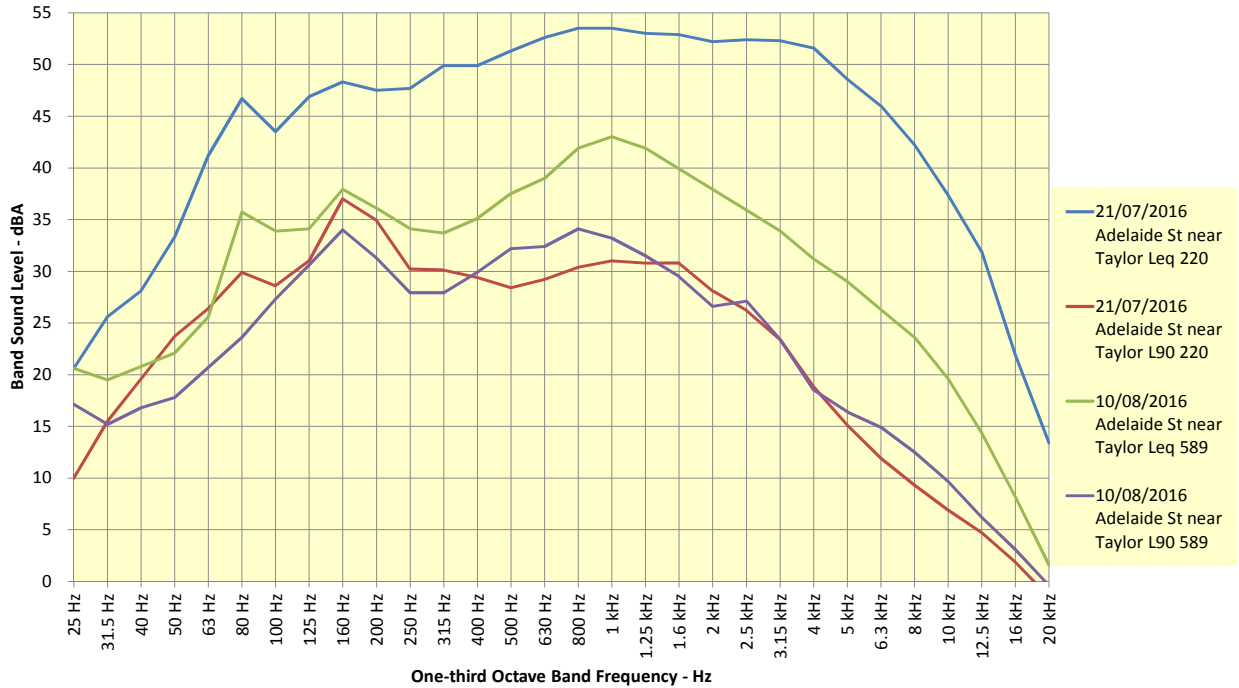
Figure 4.15: Boral Cement Berrima Annual Environmental Noise Assessment 2016 Residential Receiver & Boundary Spectra - Adelaide St near Taylor Avenue

The one-third octave band spectra were shown in Figure 4.15. All spectra were non-tonal and the peak in the 160 Hz band was slightly lower than at Melbourne St. The narrow band spectra are shown in Figures 4.28 to 4.31. The main peak is again at 175-176 Hz but with no 351 Hz on 10 August. The relative peak heights are also lower than measured at Melbourne St at only 10 to 12 dB, possibly reflecting a higher general sound level at this location.

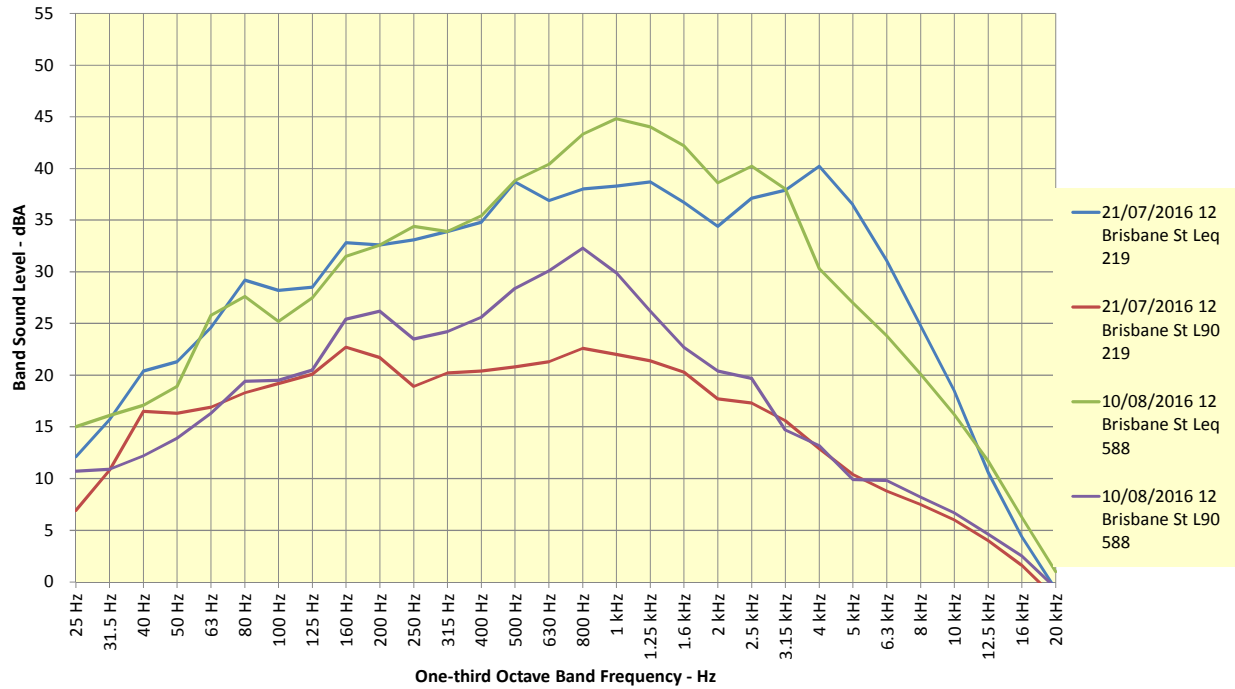
Figure 4.16: Boral Cement Berrima Annual Environmental Noise Assessment 2016 Residential Receiver & Boundary Spectra - 12 Brisbane St

One-third octave band spectra are shown in Figure 4.16. These are reasonably smooth and do not show any significant peaks. Narrow band analyses are shown in Figures 4.32 to 4.35. The main peaks are 176 and 351 Hz on 21 July and 174 Hz on 10 August. Peak heights for these were 10 to 11 dB and indicate low significance of the frequencies as tones.

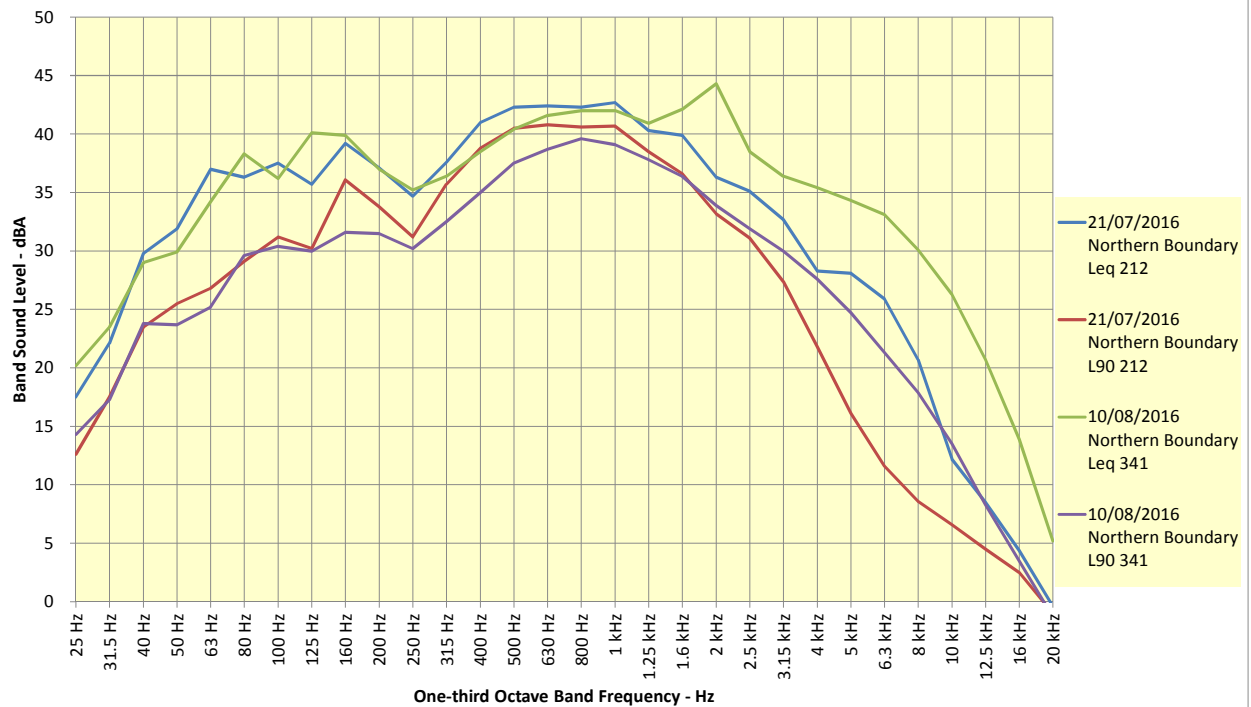
Figure 4.17: Boral Cement Berrima Annual Environmental Noise Assessment 2016 Residential Receiver & Boundary Spectra - Northern Boundary

One-third octave band spectra are shown in Figure 4.17 The L_{Aeq} and L_{A90} values are closer together than at other sites and there is a slight peak at 160 Hz seen at some other locations. Narrow band spectra are shown in Figures 4.36 to 4.39. The peak at 176 Hz is evident and has a relative peak height of 10 dB.

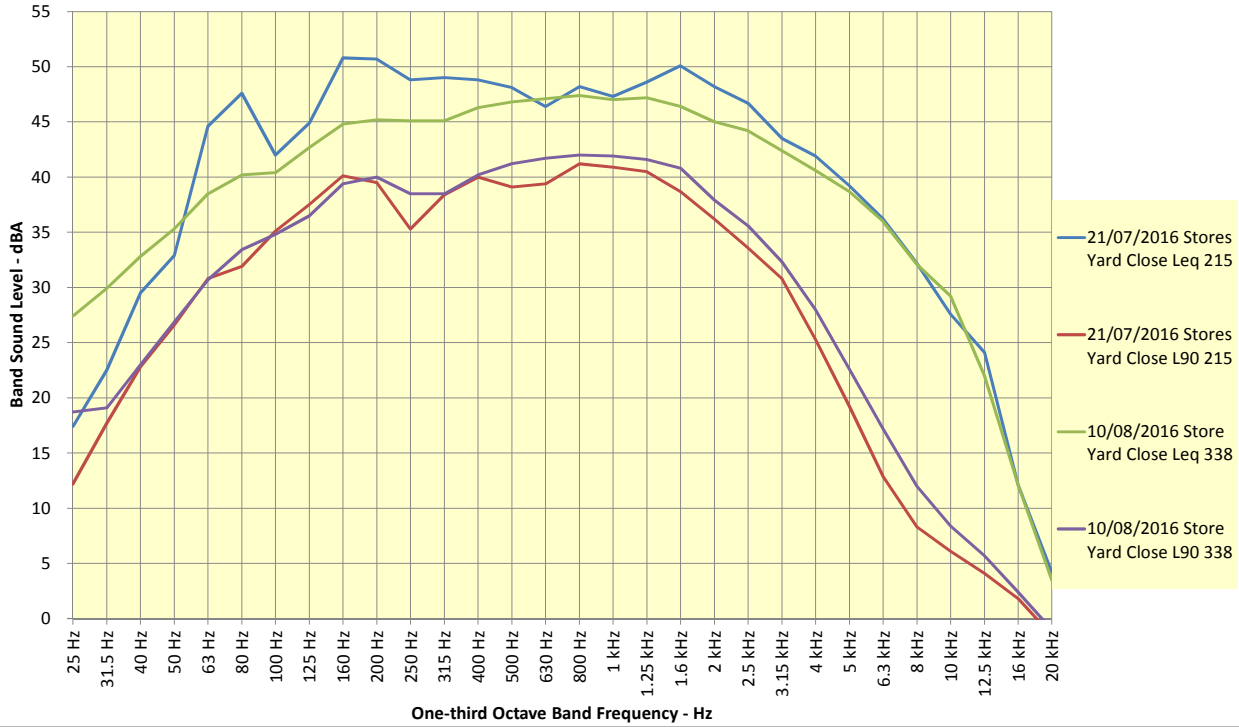
Figure 4.18: Boral Cement Berrima Annual Environmental Noise Assessment 2016 Residential Receiver & Boundary Spectra - Store Yard Close

One-third octave band spectra are shown in Figure 4.18. These are relatively smooth and show no tonal aspects. The narrow-band spectra are shown in Figures 4.40 to 4.43. Peaks in the spectra are at 176 Hz (assumed from the stack) and 404 Hz for which the source is not known.

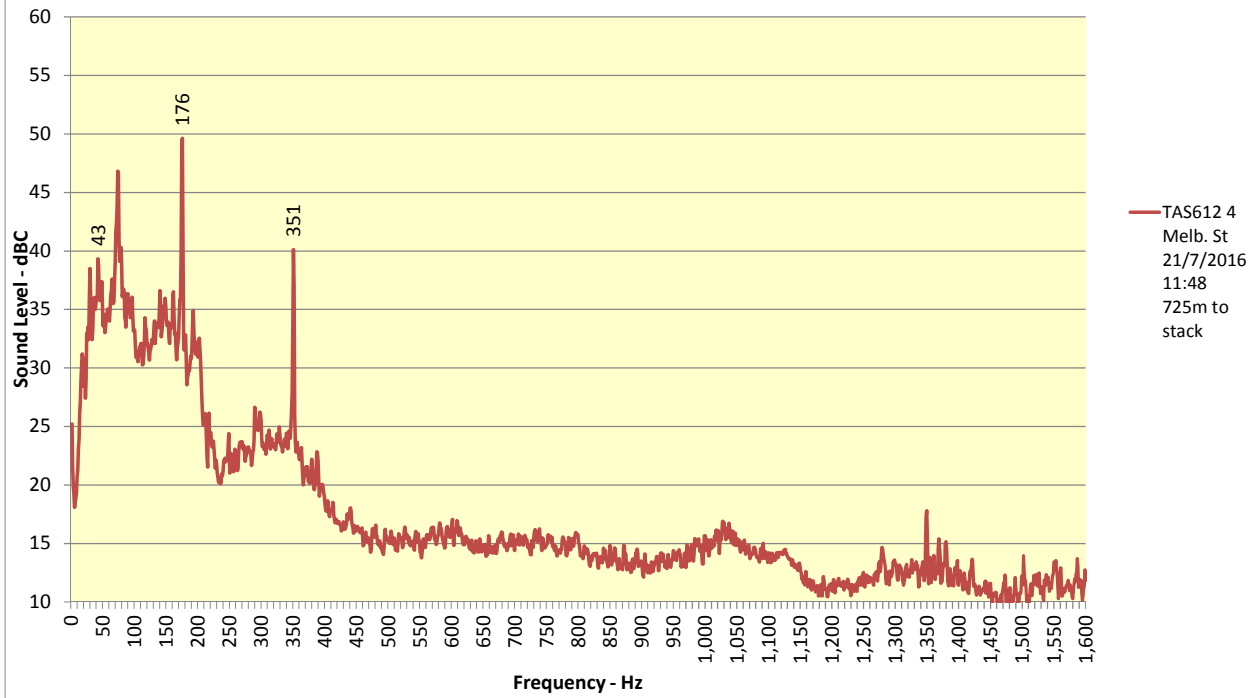
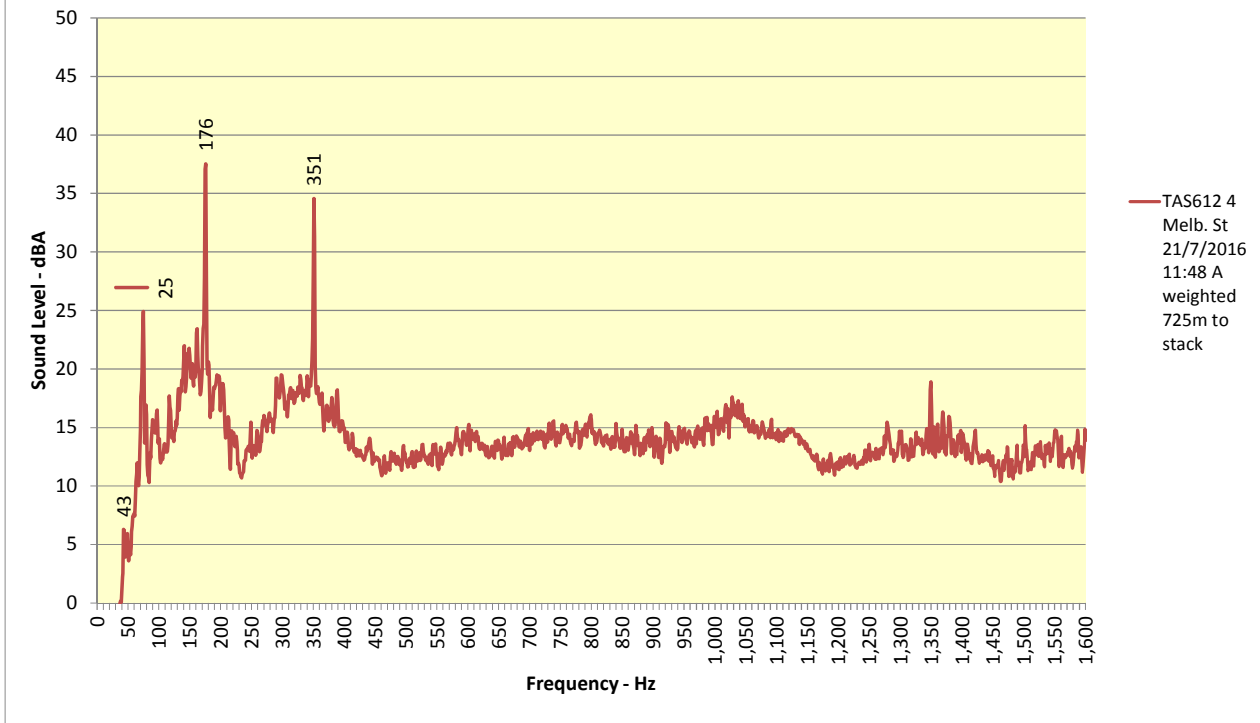
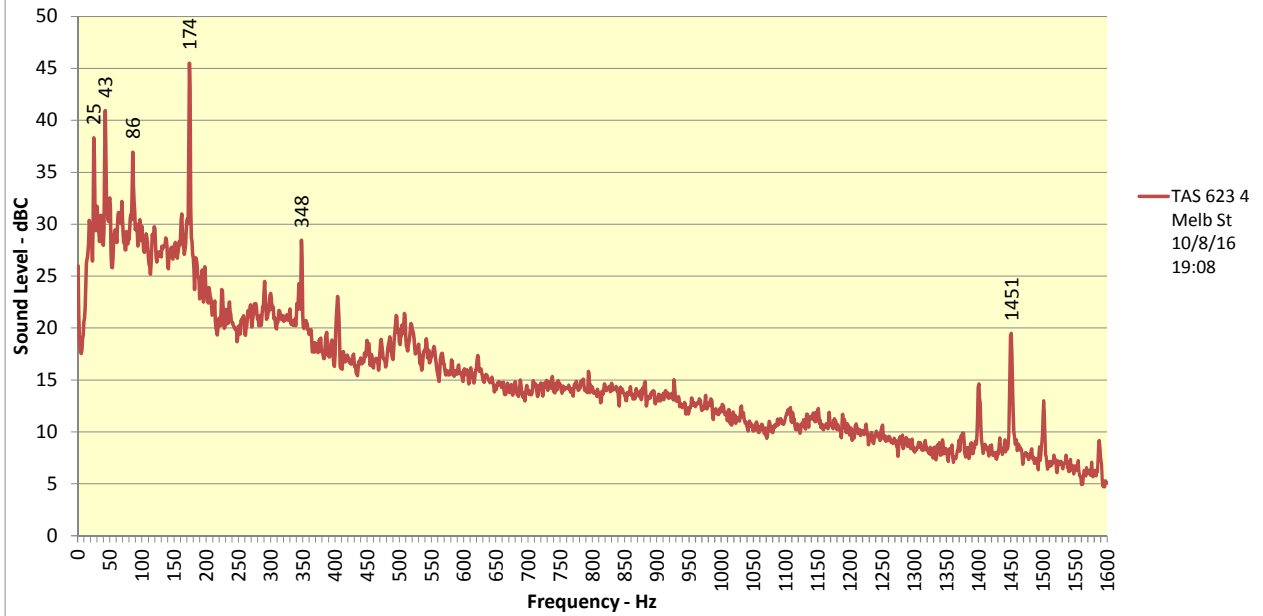
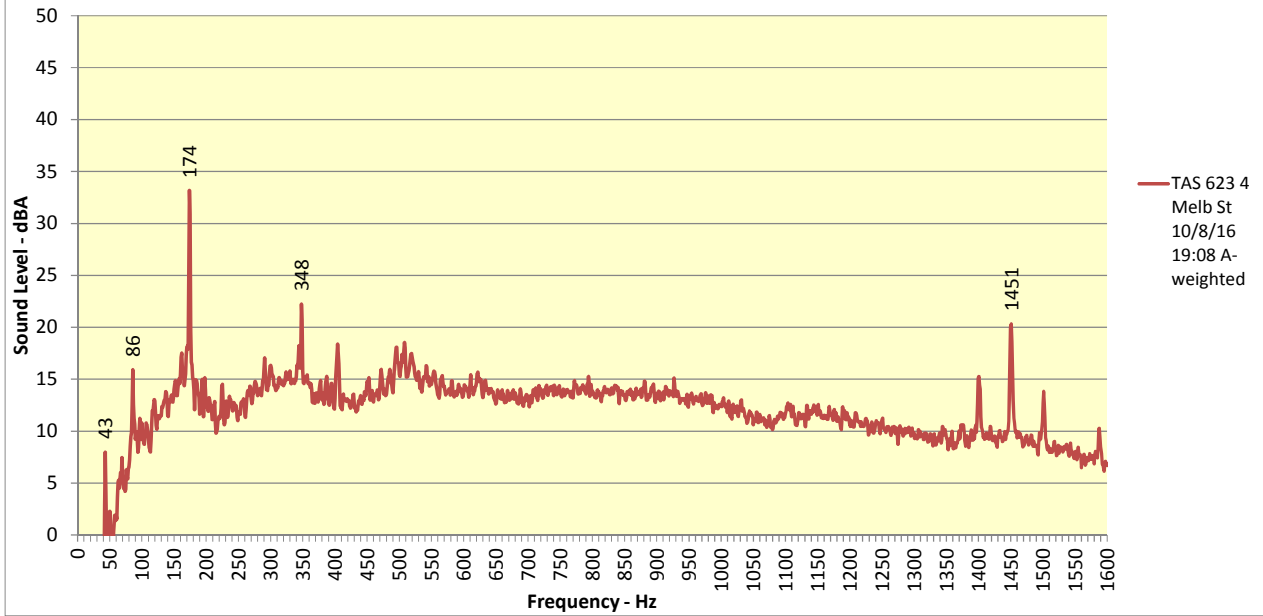
Narrow band frequency analysis was also made of recorded sound in each attended measurement. These are shown in Figures 4.24 to 4.27. Fast Fourier Transform (FFT) analysis used a typical measurement period of 60 seconds or longer and had a 1-Hz resolution. For the Melbourne St measurements the main peaks occur at 176 Hz on 21 July or 174 Hz on 10 August, which is likely to be related to FA39 blade pass frequency and 351 or 348 Hz, which is likely to be its first harmonic. The peak height of 18 dB above the adjacent spectrum level for the highest peak in a 1-Hz resolution spectrum is not considered to be significantly tonal although it is audible. Typically a peak height of greater than 20 to 25 dB would be likely to be tonal. The peak related to FA250 which is expected to be close to 200 Hz does not appear in the spectra.

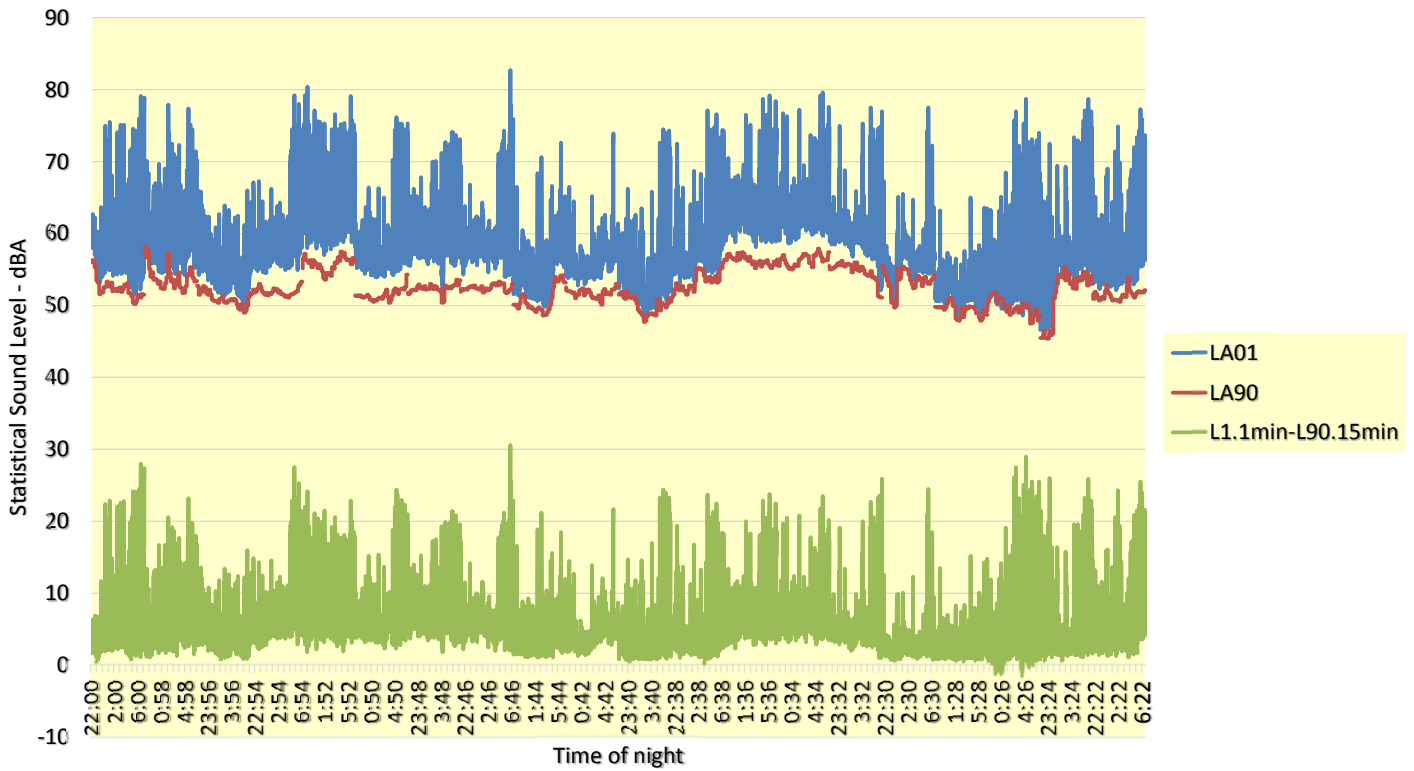
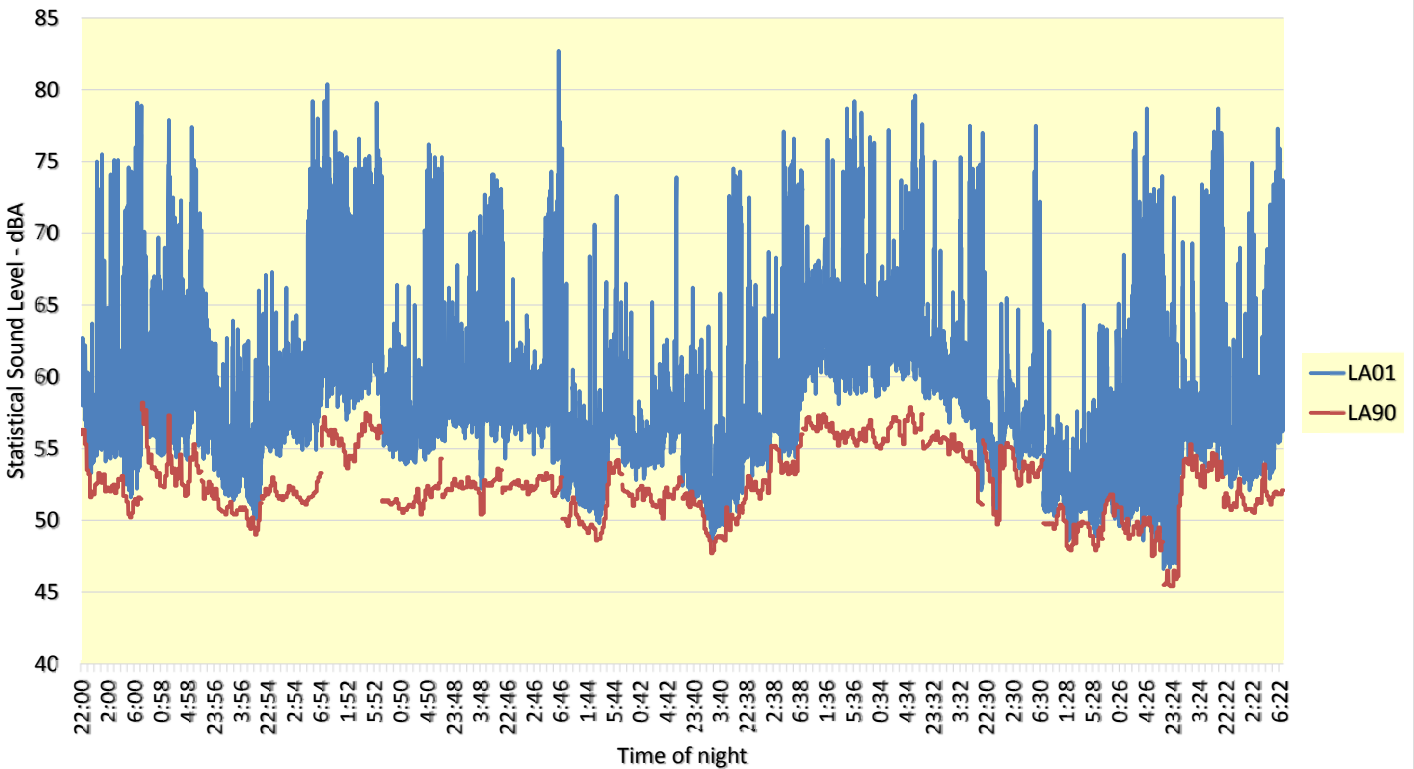
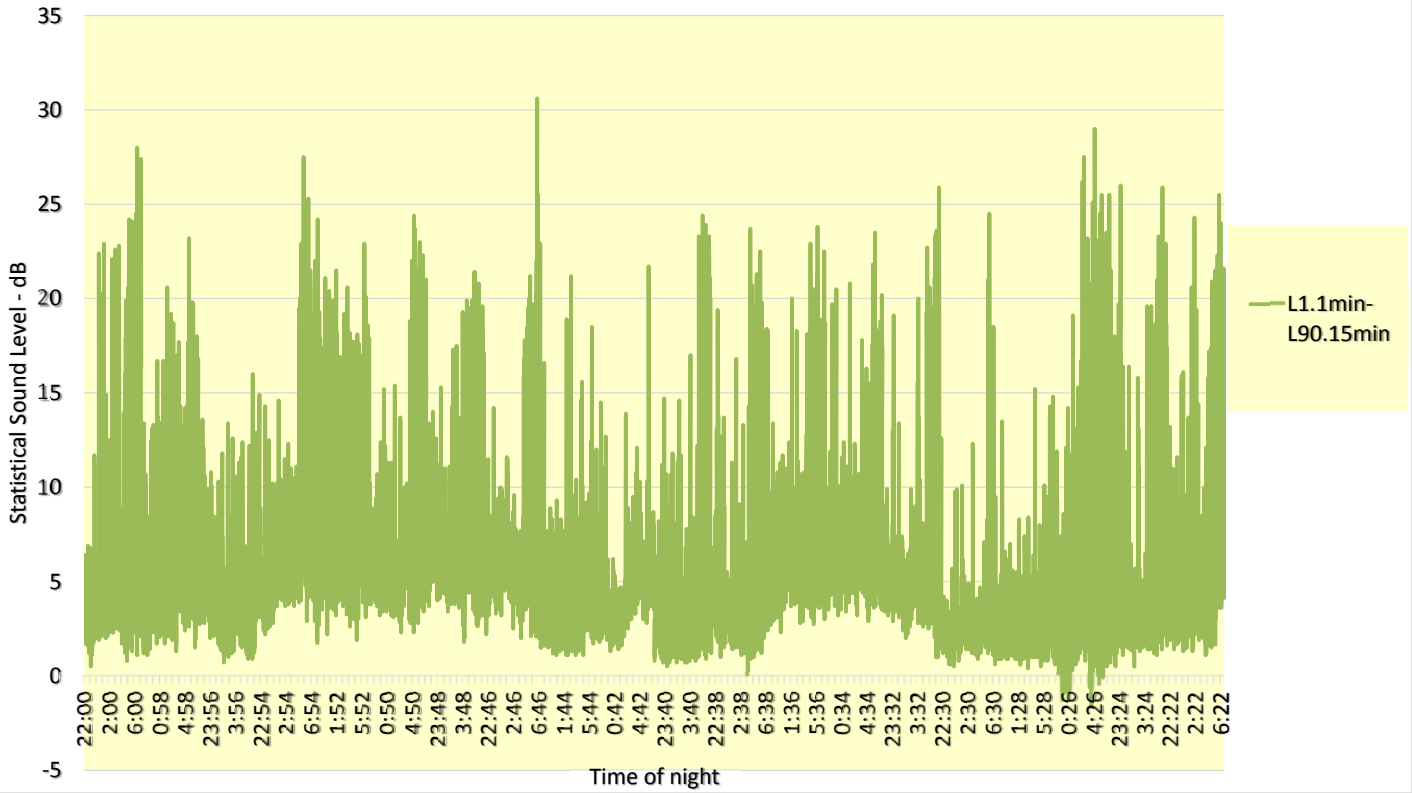
Figure 4.44 shows the values for $L_{A01.1-minute}$, $L_{A90,15-minutes}$, and the calculated $L_{A01.1-minute} - L_{A90,15-minutes}$. These values are also graphed in Figures 4.45 and 4.46 separately. The results show that there are a significant number of periods where the $L_{A01.1-minute}$ and $L_{A01.1-minute} - L_{A90,15-minutes}$ objectives are exceeded.

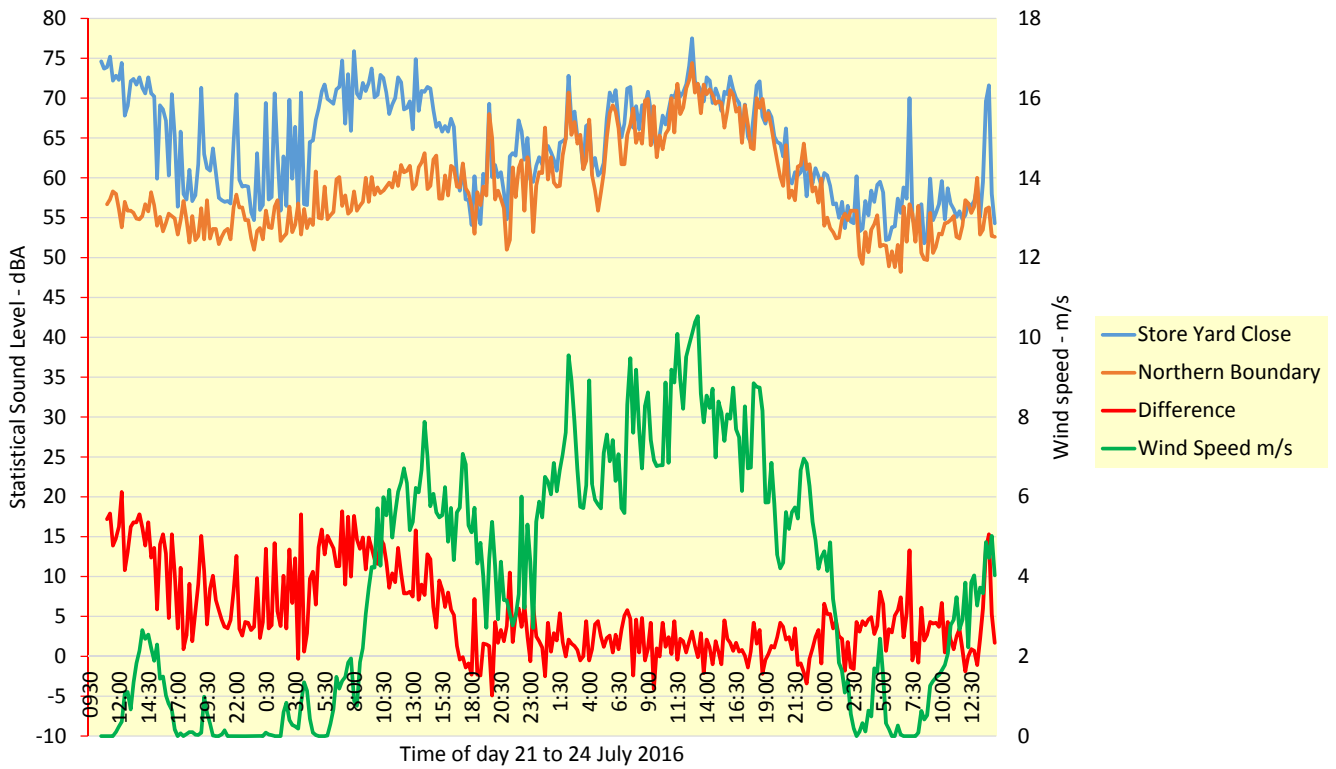
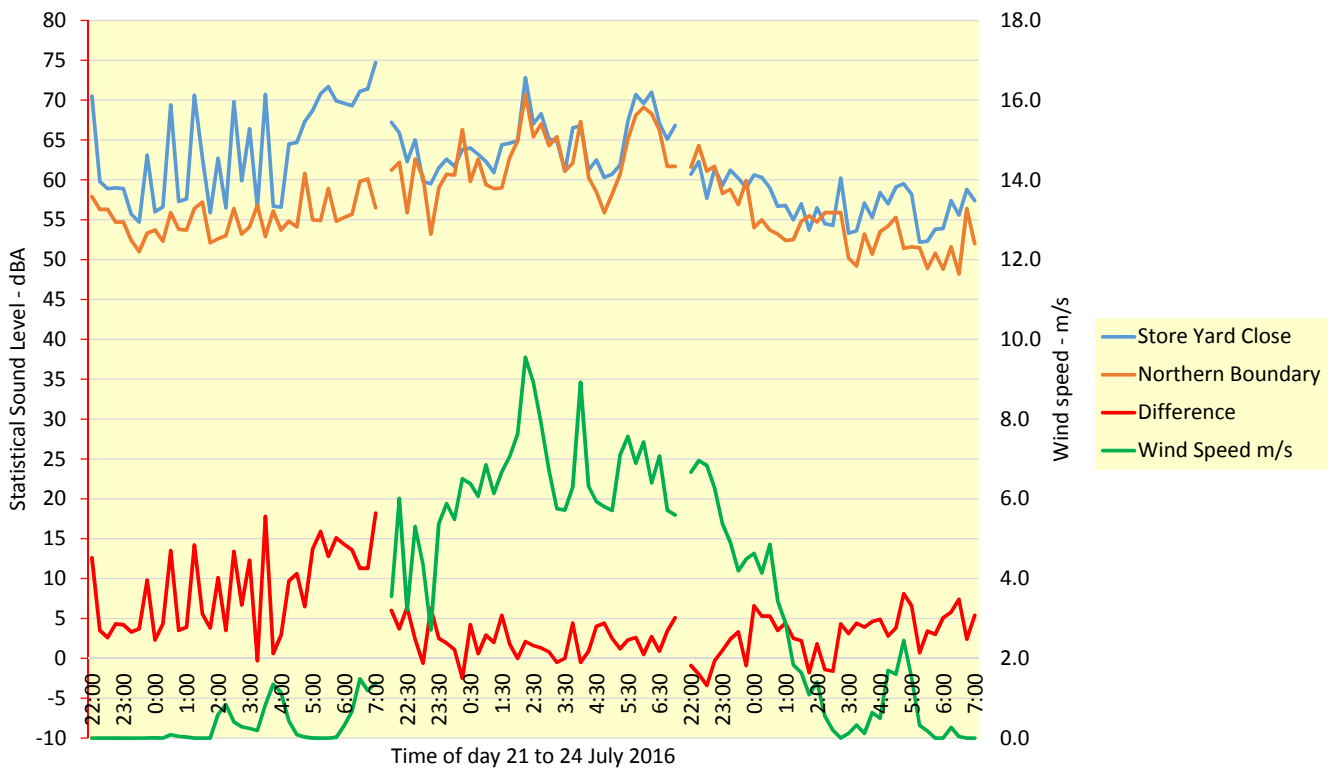
Figures 4.47 and 4.48 show an analysis comparing $L_{A01.15-minute}$ values at the Store Yard Close location and Northern Boundary location. There is not a consistent difference and wind speed has a significant effect – probably from wither wind on the microphone or wind-in-vegetation noise.

Therefore it is proposed to repeat the $L_{A01.1-minute}$ monitoring at the Northern Boundary for comparison with the objectives.

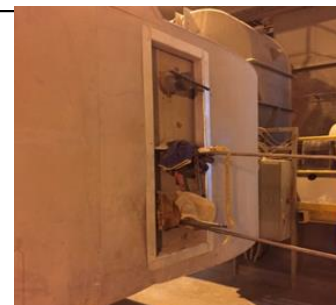
Sampling plane dimensions	1160 x 1160 mm
Sampling plane area	1.35 m ²
Sampling port size, number	3" BSP (x3)
Access & height of ports	Stairs 20 m
Duct orientation & shape	Horizontal Rectangular
Downstream disturbance	Bend 0.5 D
Upstream disturbance	Bend 0.5 D
No. traverses & points sampled	3 15
Compliance of sample plane to AS4323.1	Non-compliant

Non-compliant sampling plane; the testing precision will be reduced
The discharge is assumed to be composed of dry air and moisture

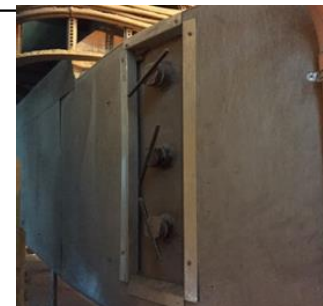
Sampling plane dimensions	700 x 1160 mm
Sampling plane area	0.812 m ²
Sampling port size, number	3" BSP (x3)
Access & height of ports	Stairs 20 m
Duct orientation & shape	Horizontal Rectangular
Downstream disturbance	Bend 0.5 D
Upstream disturbance	Bend 0.5 D
No. traverses & points sampled	3 15
Compliance of sample plane to AS4323.1	Non-compliant

Non-compliant sampling plane; the testing precision will be reduced
The discharge is assumed to be composed of dry air and moisture
