Surface Water Assessment

Bombo Quarry Modification

Prepared for Boral Resources (NSW) Pty Ltd
May 2019

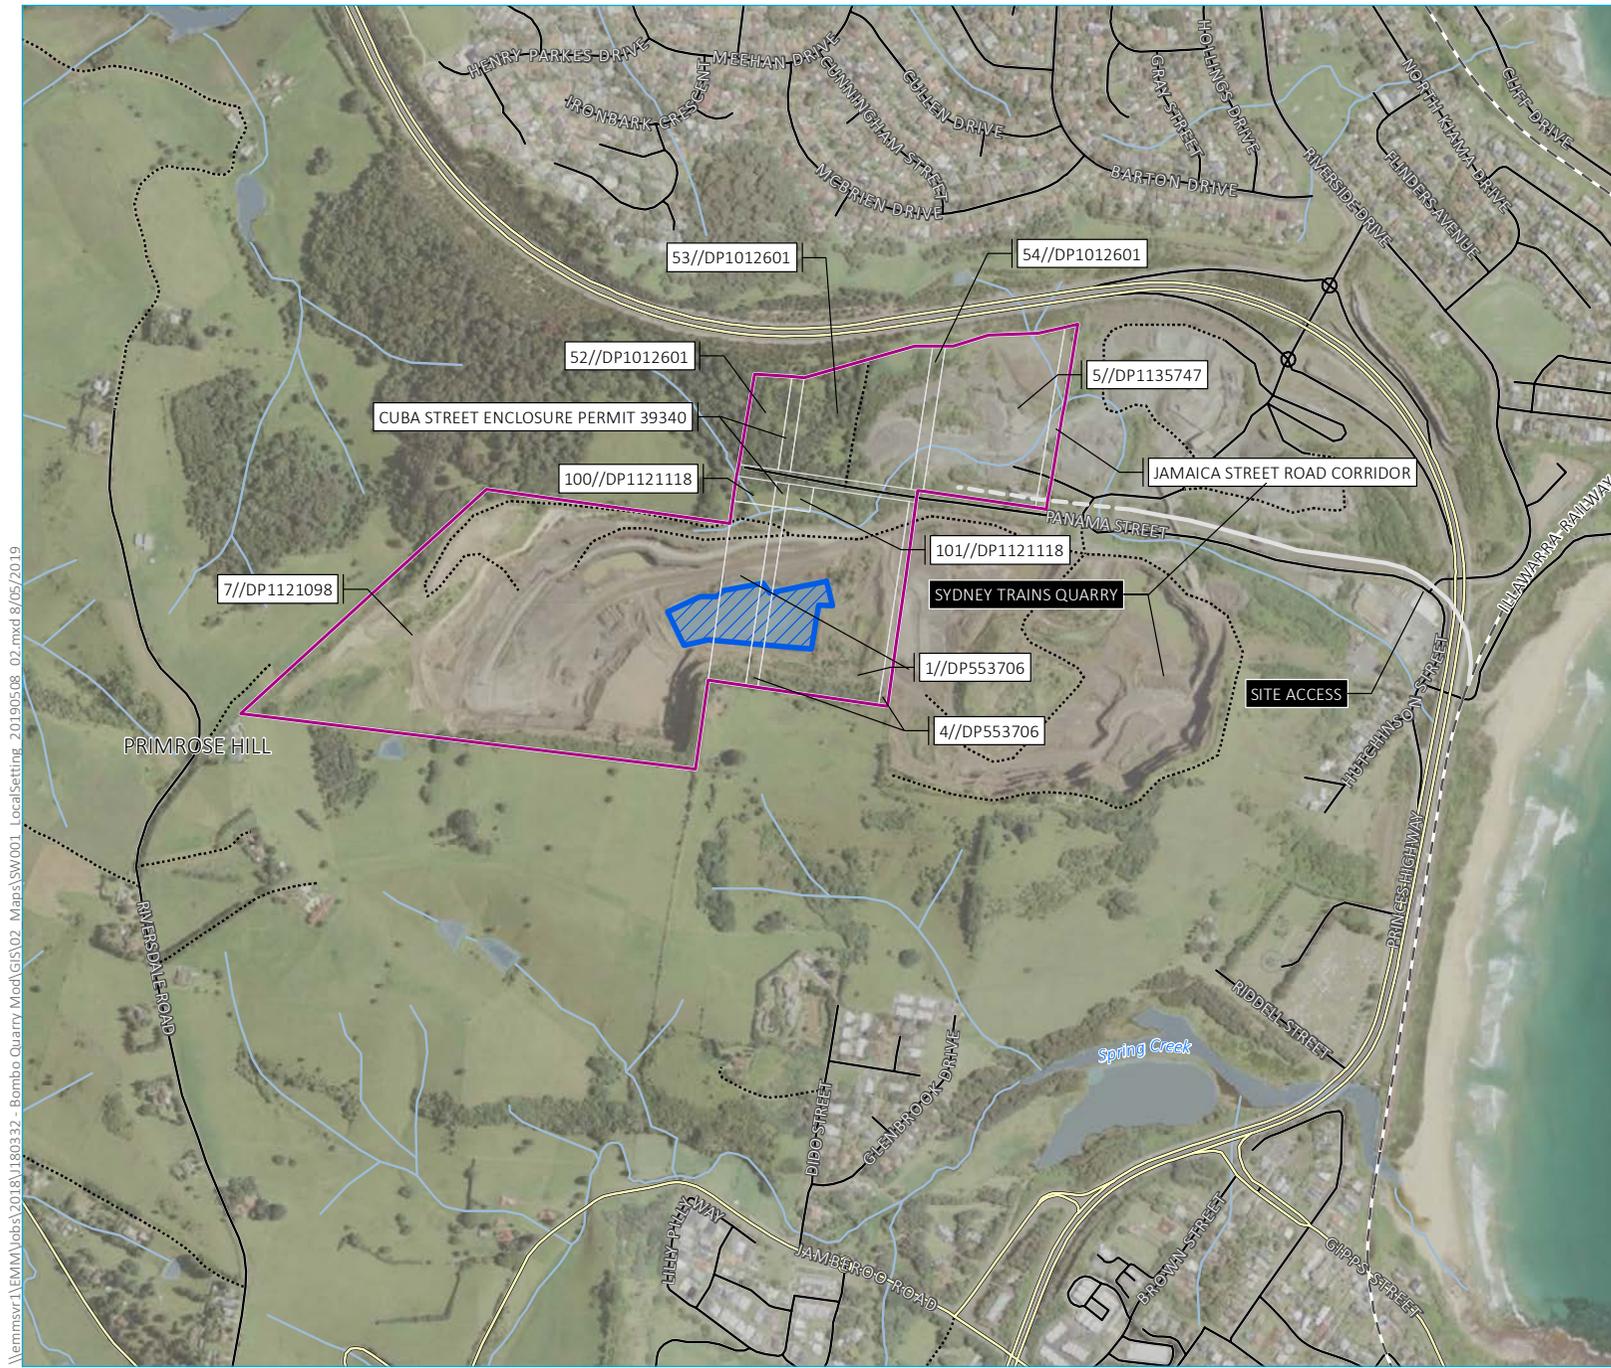
Local setting

- KEY**
- Site boundary
 - Site cadastre
 - Pit sump
 - Bombo rail siding (existing)
 - Bombo rail siding (to be reinstated)
 - Main southern railway line
 - Main road
 - Local road
 - Vehicular track
 - Watercourse / drainage line
 - Waterbody

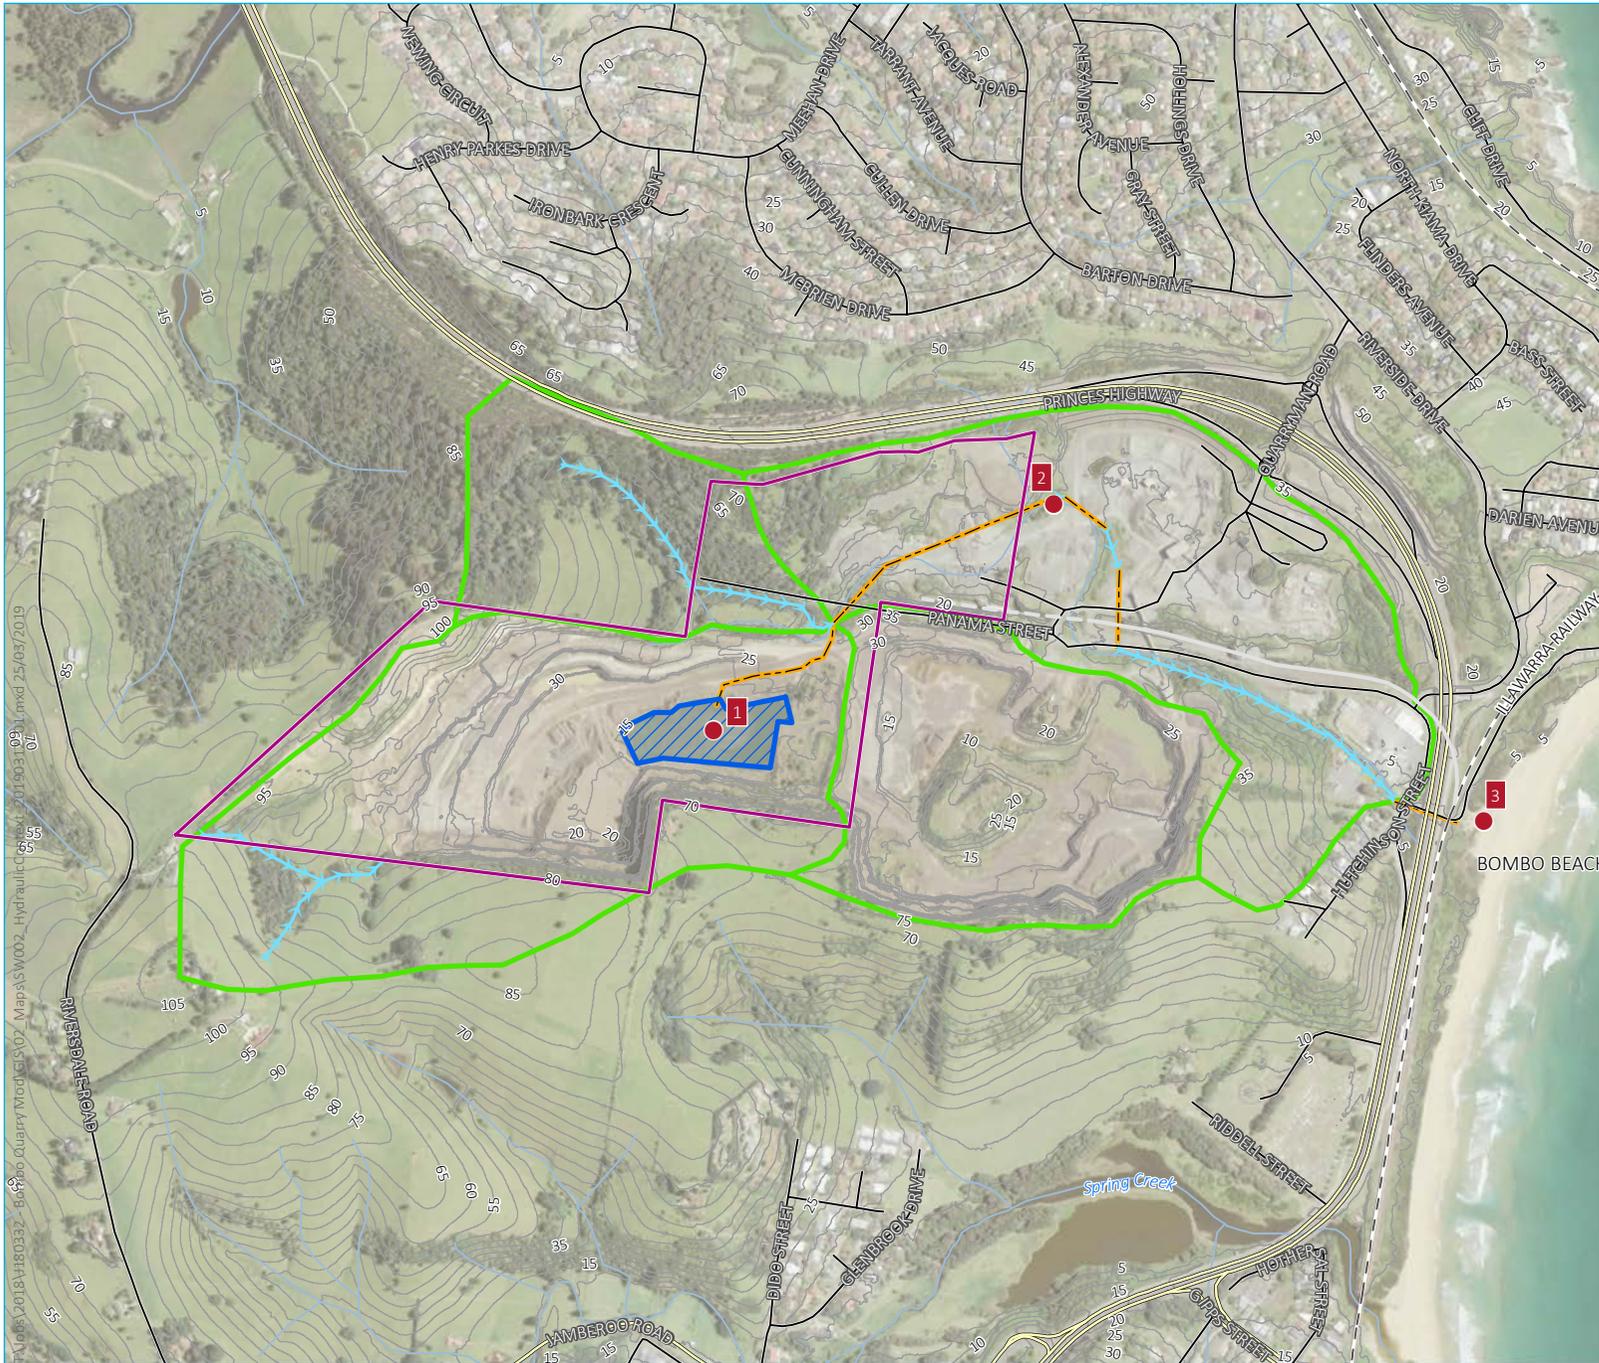
Bombo quarry modification
Surface water assessment
Figure 3.1

- KEY**
- Site boundary
 - Pit sump
 - Water monitoring location
 - Catchment boundary
 - ▶ Open channel
 - Piped drainage
 - Bombo rail siding (existing)
 - Bombo rail siding (to be reinstated)
 - Main southern railway line
 - Main road
 - Local road
 - Watercourse/drainage line (DFS1, 2017)
 - Contour (5 m interval)

Local hydrologic context

The local hydrologic context for the quarry is shown on Figure 3.1, which should be referred to when reading this section of the SWA. Key features presented include:

The regional topography falls generally from west to east towards Bombo Beach, draining across the beach and into the ocean via an unnamed watercourse. The quarry and neighbouring Sydney Trains site have been extensively modified since quarrying began. Each site has effectively formed its own subcatchment, and these subcatchments are shown on Figure 3.1. An additional subcatchment is shown on the figure to illustrate the total catchment contributing to the unnamed watercourse at its piped crossing of the Princes Highway.

Available data to assist in characterisation of existing water quality within and downstream of the quarry is limited to monitoring that was undertaken by Boral throughout the recent dewatering phase March to August 2018. Water quality monitoring was undertaken at three locations as shown on Figure 3.1, and include within the quarry pit [Point 1], at the licensed discharge point immediately downstream of the site boundary at the Licensed Discharge Point (LDP) [Point 2], and at Bombo Beach [Point 3].

Whilst a higher number of exceedances were detected at the pit upstream of the LDP (Point 1), these were generally not detected downstream at either the LDP or the Bombo Beach discharge point (Point 3), which indicates that existing water management systems and practices are effective in managing water quality.

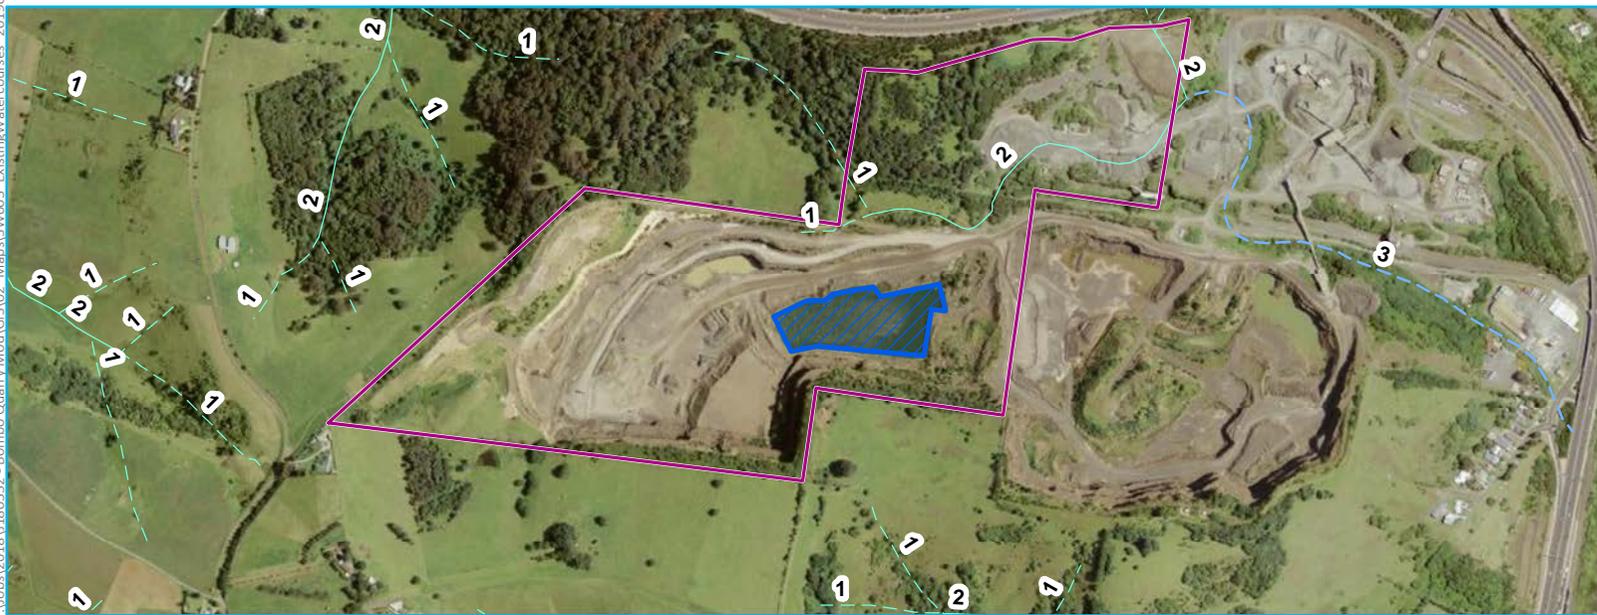
Figure 3.2b: DPI watercourse mapping

- KEY
- Site boundary
 - Pit sump
 - Stream order (DPI, 2013)
 - 1
 - 2
 - 3

Both DoI-Water and Council have available watercourse mapping which covers the quarry and surrounds. This is presented in Figure 3.2. However, on review it was noted that:

- inconsistencies exist between the DoI-Water and Council mapping; and
- both DoI-Water and Council watercourse mapping do not accurately reflect current site conditions, given the extraction and supporting activities and associated extensive modifications to watercourses that have occurred over time.

DoI-Water mapping (refer Figure 3.2b) shows first and second order streams within the quarry, with corresponding riparian corridor widths extending 10 m and 20 m, respectively, from top of bank. This mapping appears to

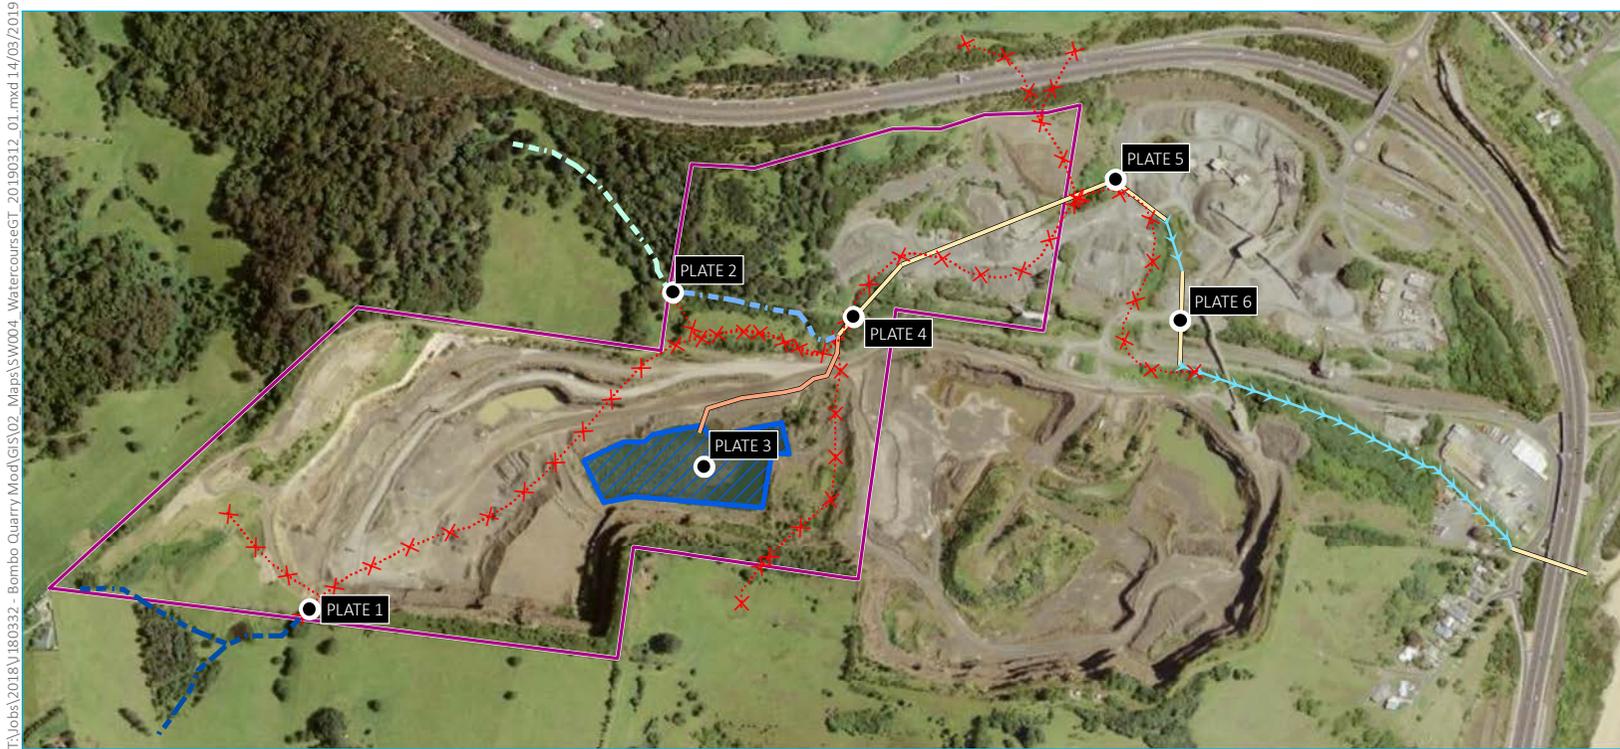
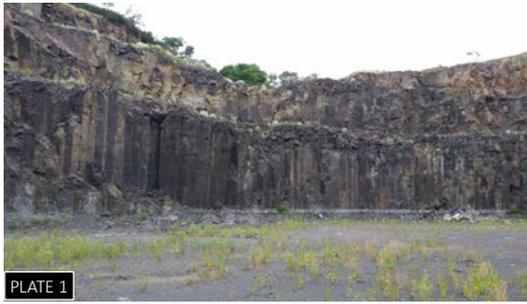
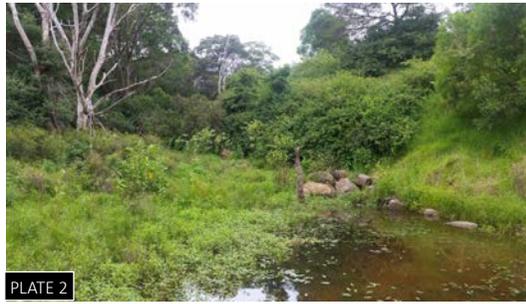
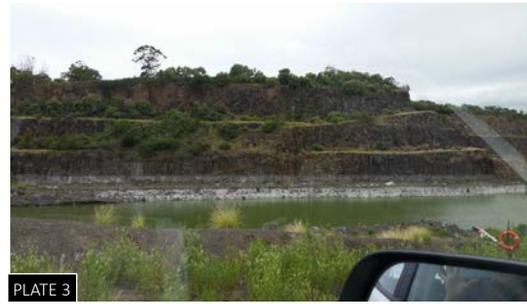
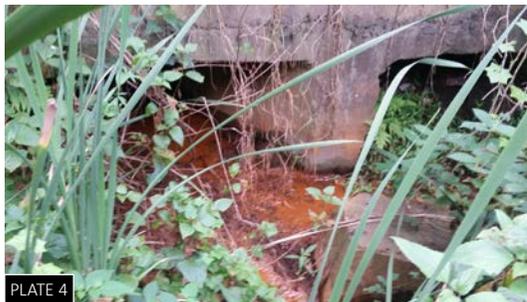
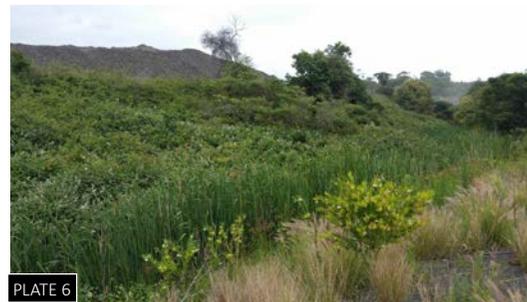
Bombo quarry modification
Surface water assessment
Figure 3.3

- KEY**
- Site boundary
 - ▣ Pit sump
 - Water management system based on observations
 - Indicative rainfall-dependent watercourse (LEP)
 - Indicative modified watercourse (EMM)
 - Indicative watercourse (LEP & DPI)
 - ✗ Watercourse does not exist
 - Piped drainage
 - Remnant reaches of open channel
 - Temporary dewatering pipe
 - Plate

Outcomes of watercourse ground-truthing exercise

A site inspection was conducted on 12 December 2018 to ground-truth the location and arrangement of existing drainage elements within the quarry and extending downstream to the Princes Highway. The outcomes of the site inspection and confirmed current drainage system, including photographs for key representative locations, are shown in Figure 3.3.

- the existing drainage system was observed to be generally consistent with arrangements set out in the dewatering plan, which were installed to facilitate dewatering of the pit over the period March to August 2018 (refer Section 2.3 for details); and
- all existing open channel reaches within the site boundary have been relocated and/or heavily modified by historic quarrying activities, forming part of the quarry's water management system, and no longer occur as shown in either DoI-Water/Council watercourse mapping.
