## Berrima Colliery

# ***Berrima Colliery Rehabilitation Management Plan July 2022***

Name of mine	Berrima Colliery
Rehabilitation management plan commencement date	2 July 2022
Rehabilitation Management plan revision dates and version numbers	2 July 2022, Version 1
Mining leases	Consolidated Coal Lease 748, MPL603 and 604
Name of lease holder	Boral Limited
Date of submission	1 July 2022

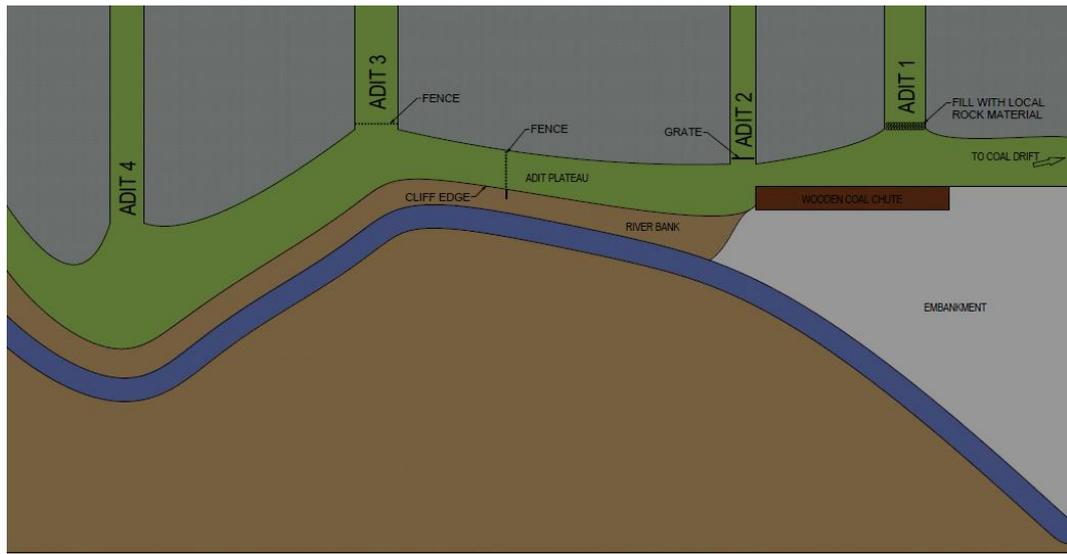
**Diagram 1 – Plan view of Loch Catherine Closure Methodology**

opening. The design having horizontal bars will accommodate for the entry and exit of any local bat colonies.

- ❑ Adit 3 will be sealed in a similar fashion using the same horizontal bar arrangement but will be located approximately 4 m in-by of the adit entry.
- ❑ Adit 4 is unsafe to access due to the unstable overhanging rock cliff above the entry. The adit however will be sealed by constructing an additional steel fence barrier located on the bench between Adits 2 and 3 as shown in the sketch below. The fence barrier will overhang the bench to further exclude human access. Bat access to Adit 4 will remain unaffected.

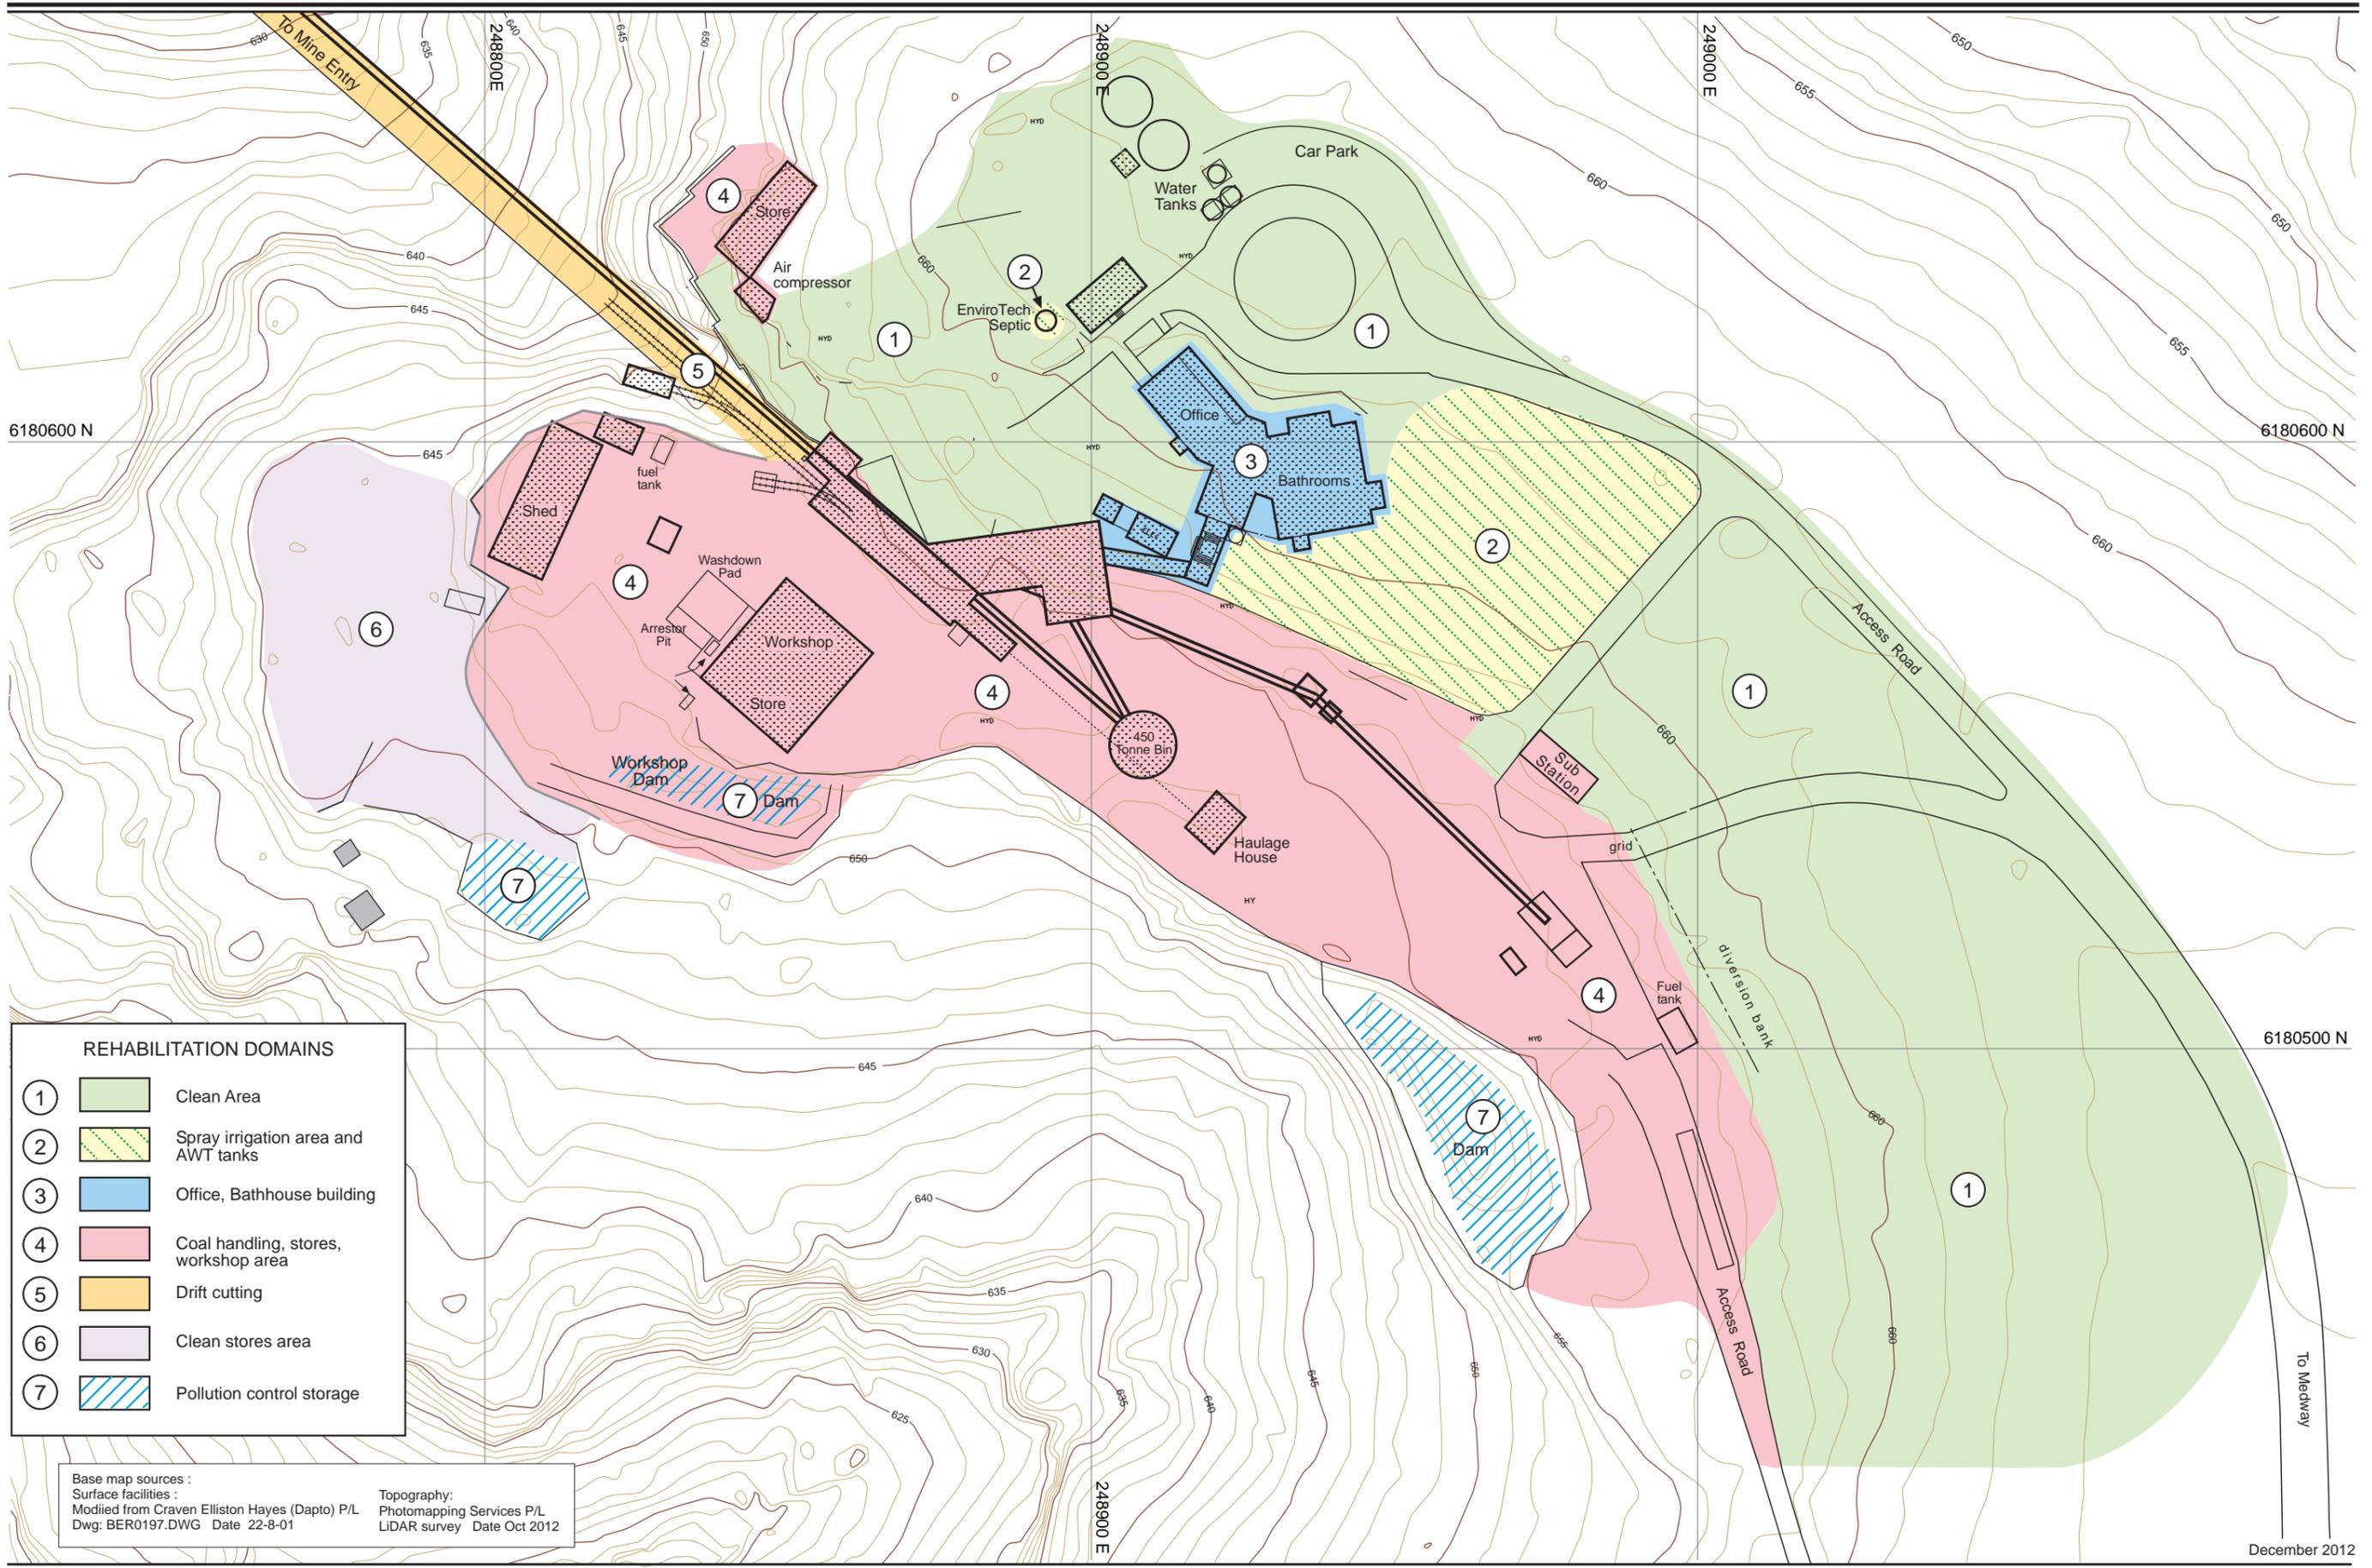
**REHABILITATION DOMAINS**

- ①  Clean Area
- ②  Spray irrigation area and AWT tanks
- ③  Office, Bathhouse building
- ④  Coal handling, stores, workshop area
- ⑤  Drift cutting
- ⑥  Clean stores area
- ⑦  Pollution control storage

- ❑ Primary Water Treatment. This domain covers the pit top area previously described by 7 separate operating domains. Under this RMP, the water treatment operation will continue at the pit top and will not be subject to lease relinquishment. It has been noted as an industrial land use.

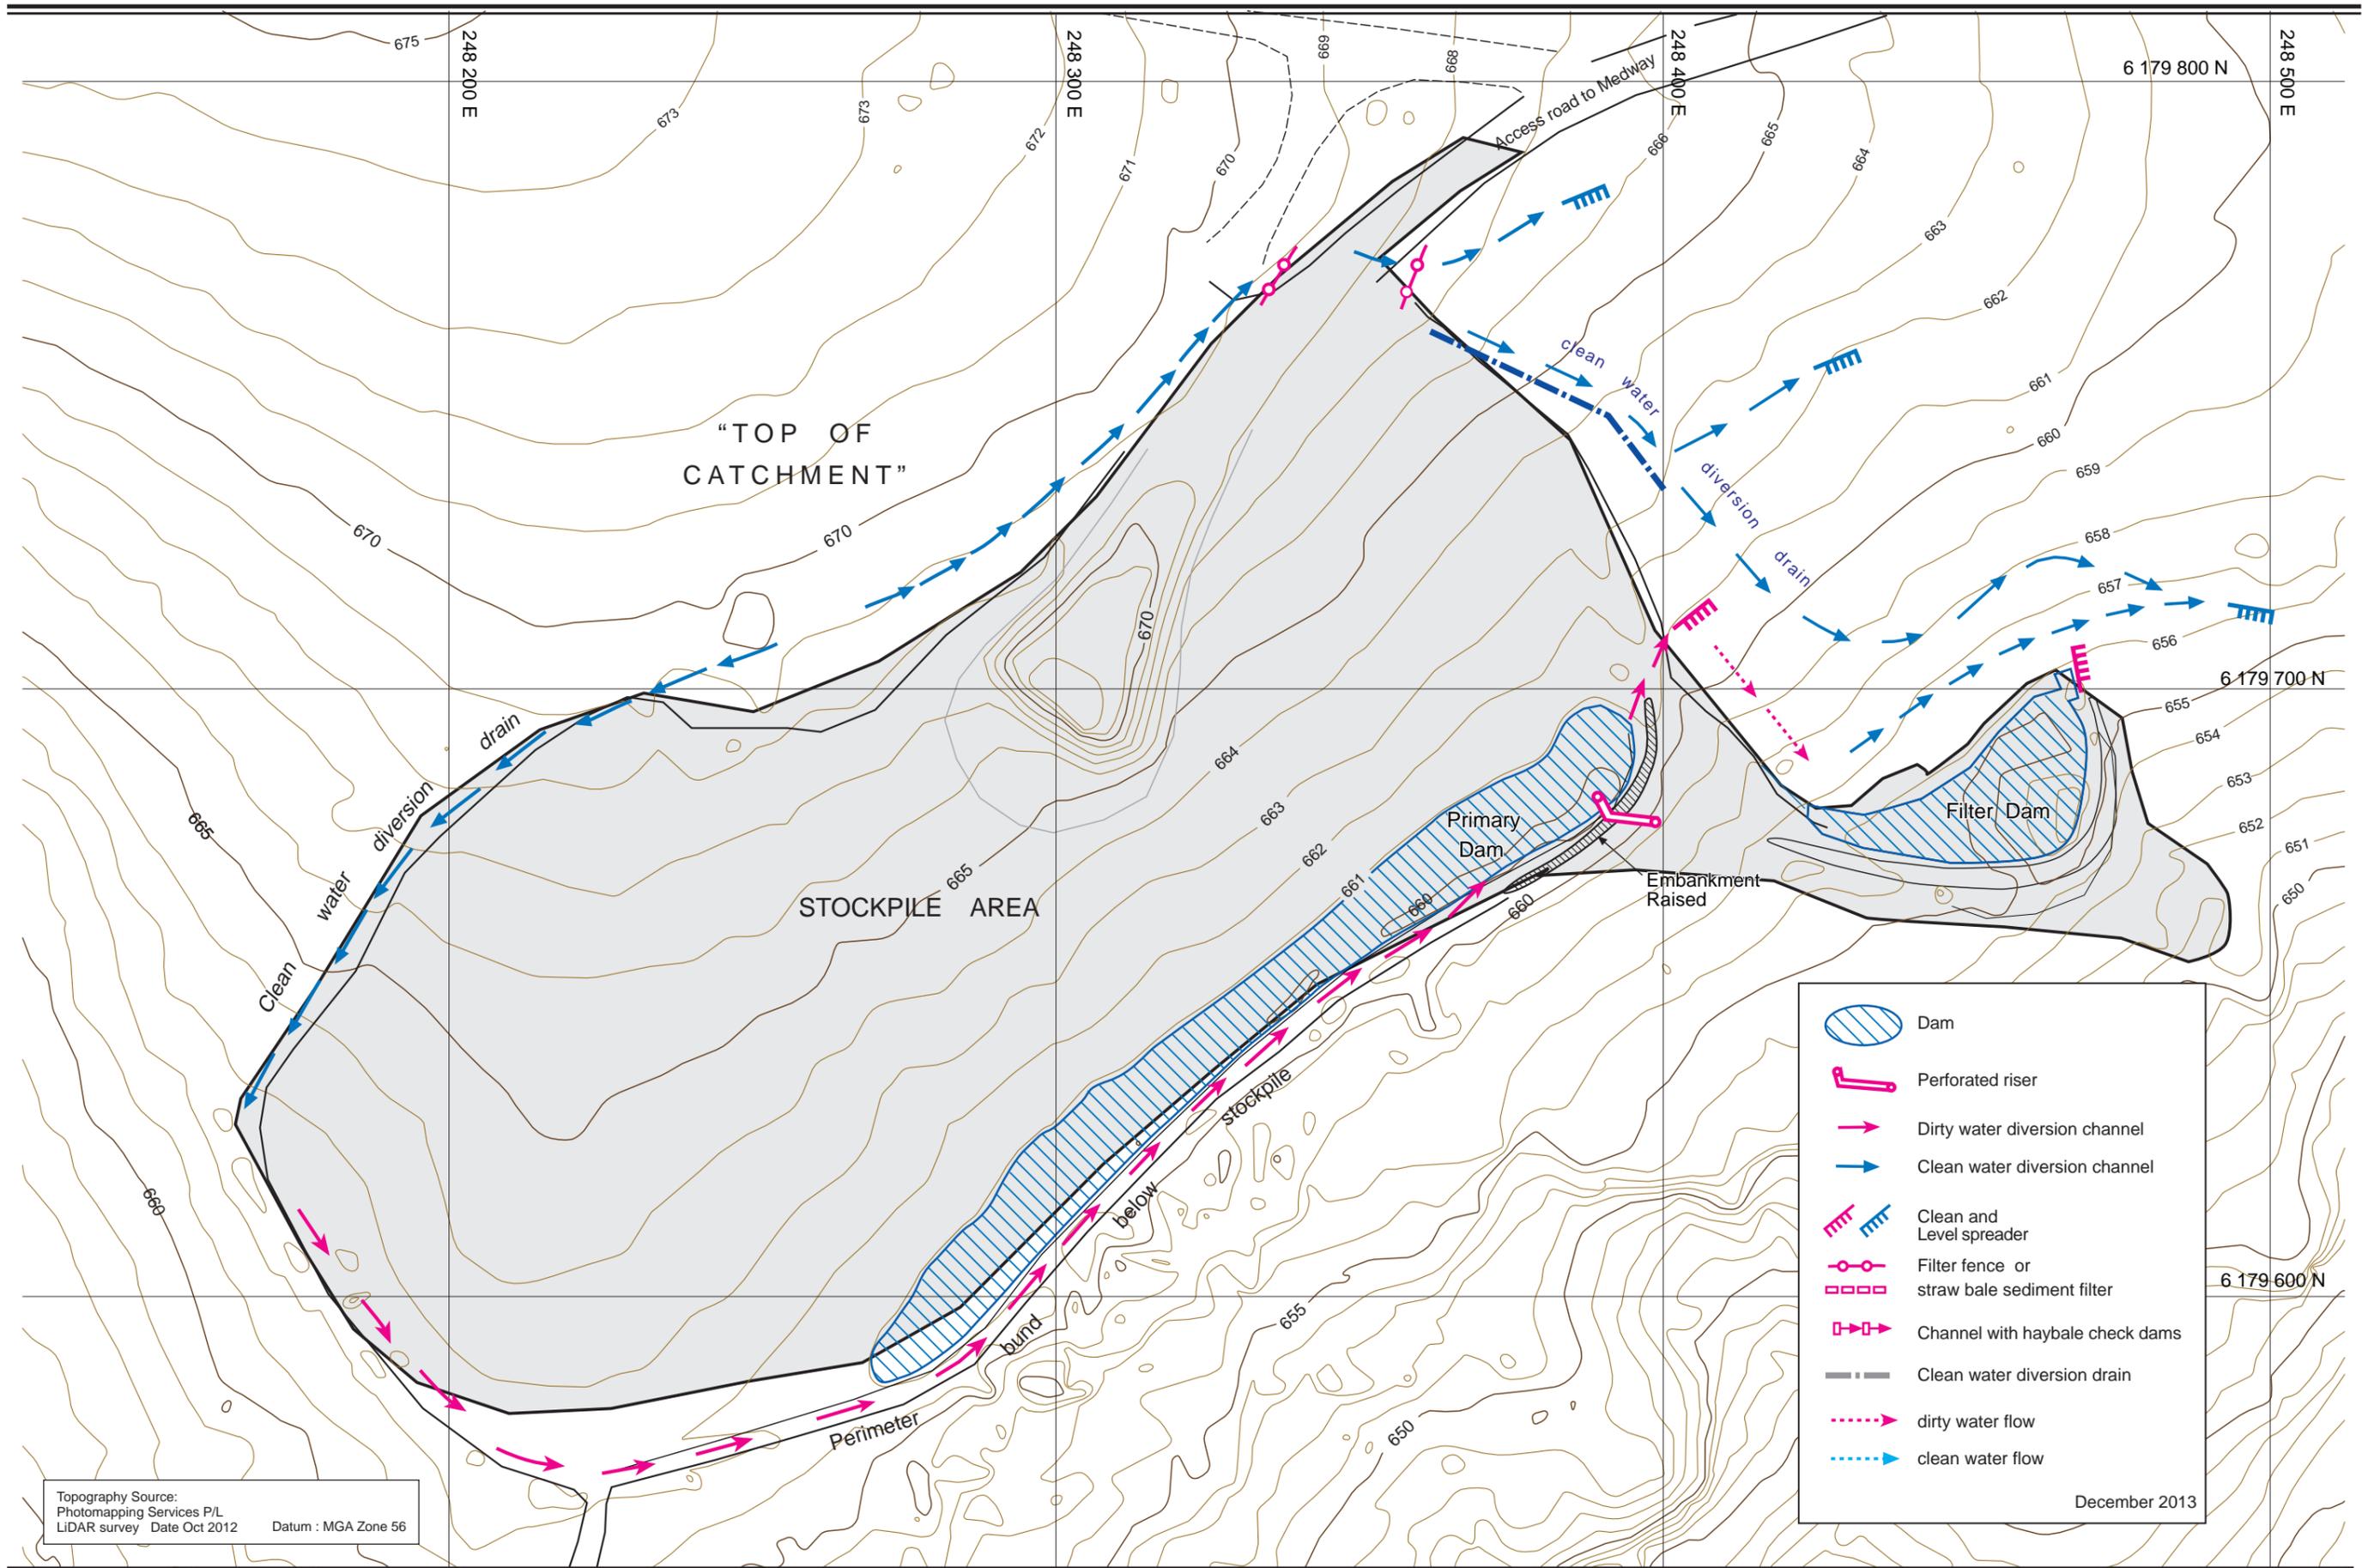
Dam
	Perforated riser
	Dirty water diversion channel
	Clean water diversion channel
	Clean and Level spreader
	Filter fence or straw bale sediment filter
	Channel with haybale check dams
	Clean water diversion drain
	dirty water flow
	clean water flow

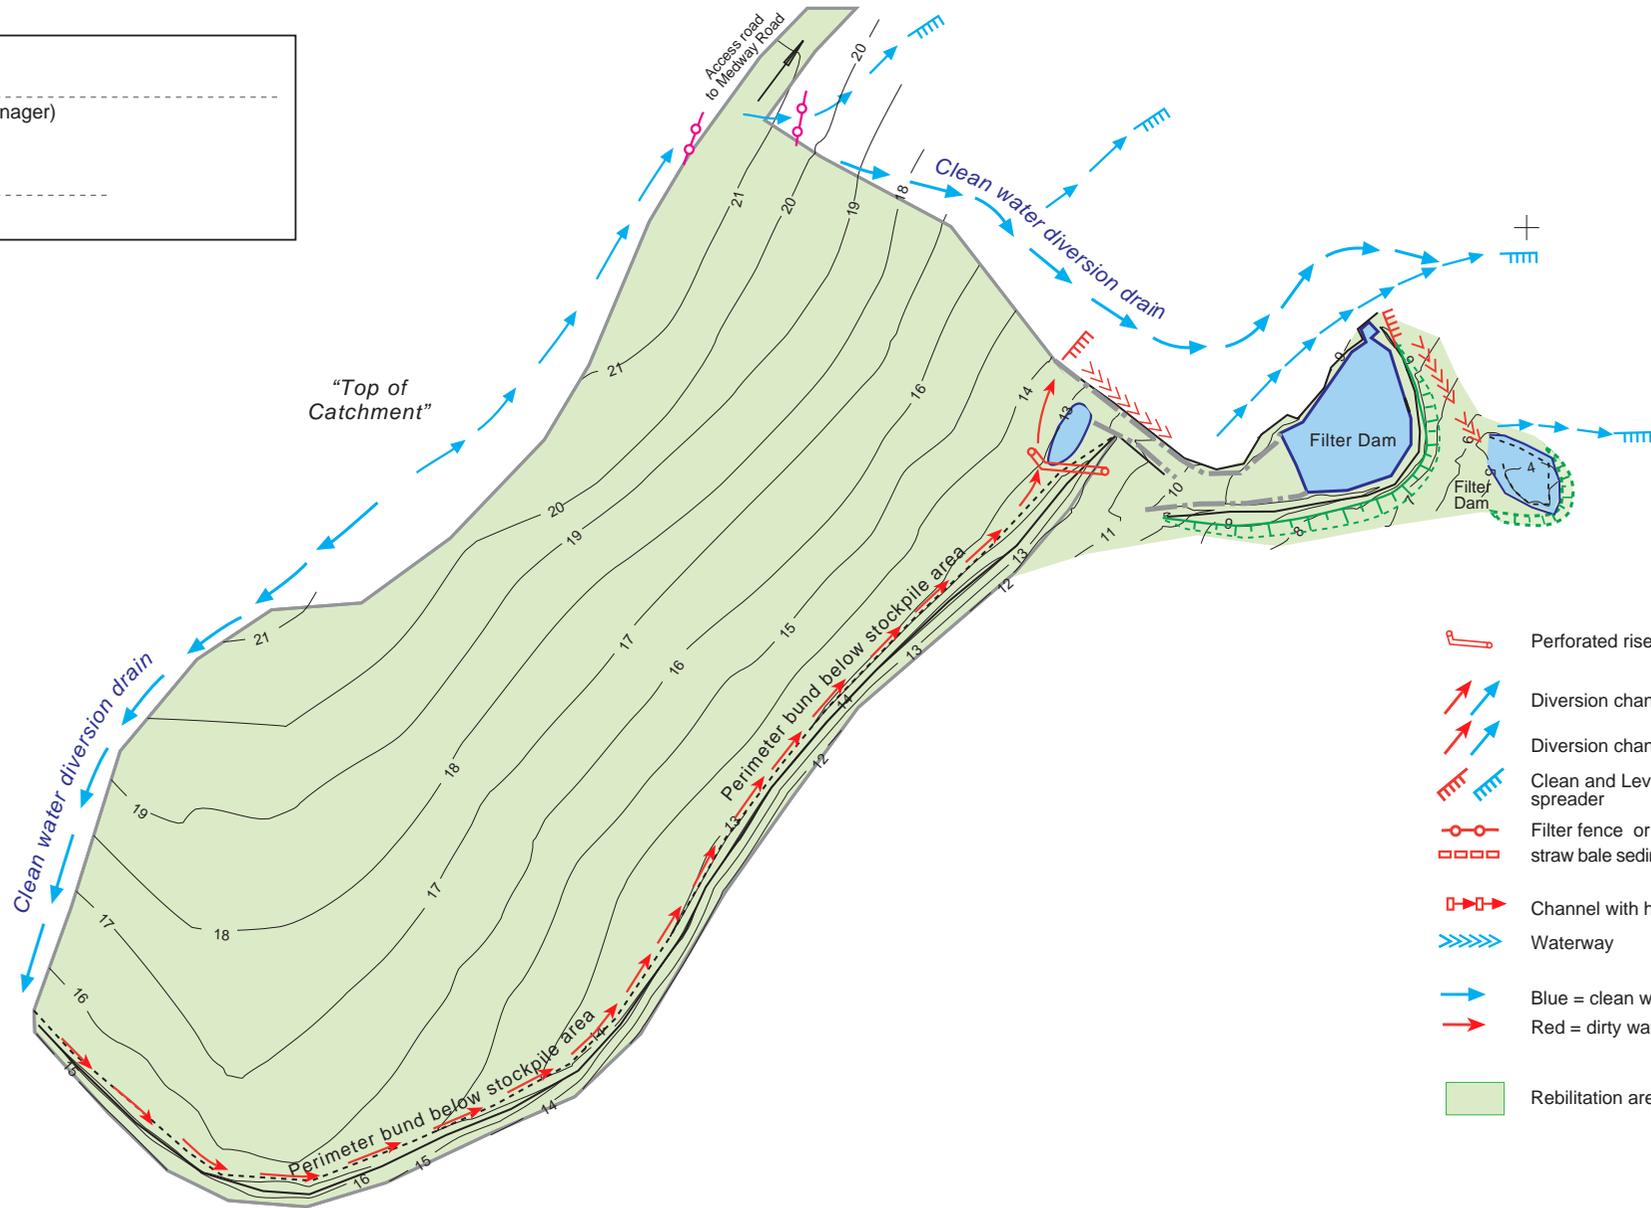
PLAN 4b  
**Berrima Colliery - Loch Catherine**  
**Final Rehabilitation**

- Perforated riser
- Divergence channel
- Divergence channel
- Clean and Level spreader
- Filter fence or straw bale sediment filter
- Channel with haybale check dams
- Waterway
- Blue = clean water flow
- Red = dirty water flow
- Rehabilitation areas

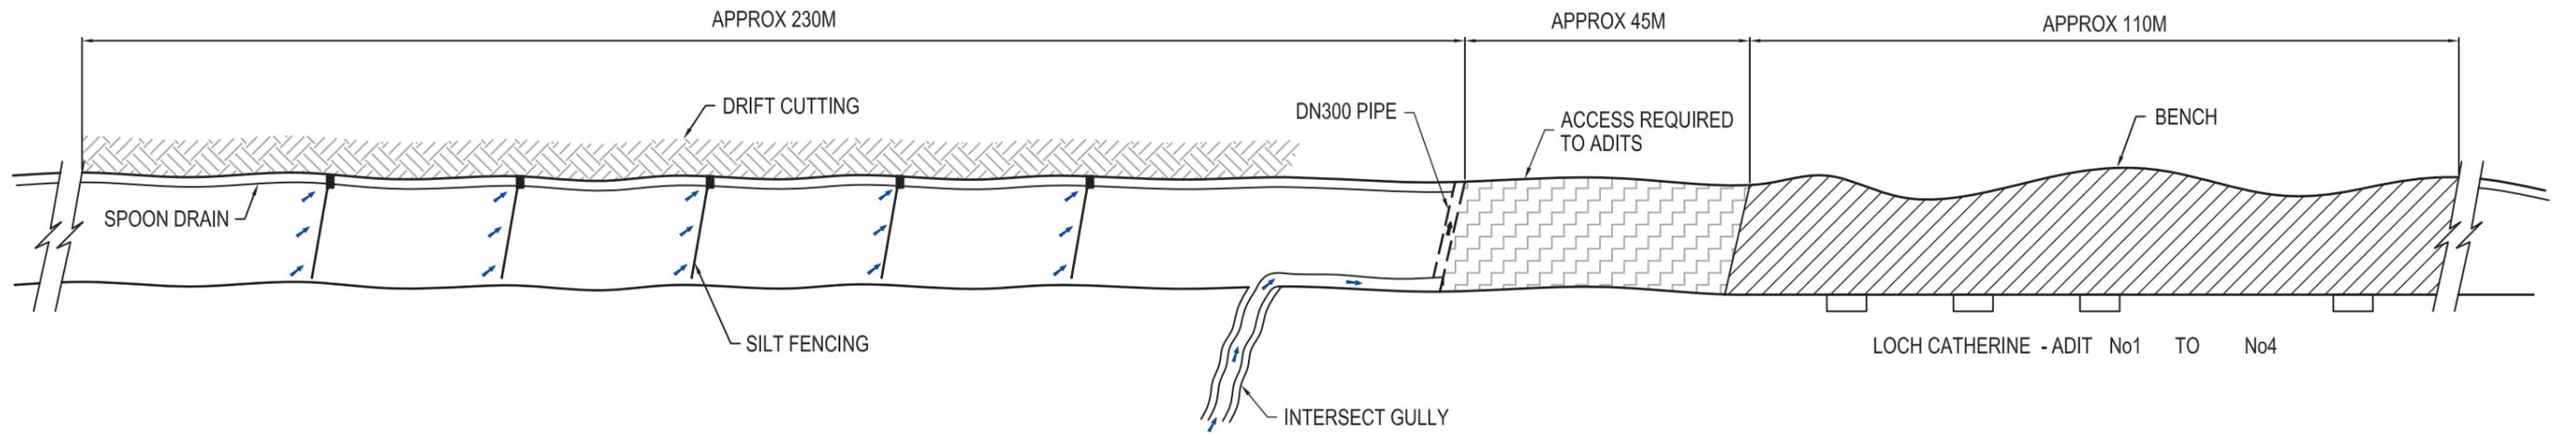
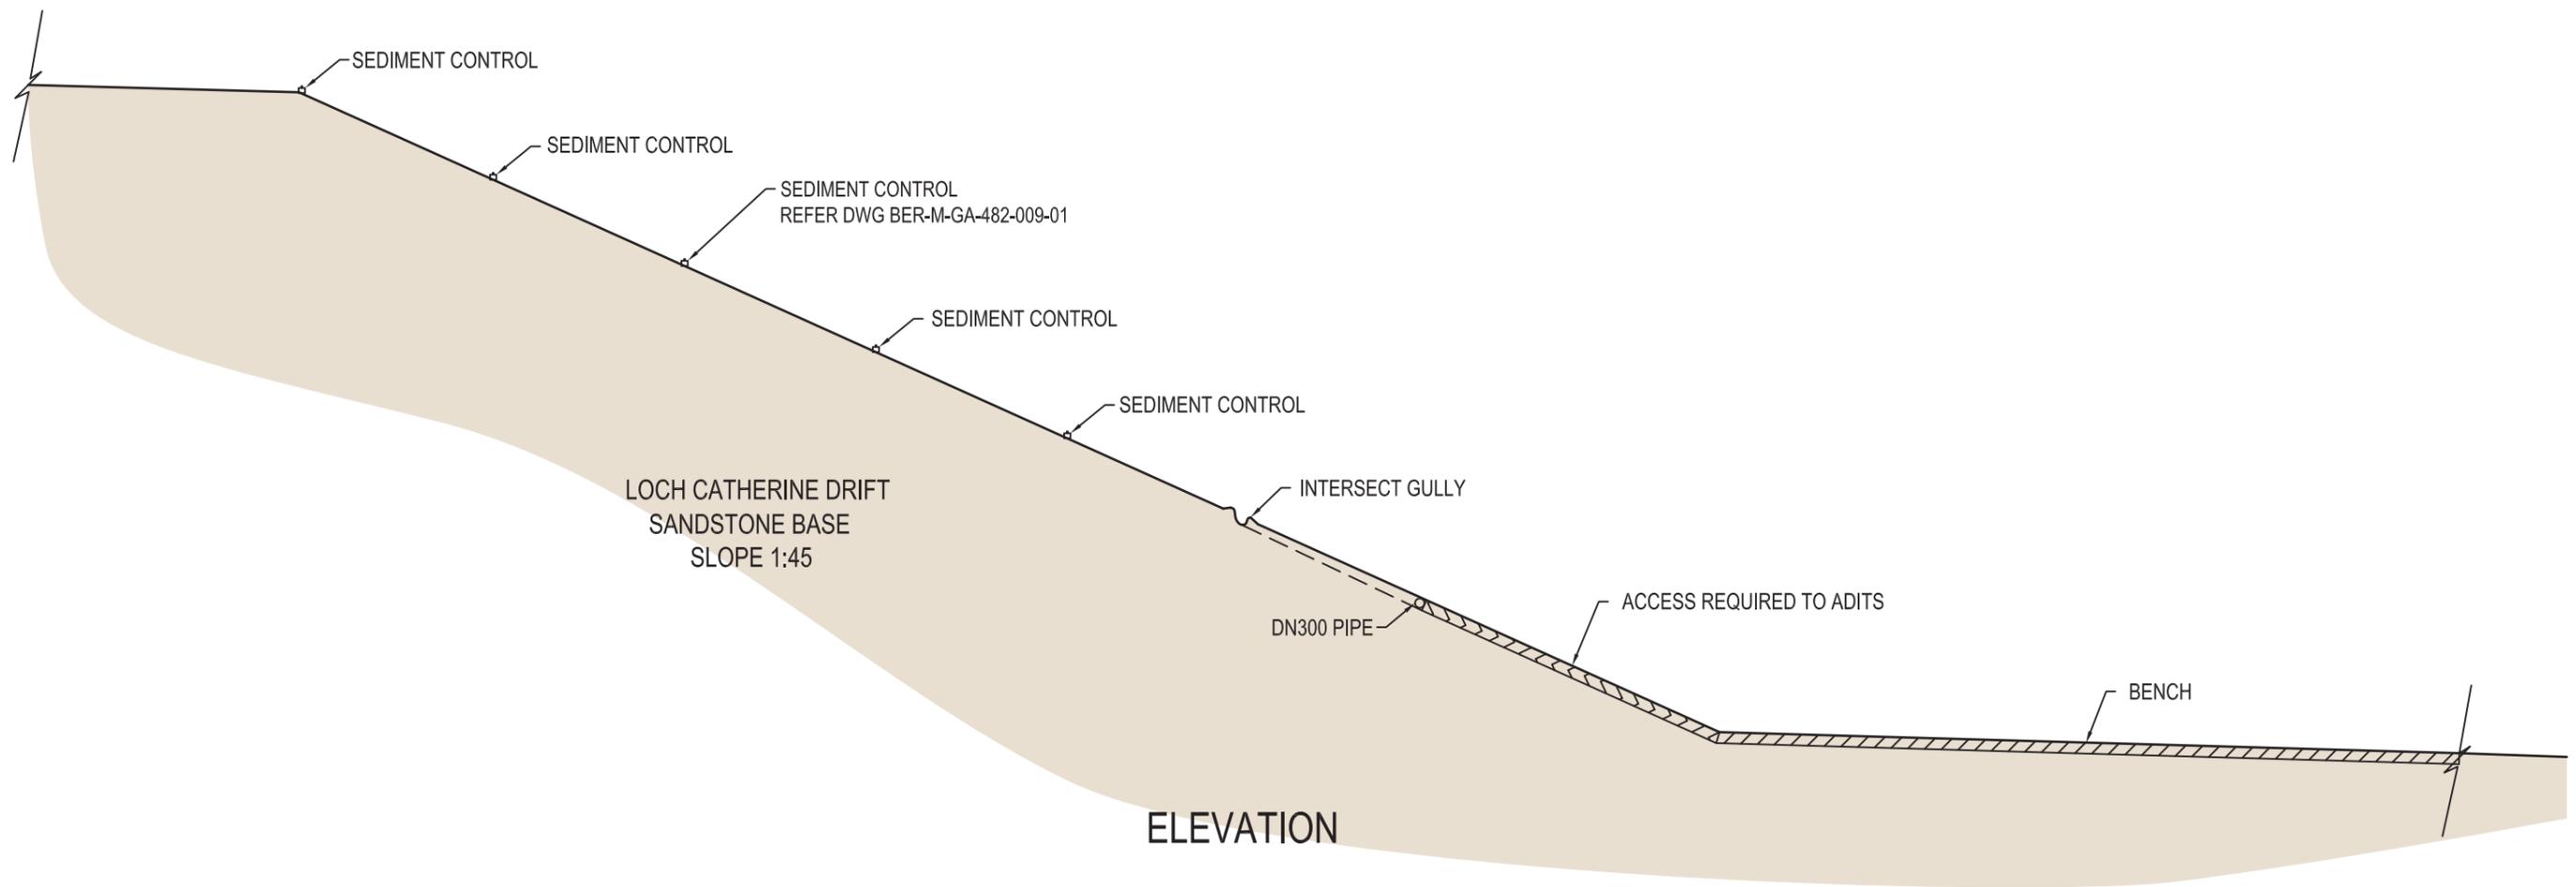
Source - Boral DWG No:  
 BER-M-GA-482-009-01 REV. A  
 21 June 2108

PLAN

ELEVATION

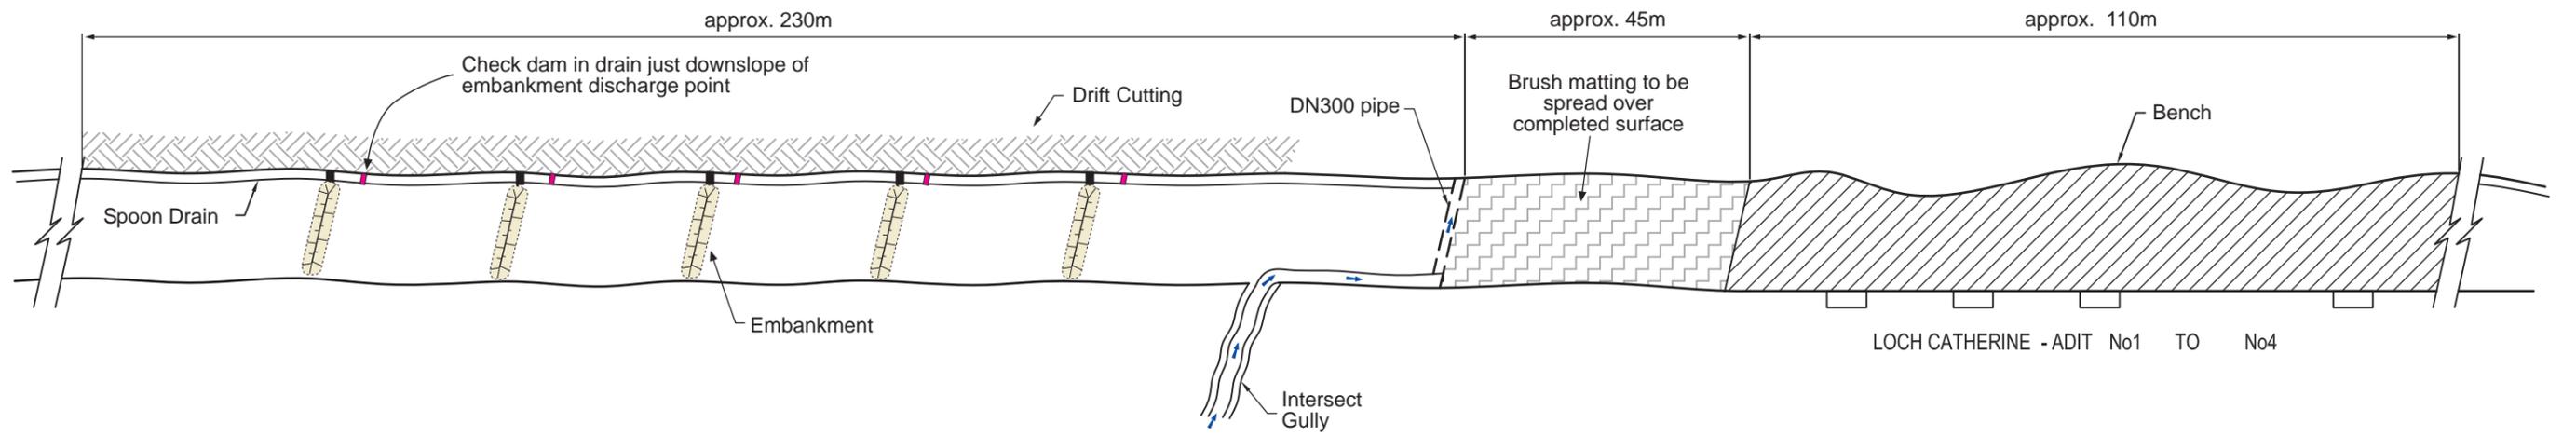
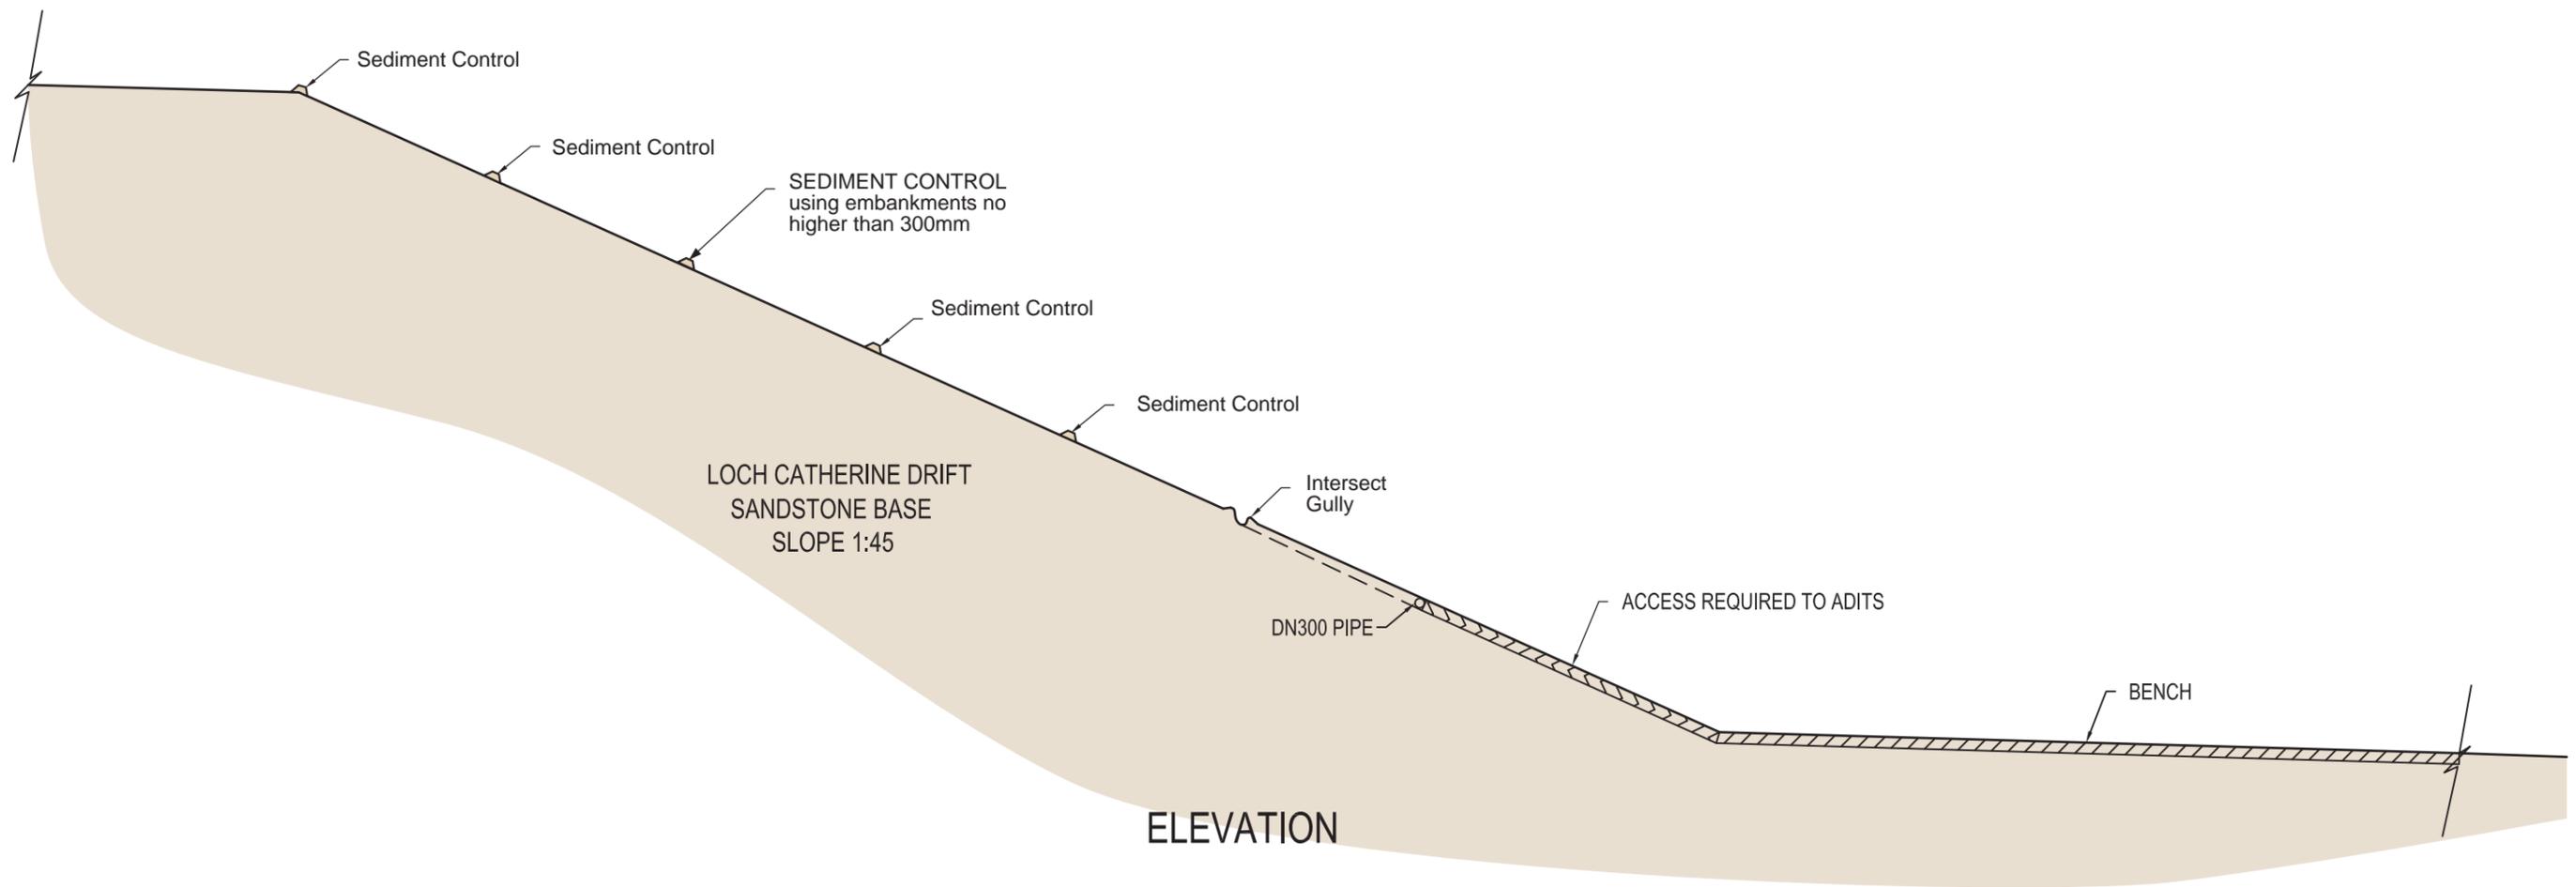
Source - Boral DWG No:  
 BER-M-GA-482-009-01 REV. A  
 21 June 2108

PLAN

ELEVATION

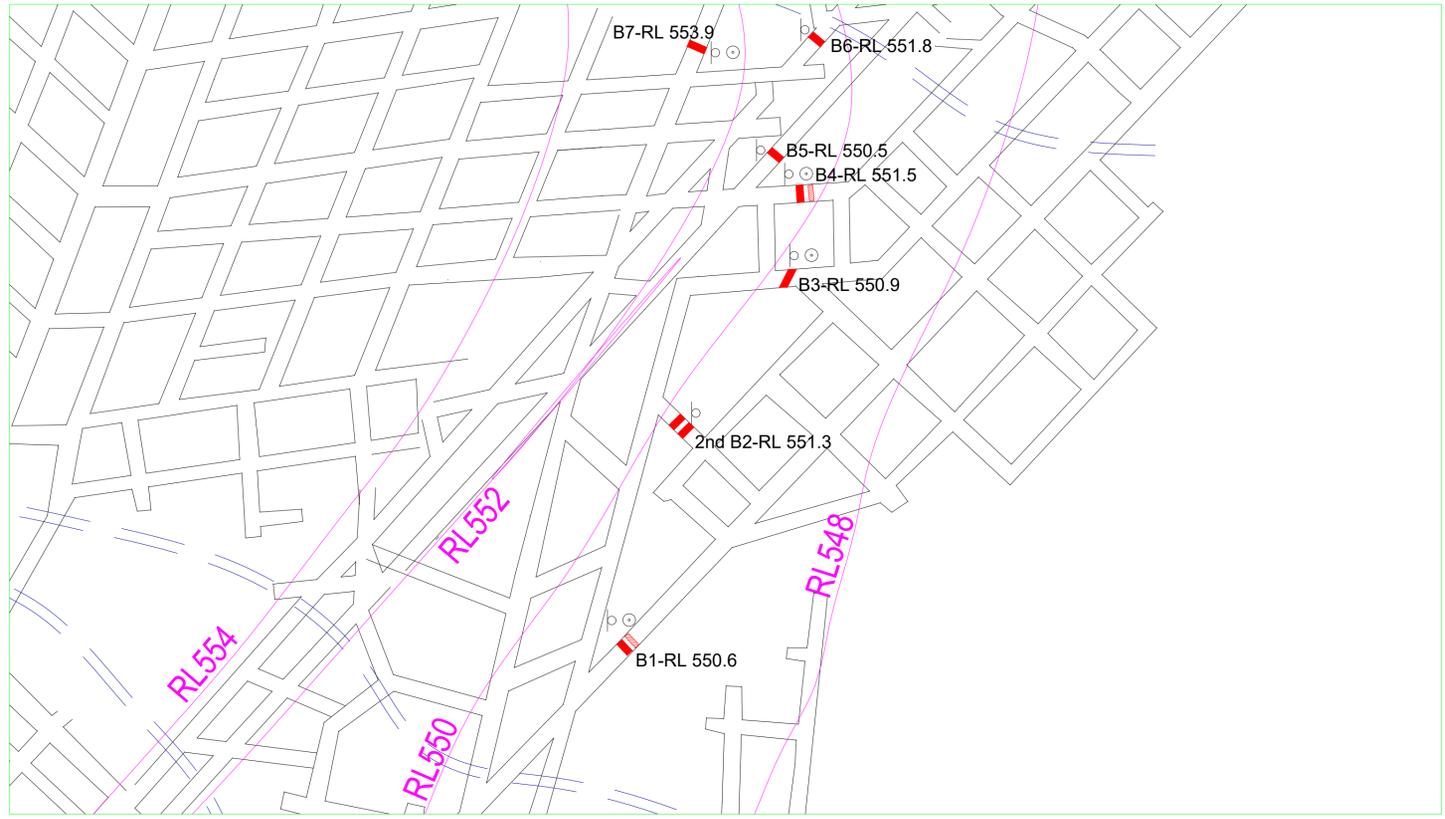
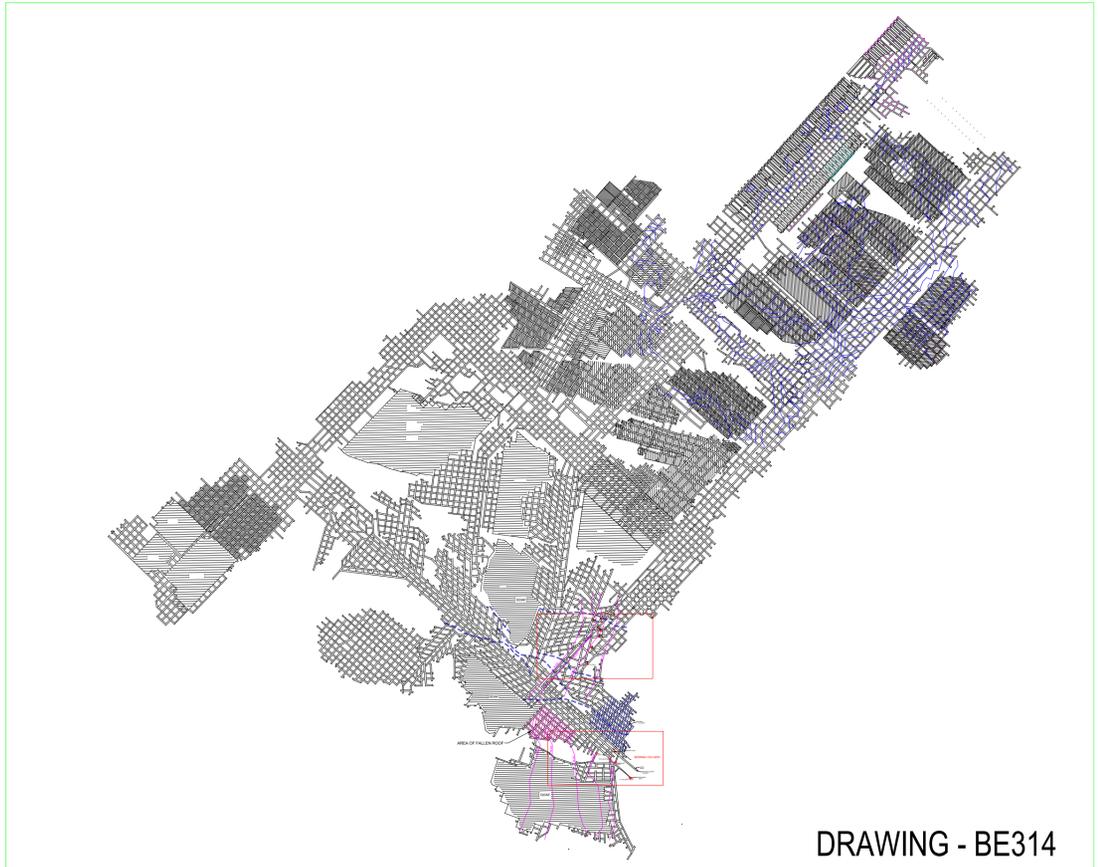
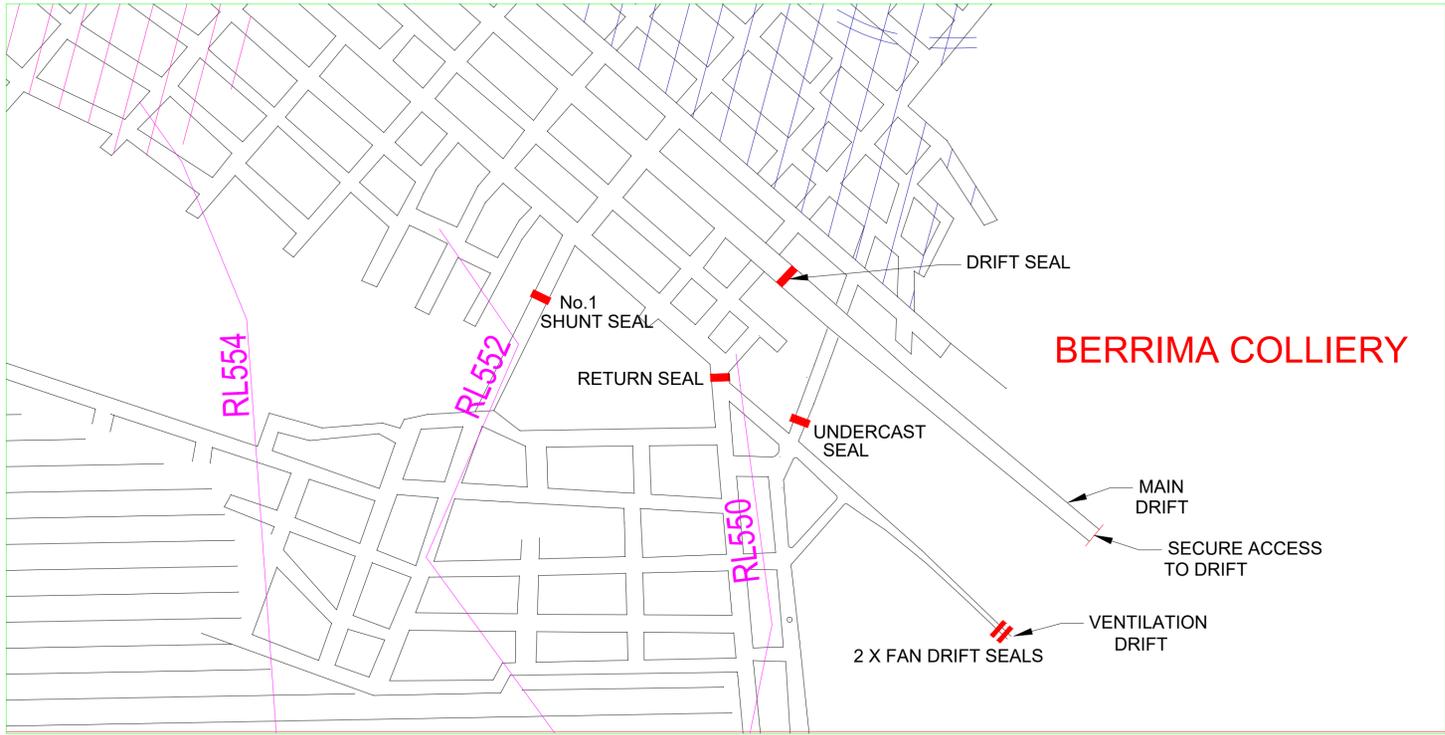
DRAWING No:	BER-M-GA-482-012-01
WORKS No:	<b>Plan 5A</b>
REV.	<b>A</b>

- PIT BOTTOM SEALS
- COAL SEAM CONTOURS
- TRANSFORMER
- PRESSURE GAUGE
- PRESSURE TRANSMITTER

PLANT:	BERRIMA COLLIERY
PROJECT:	COLLIERY CLOSURE
SECTION:	MINE
SUB SECTION:	
TITLE:	<b>INTERNAL BULKHEADS</b>
CLASSIFICATION:	<b>GENERAL ARRANGEMENT</b>

Data gathered since the installation of the bulkheads has included water level and pressure behind the bulkheads, pumping rates, leakage and water quality. This data was then used in the updated groundwater model along with more accurate seam floor data, permeabilities and water level data from groundwater bores.
