## Berrima Colliery

# ***Berrima Colliery Rehabilitation Management Plan July 2022***

Name of mine	Berrima Colliery
Rehabilitation management plan commencement date	2 July 2022
Rehabilitation Management plan revision dates and version numbers	2 July 2022, Version 1
Mining leases	Consolidated Coal Lease 748, MPL603 and 604
Name of lease holder	Boral Limited
Date of submission	1 July 2022

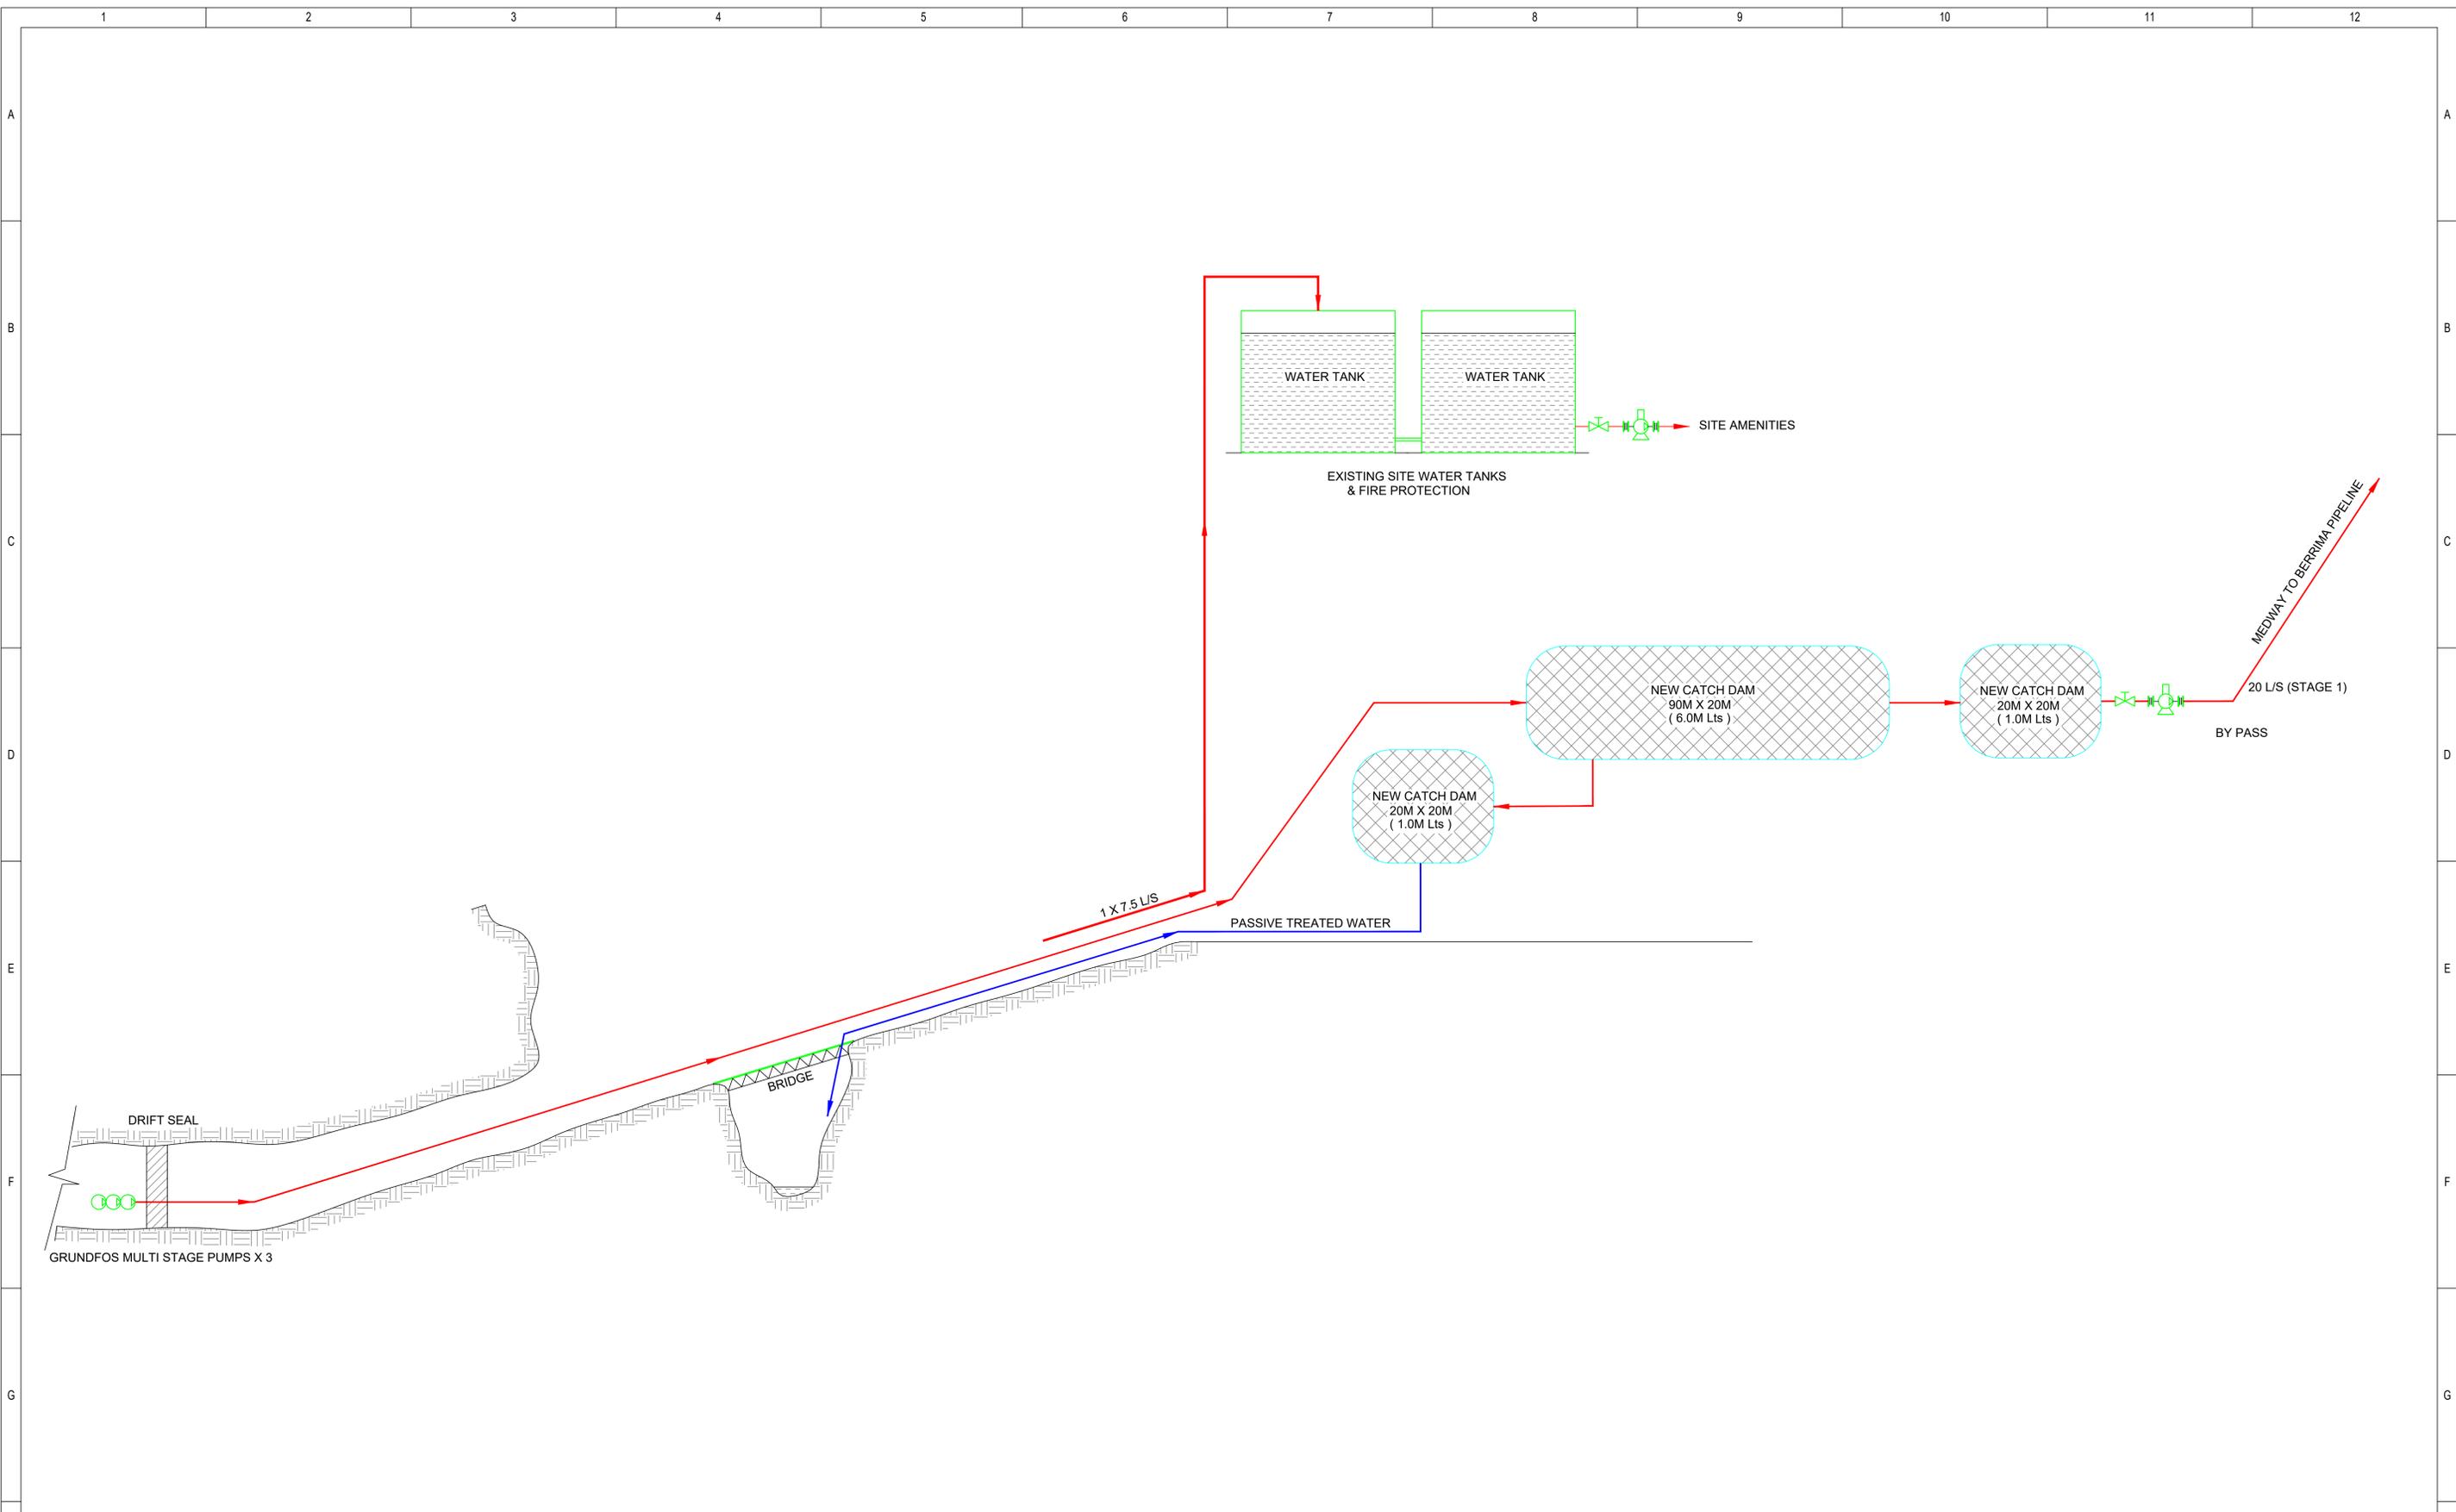
DRAWING No		DESCRIPTION		REV. A	DATE 05-11-20	REV-BY L.P.McIntosh	APPROVED	REVISION	DRAWN: L.P.McIntosh	DATE: 05-11-20	<b>Boral Cement</b> ABN 62 008 528 523 <b>Engineering Services</b> Taylor Avenue New Berrima NSW 2577 Phone: +61 2 4860 2325 Locked Bag 4 New Berrima NSW 2577 Fax: +61 2 4860 2399 Email: drawing.office@boral.com.au	STATUS: <b>PRELIMINARY</b>	PLANT: MEDWAY	DRAWING No: BER-M-PFD-482-05-01
REFERENCE DRAWINGS		REVISIONS		DRAWING ISSUED FOR COMMENT		APPROVED:		DATE:	ALPHA NUMERIC:	BCES JOB No: <b>GBM482</b>		PROJECT: BERRIMA COLLIERY CLOSURE	SECTION: MINE	
								DATE:	STOCK NUMBER:	SHEET: <b>B1</b>		SUB SECTION: PIT TOP WATER TREATMENT	TITLE: GENERAL ARRANGEMENT	WORKS No: <b>Plan 5b</b>
								DATE:	SCALE: <b>NTS</b>	CLASSIFICATION:				REV. <b>A</b>

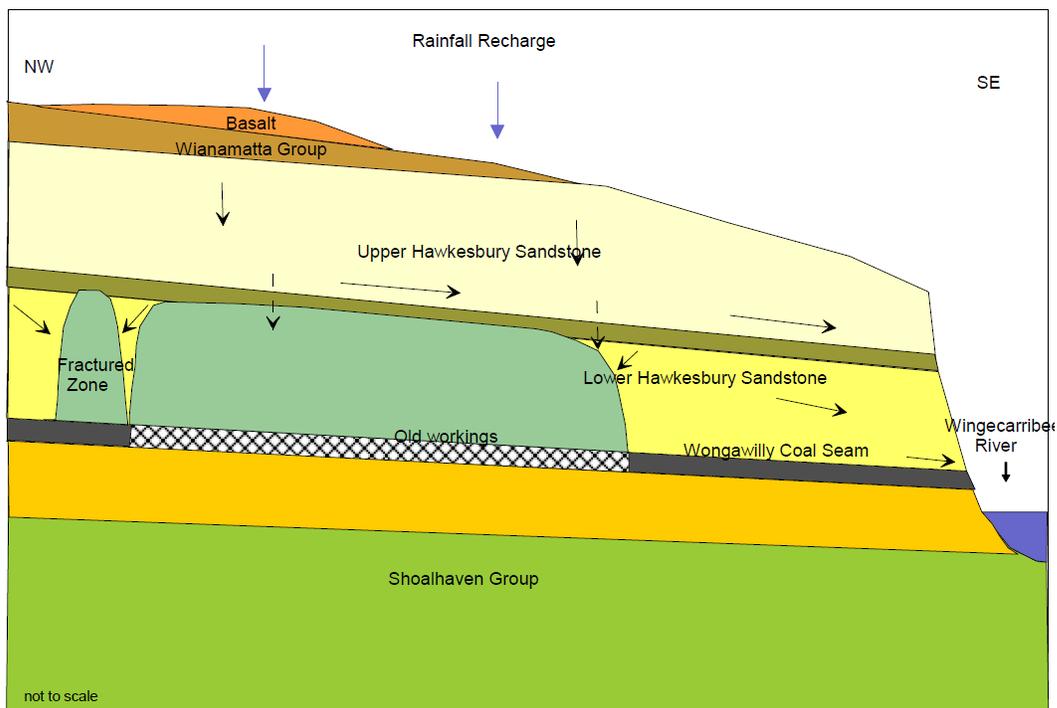
**Figure 1 Conceptual model for Berrima colliery**

Over the past 5 years Berrima Colliery collected the monitoring data from the production and monitoring bores (3 bores and one vibrating wire piezometer) and outflow volumes at the Mine Adit. Below is the summary of monitoring results which added information to improve the conceptual model (**Figure 1**):

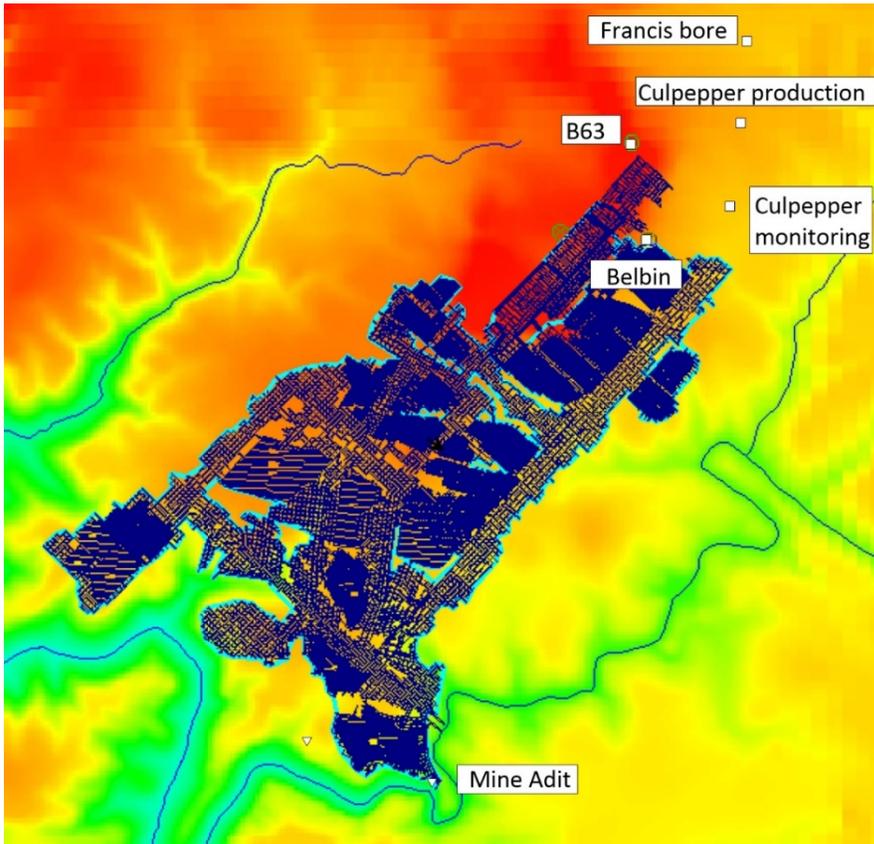
**Figure 2 Map with location of monitoring bores and mine Adit (colours represent the topography)**

- Higher rainfall events prevailed in the period from late 2014 to 2017, followed by drier period to 2020 and wetter during 2020.
- The monitoring data for Belbin bore (**Figure 2**) was not available after mid 2016 until mid-2020 (**Figure 3**). The results indicate that the overall groundwater level has increased slightly (2 m) over that time. Recently, the piezometric head has been decreasing since September 2020. However, the bore has been pumping daily and the drawdown during pumping ranged around 30-35 m. At that time, the was pumped twice per day for a short period of time, however since early October 2020 it was pumping 8 hours a day resulting in 40 m drawdown.

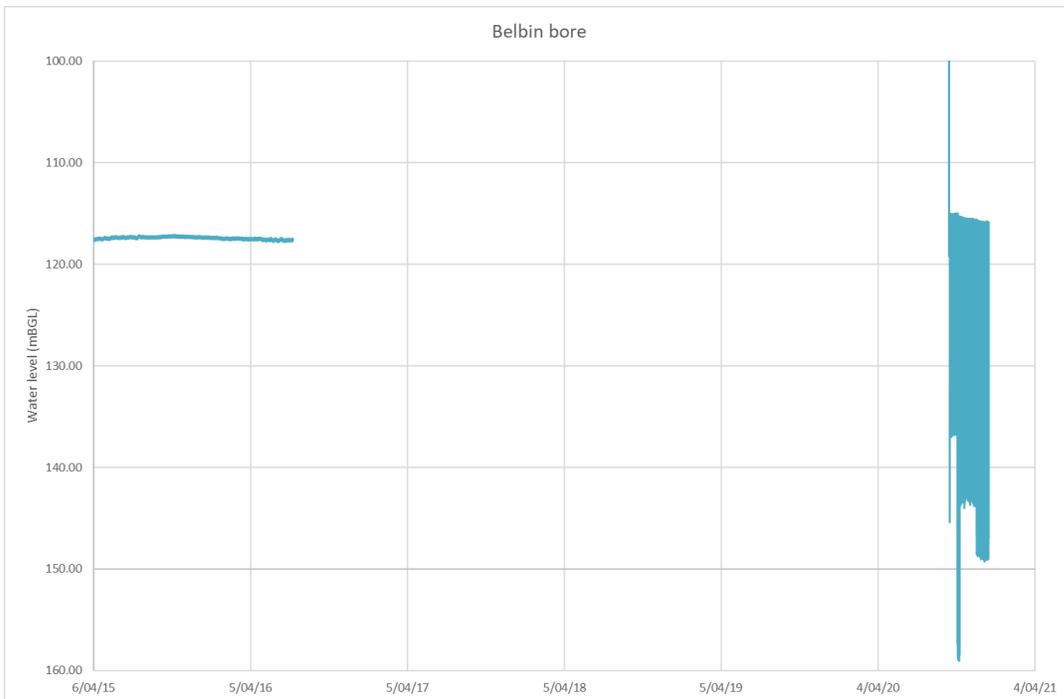
**Figure 3 Hydrograph for Belbin bore (2015 to 2020)**

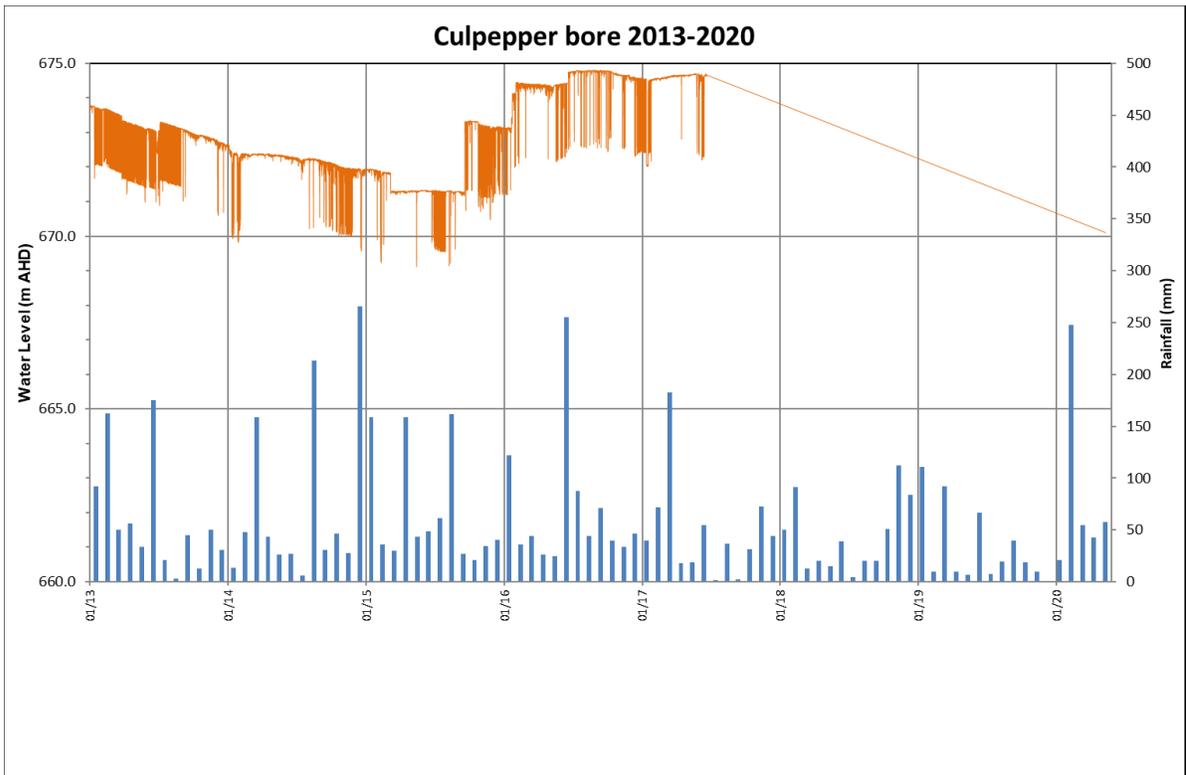
**Figure 4 Hydrograph for Culpeper production bore 2013-2020**

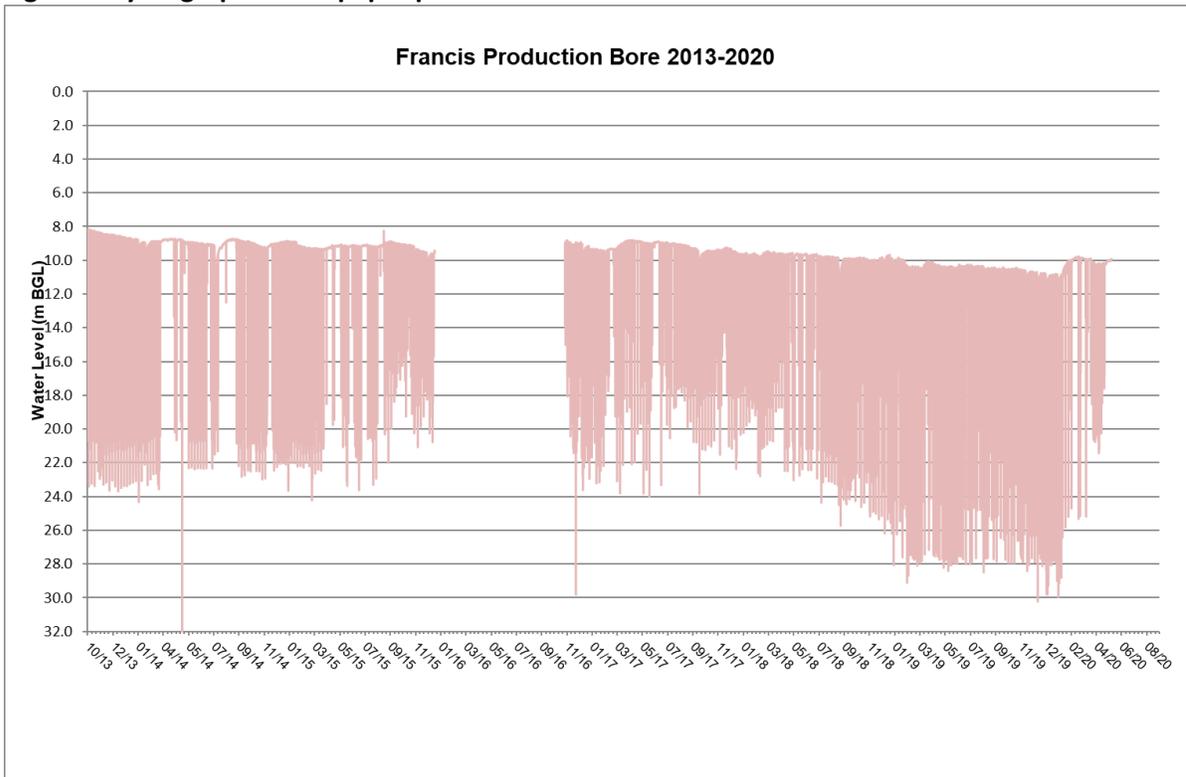
**Figure 5 Hydrograph for Francis production bore 2014-2020**

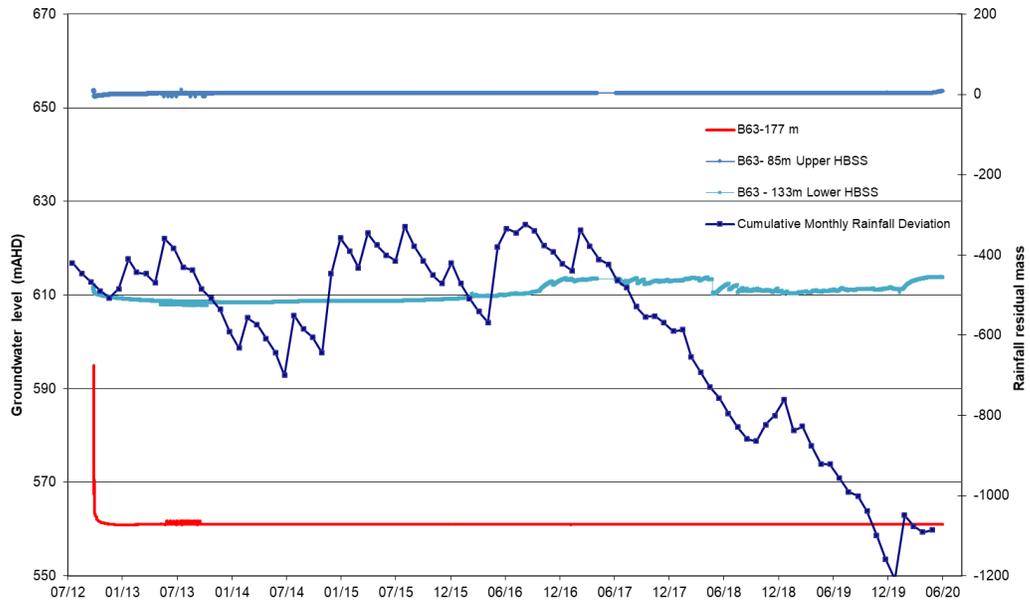
Figure 6 Hydrograph for VWP B63 2013-2020

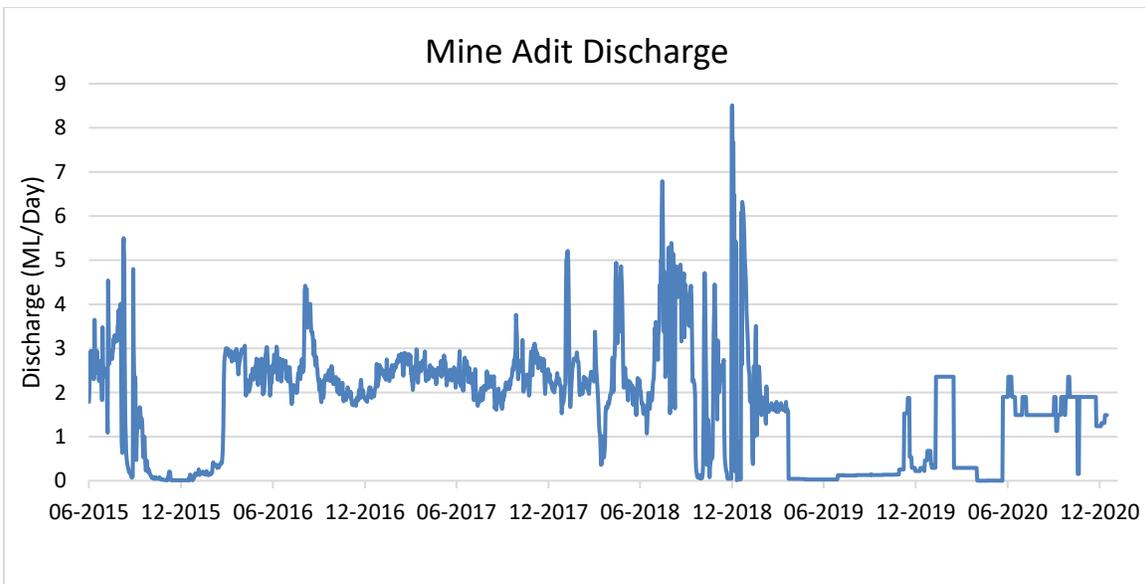
Figure 7 Outflow at the V-notch weir at Mine Adit 2015-2020

- Mine discharge via the Adit remained within the 2-3 ML/day range over the period from 2016 to 2018 (**Figure 7**). The exception were the periods where water was diverted for water quality trial. Following the installation of the bulkheads mid 2019 the drainage and outflow at the Adit was variable due to water being allowed to backup behind the

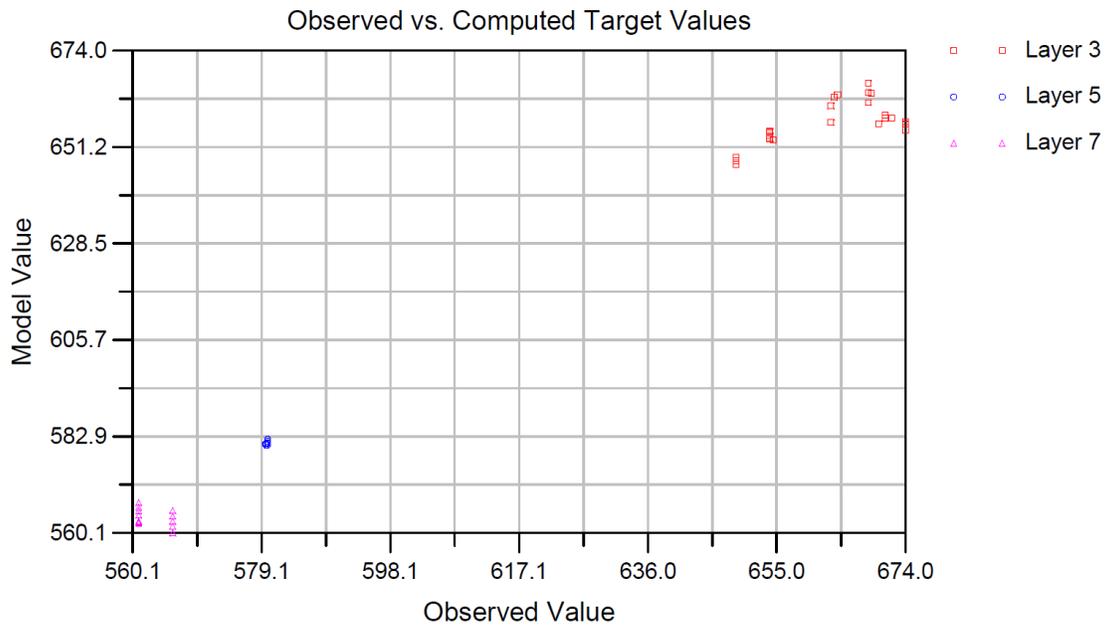
**Figure 8 Observed versus modelled heads**

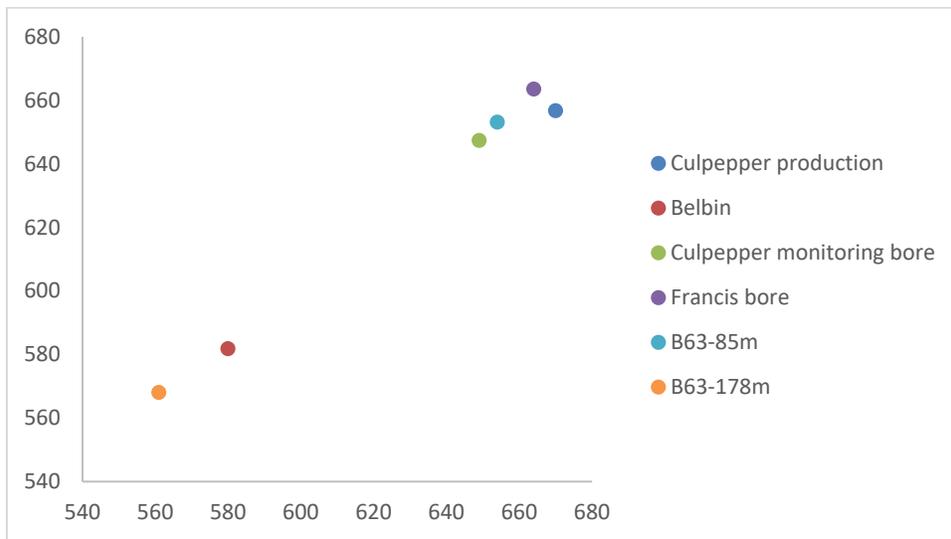
**Figure 9 Results of model verification – observed versus predicted heads for December 2020**

The results of model verification are provided in **Figure 9**. The results show that the model is correctly predicting heads when compared to the December 2020 dataset. Most monitoring points fall on the 1:1 line with the exception of the Culpepper production bore for which the model underestimates the water levels.

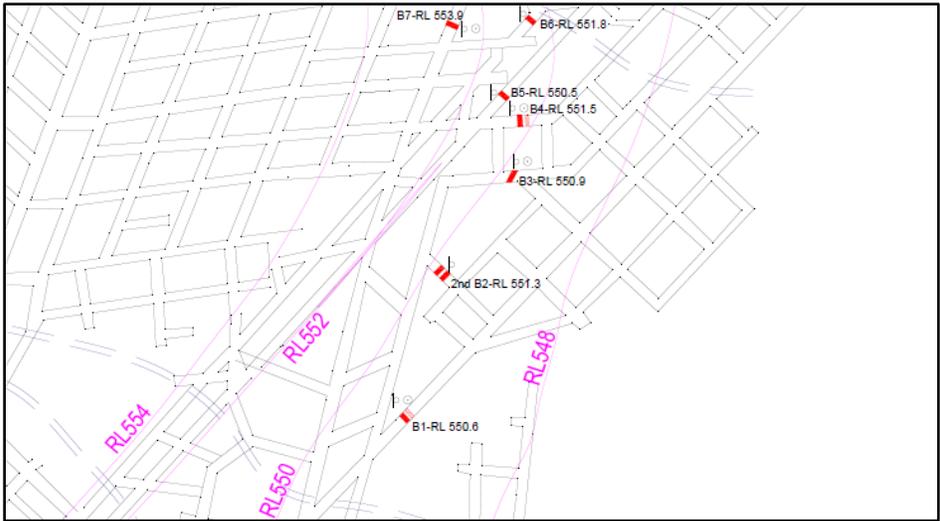
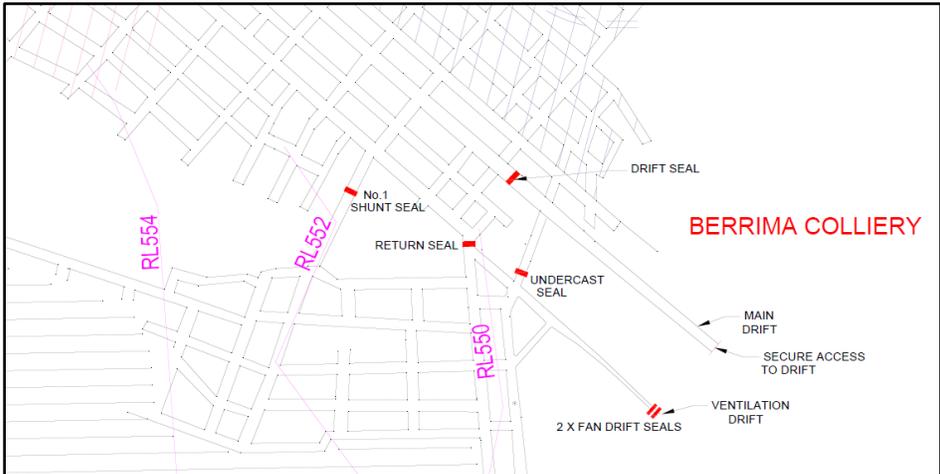
**Figure 10a and 10b Location of installed bulkheads (8a) and pumping location behind the Drift Seal (8b)**

A predictive model run was undertaken following the calibration of the model to 2020 observed data. This predictive run was undertaken considering the presence of seven bulkheads installed in 2019 and pumping from a point behind the drift seal. Figures 10a and 10b show the location of

The locations of the bulkheads are given in **Figure 10a** and the location of pumping is given in **Figure 10b** along with 4 additional bulkheads at pit bottom and ventilation shaft located above the seam level. The predicted water level contours at the coal seam level are given in **Figure 11**. The outflow volumes at the Adit are given in Table 1.

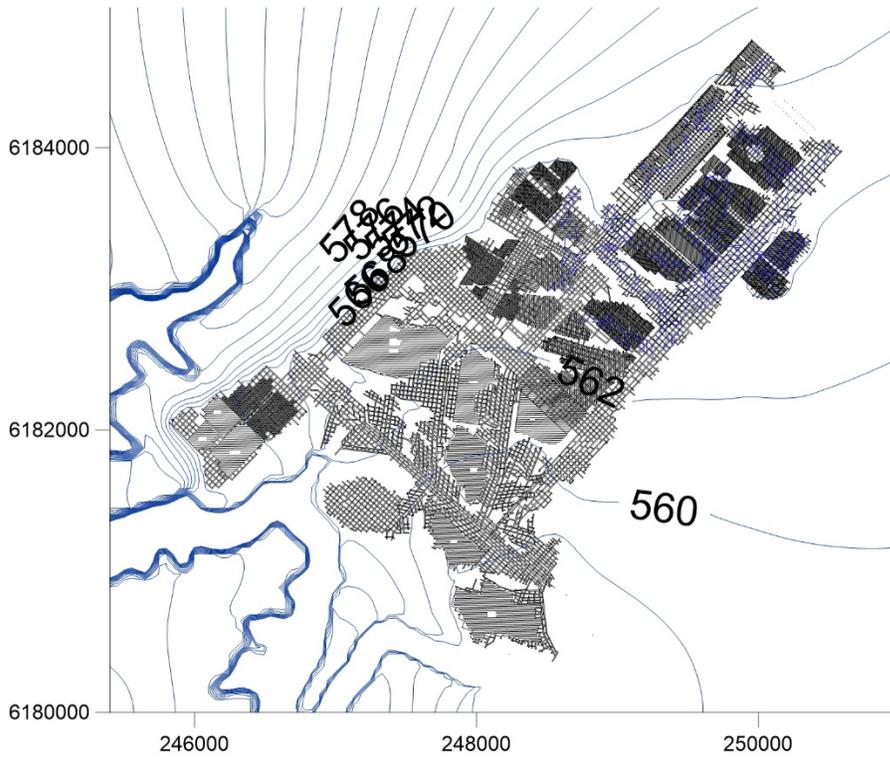
**Figure 11** Predicted water levels at Year 10 from 2020 and the locations of the installed bulkheads

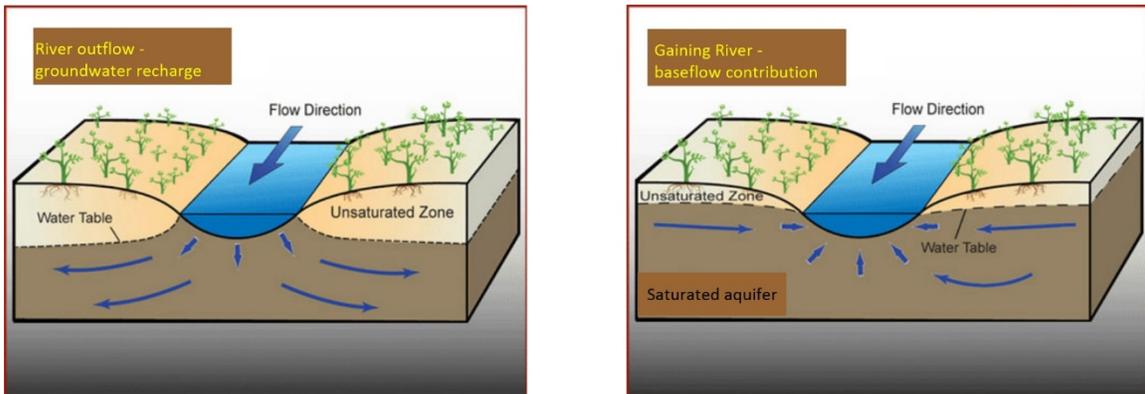
**Figure 12** Groundwater-surface water connectivity (adapted from Geoscience Australia, 2021)

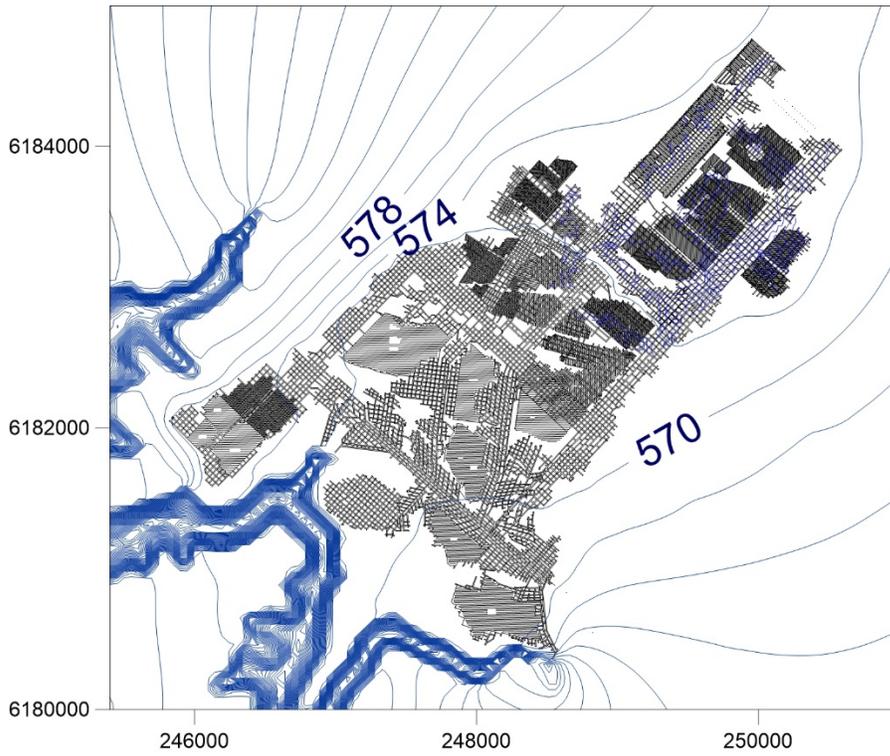
**Figure 13 Predicted water levels after 10 years of pumps not operating with 7 installed bulkheads**

points to minimal exchange of waters downstream of the mine past the Medway Rivulet. The water level contours after 10 years of no pumping are provided in **Figure 13**.

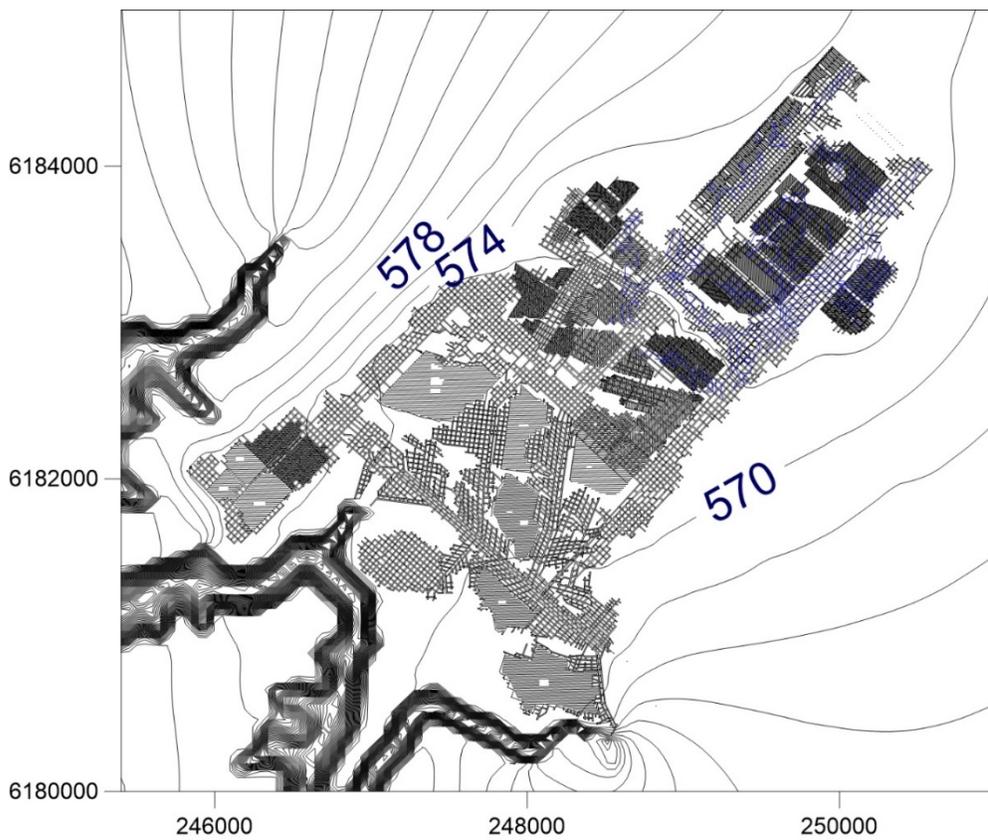
**Figure 14 Predicted water levels after 100 years of pumps not operating with 7 installed bulkheads**

The model scenario from the previous run was run for another 90 years to understand the impact of no pumping for a long time period. The predicted mine inflow for Year 20 and Year 100 are provided in Table 4 and the water level contour at the coal seam level are given in **Figure 14**.

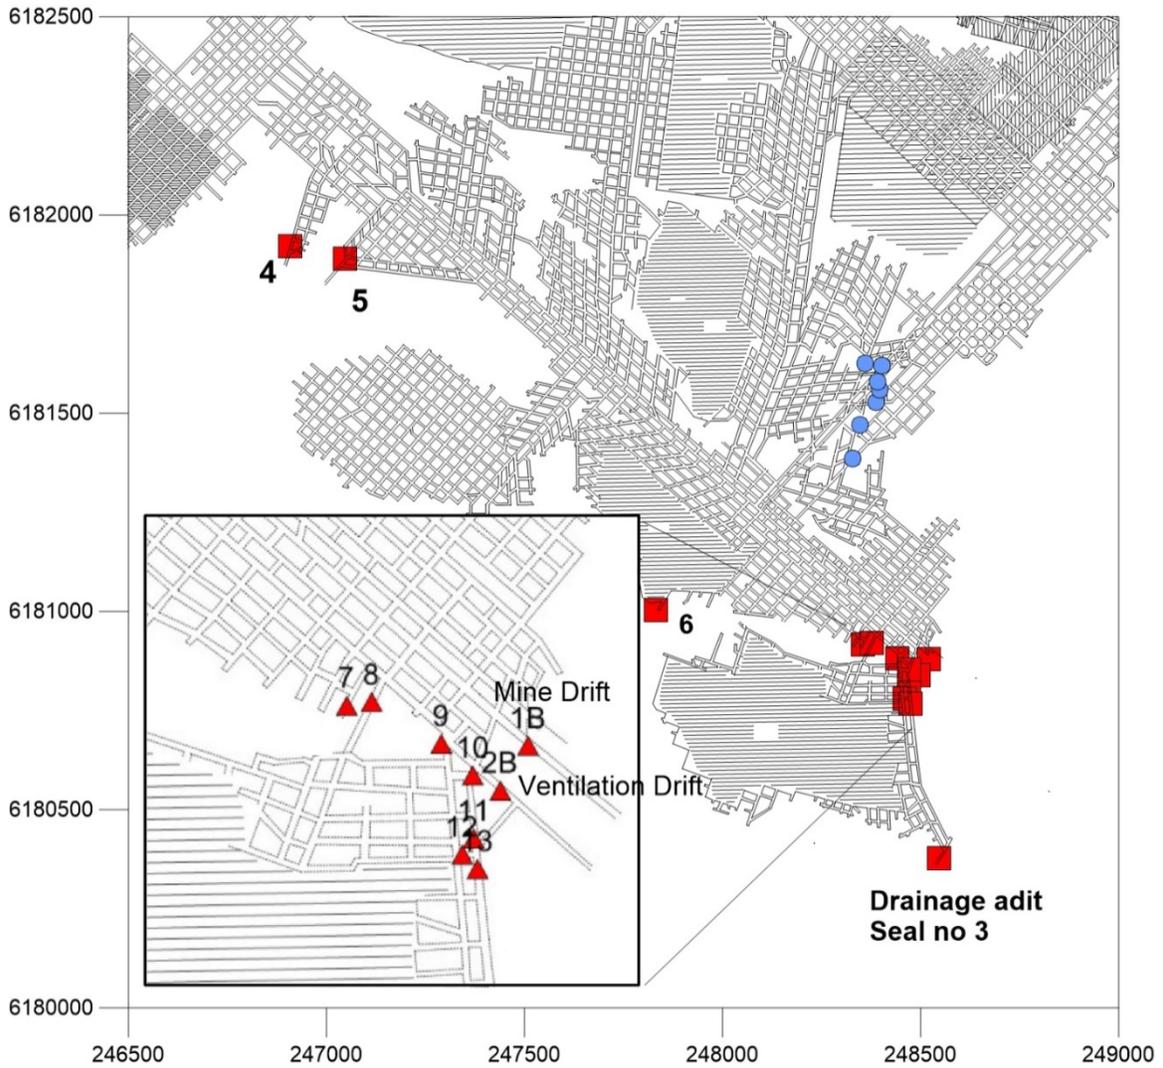
**Figure 15 Location of all bulkheads for Scenario 4 and 5 (blue dots show the installed bulkheads)**

This predictive model run includes the addition of ten bulkheads as shown on **Figure 15**. These bulkheads are in addition to the seven already installed and the aim of the run was to understand the effectiveness of additional bulkhead installation to further reduce the impact on the environment.

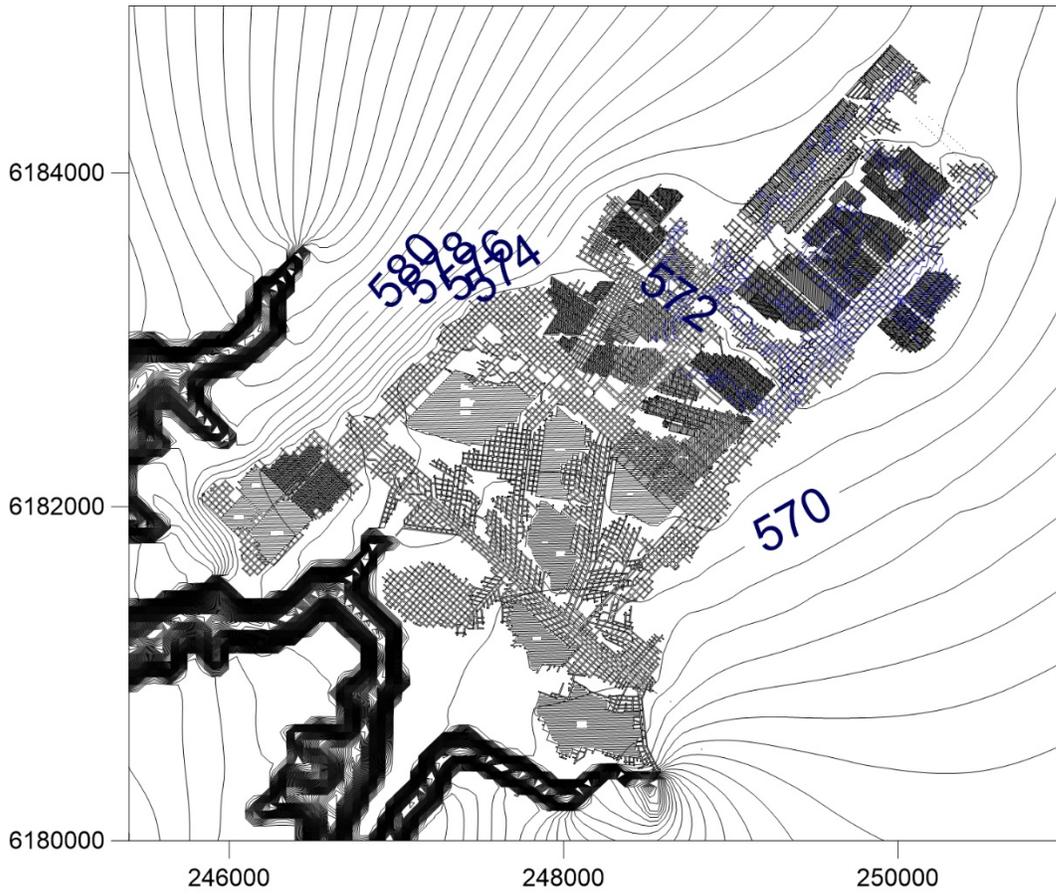
**Figure 16 Predicted water levels with 17 bulkheads installed and no pumping for a period of 10 years**

The results of the model run are presented in **Figure 16**. **Figure 16** shows the predicted water level contours after ten years of no pumping. Under this no pumping scenario the outflow at the Adit was estimated at 2.6 ML/day. The water fluxes to and from the River are presented on **Table 6** and show negligible change from previous scenario and also between the River outflow and baseflow contribution.

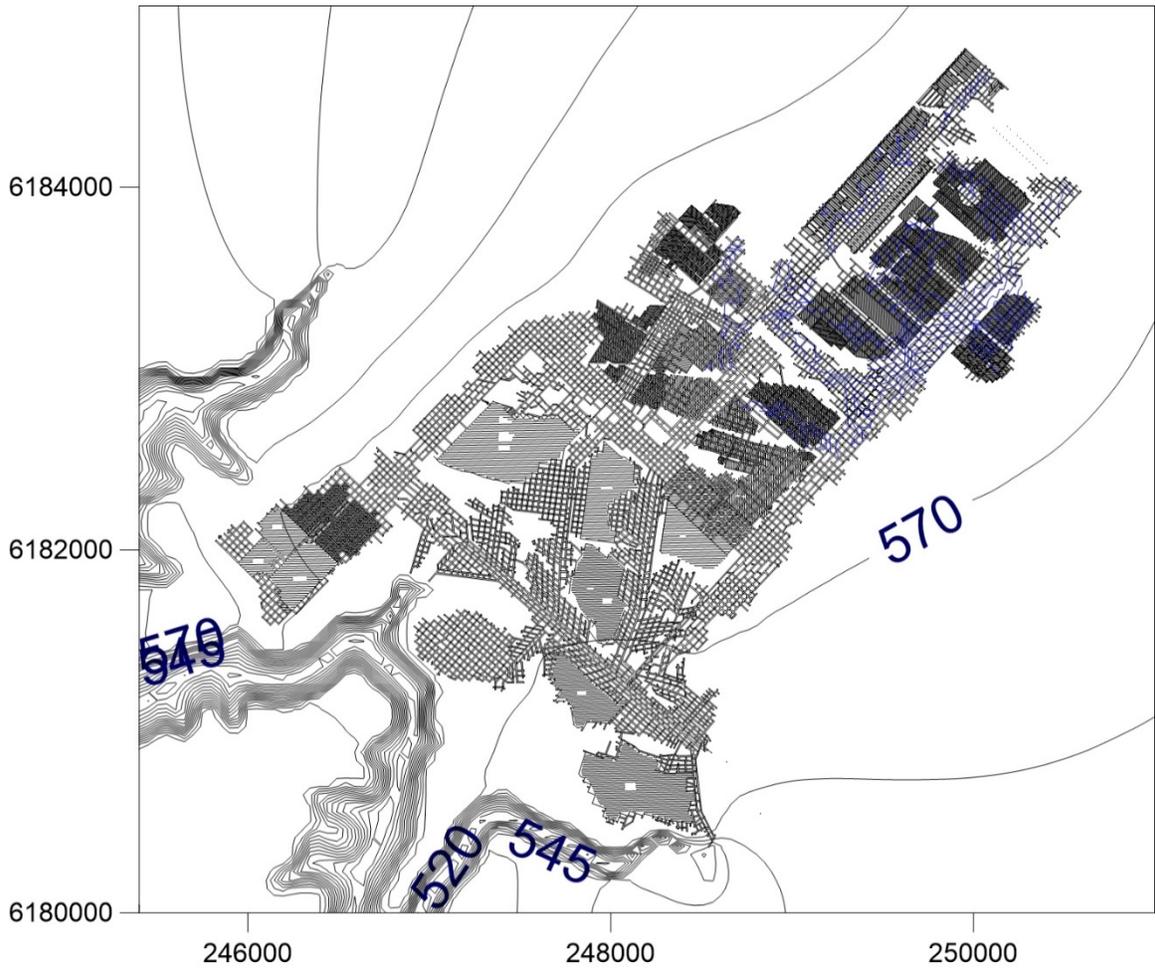
**Figure 17 Predicted water levels with 17 bulkheads installed and no pumping for a period of 100 years.**

Predictive model run with additional bulkheads was run for additional 100 years with no pumping. The model results are shown on **Figure 17** for long term period of 100 years. The results indicate minor change from 10 year period and the volume of outflow at the Adit has not changed. **Table 8** shows that after 100 years of no pumping, the exchange of water between the River and groundwater in River Section 2 remains stable and the river outflow is offset by baseflow contribution to the River.
