Marulan South Limestone Mine | SSD 7009

REHABILITATION MANAGEMENT PLAN

Prepared for Boral Cement Limited | 29 December 2023

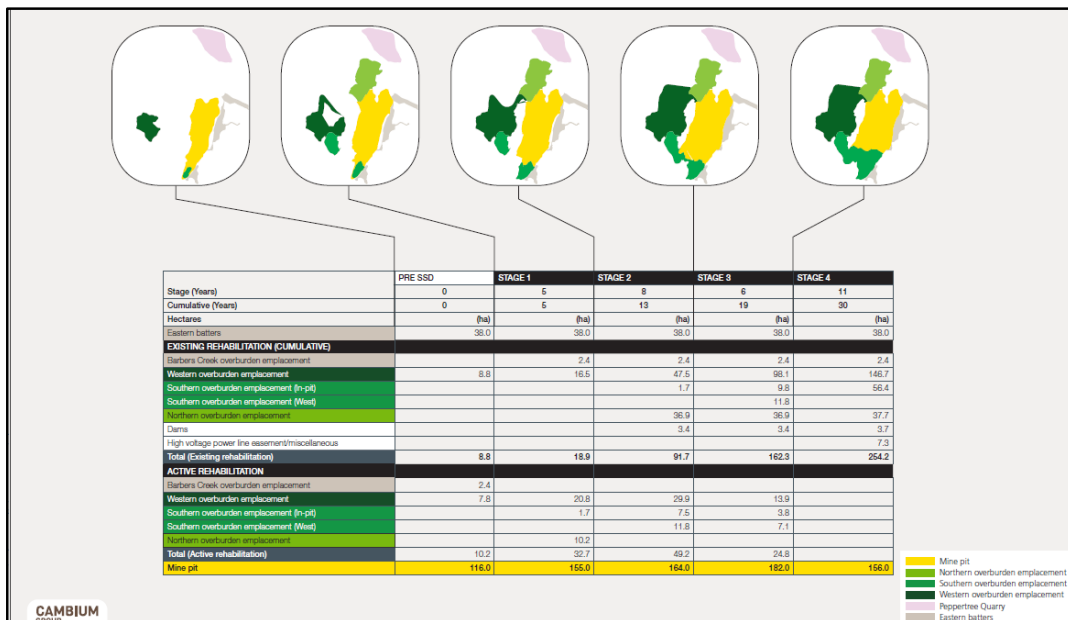
Plate 2 30 year rehabilitation schedule

A life of mine rehabilitation schedule for the 30 year mine development was developed as part of the 2019 EIS. The four stage development is conceptually presented in Plate 2 and discussed in terms of mining, surface water management and rehabilitation in the following Section 6.1.

During the amended five year, Stage 1 period (2023-2028) the rehabilitation schedule is forecast to re-align with the proposed 30 year rehabilitation schedule noting that the majority of the northern overburden emplacement (NOE) currently undergoing development by Peppertree Quarry is excluded from ML 1857.

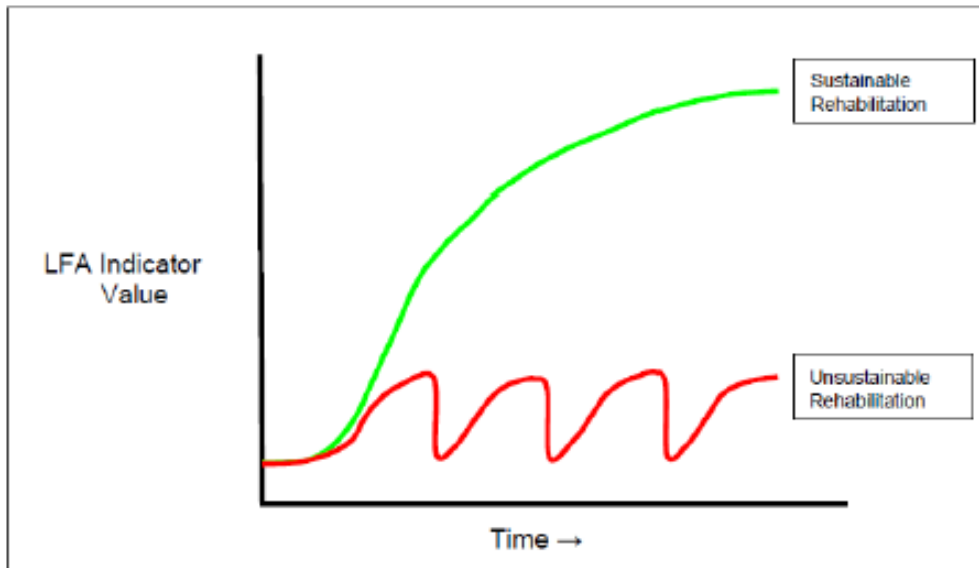
Plate 4 Using LFA to assess Ecosystem Functionality

The expected trend of an ecosystem approaching stability and functionality are for LFA values to improve over time resulting in a parabolic trend toward pre-disturbance and/or analogue conditions as indicated in Plate 4.

Sites that are not improving or are declining would indicate that the site is not approaching a stable state and may require further remediation to achieve ecosystem functionality. In this instance, Boral will need to reassess areas of rehabilitation failure and undertake further rehabilitation or maintenance works.
