# **Boral Cement – Berrima Works Blue Shale Quarry Rehabilitation Management Plan ML 1723**

**July 2022**

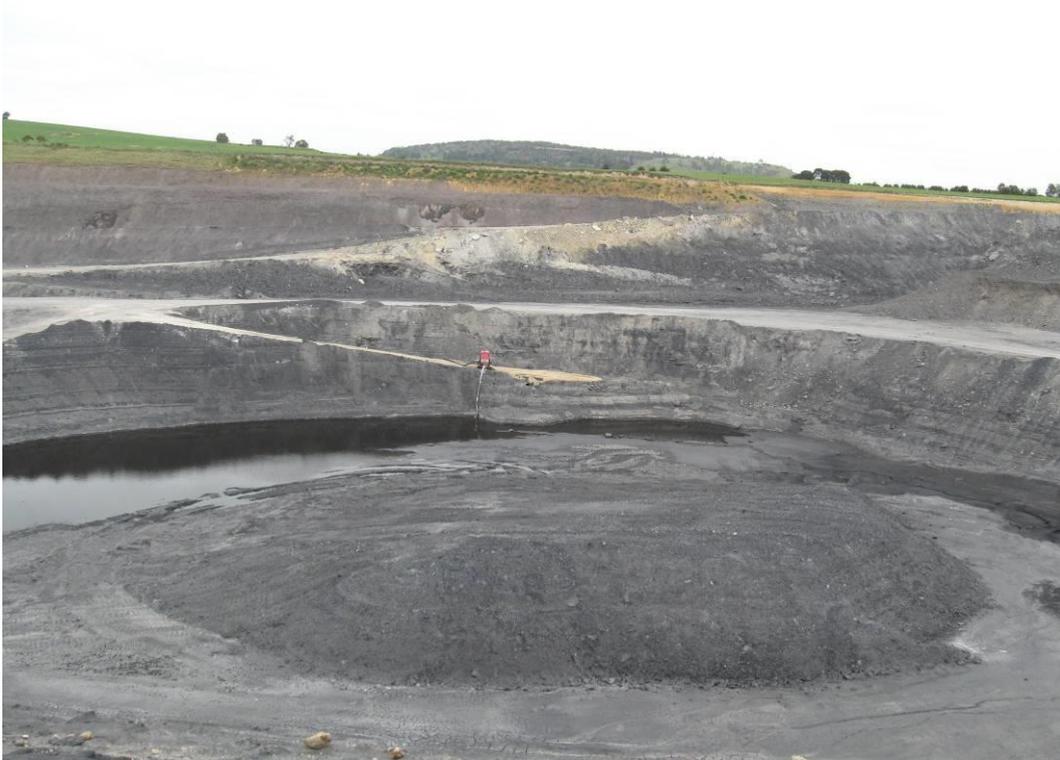
**Plate 1 - Current extraction area showing ripped shale pushed up ready for loading**

The shale is extracted by a series of shallow benches by dozer ripping then pushing up into piles which are then loaded onto trucks for transport to the storage shed. Generally bench height is approximately 7 m with an intervening 5 m berm. Batter slopes are 1:1 or 45 degrees.

The current extraction area is shown in Plate 1.

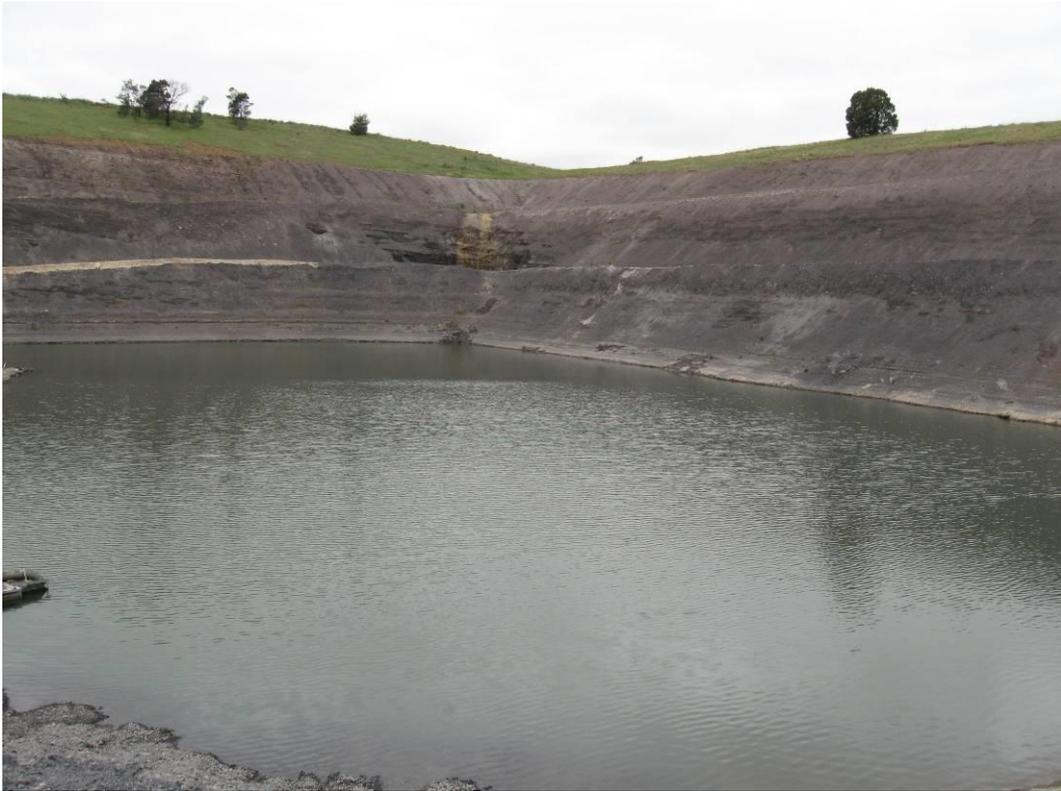
**Plate 2 - Water Storage in Eastern Void**

During sustained rainfall, excess water is pumped into the eastern void of the shale quarry. This void has been developed as a large water storage as shown on Plate 2. This system has allowed the Works to significantly reduce its dependence on the Wingecarribee River and only use the river as a backup during periods of extended dry weather when the dams are low. Water is pumped back to the Cement Works via an overland pipeline as shown on Plate 3.

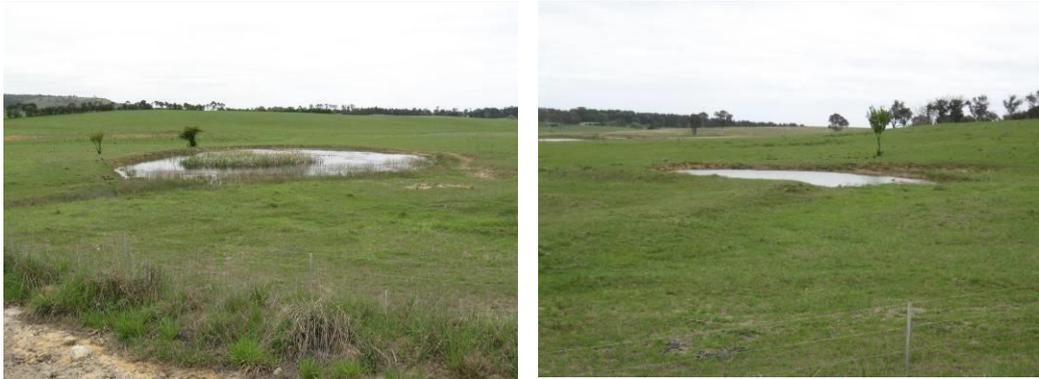
**Plate 4 - Clean Water Catch Dams to west of current extraction area**

There are two dams which are located on drainage lines that enter the quarry area that were established as construction sediment control dams when the quarry commenced.

These dams will eventually be mined through and will be replaced by additional clean water diversion channels. The two dams are shown on Plate 4.

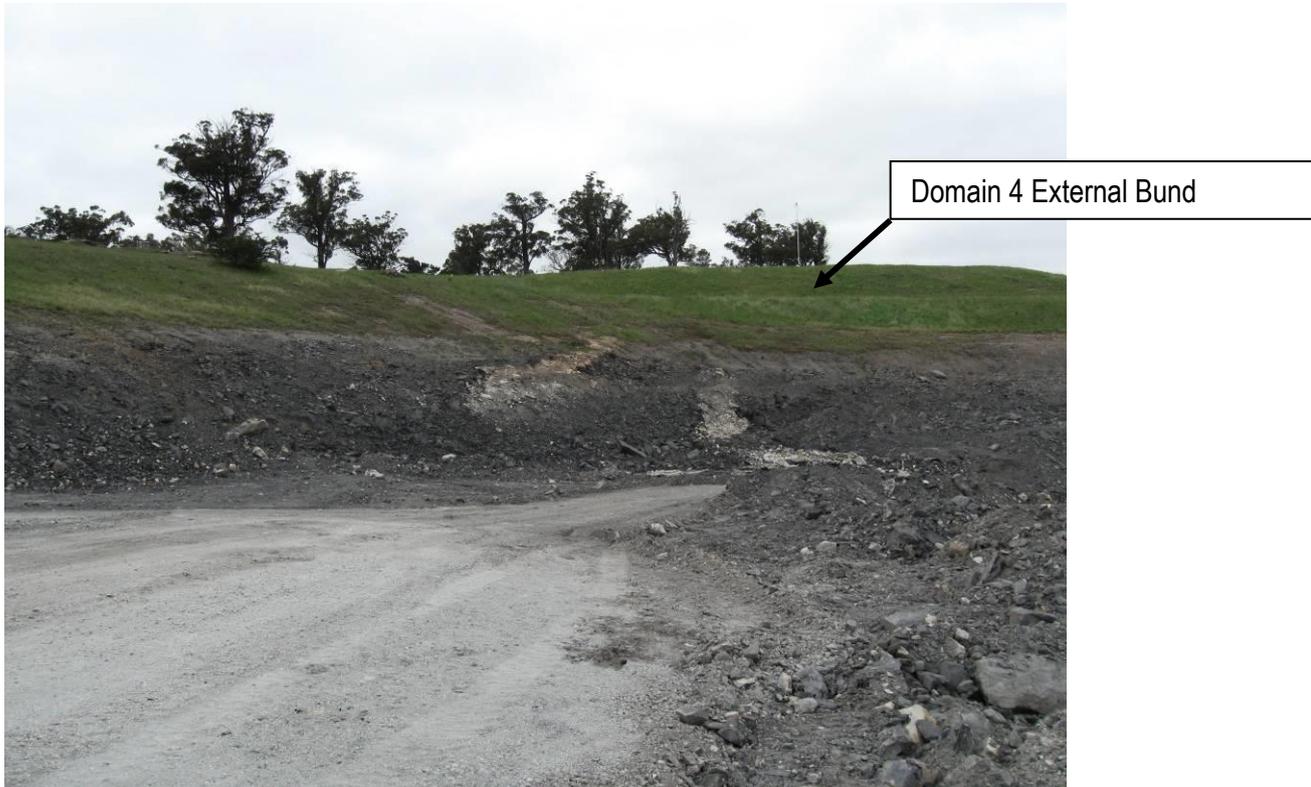
**Plate 5 - View of Domain 4 in Background**

At the commencement of this RMP Period, rehabilitation activities have occurred on the external areas around the quarry void. The main area is Domain 4 which includes the original overburden emplacement which has been shaped as a bund around the eastern quarry extraction area as shown on Plate 5.

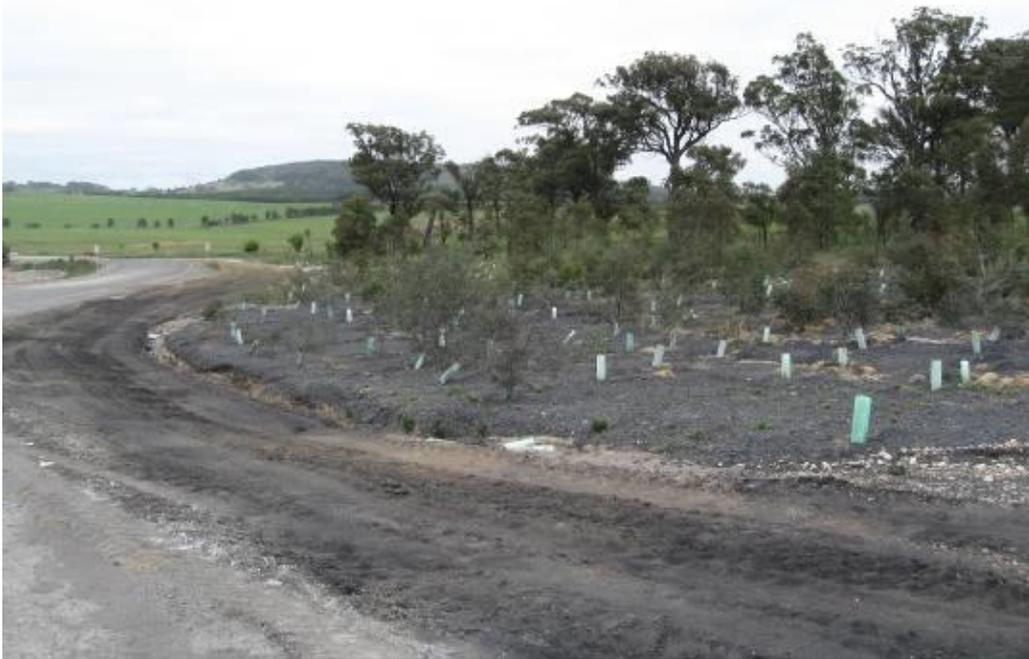
**Plate 6 - Tree Planting Directly into Ashfield Shale**

Domain 4 also includes areas of tree planting to the north of the quarry extraction area. The tree planting was part of an overall program at the cement works to improve dust control, scenic quality and habitat improvement. The planting involved areas that had previously been rehabilitated to improved pasture as well as recent disturbed areas adjacent to haul roads, as shown on Plate 6.

Plate 6 was taken adjacent to the main access road on the northern side of the quarry. This shows an area of direct tree planting into Ashfield Shale. These trees are growing well, arguably better than areas that were previously rehabilitated using improved pasture.

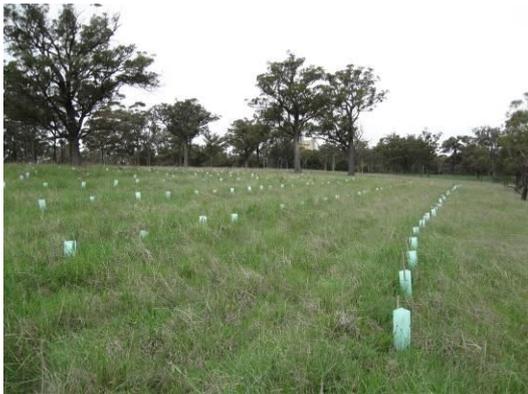
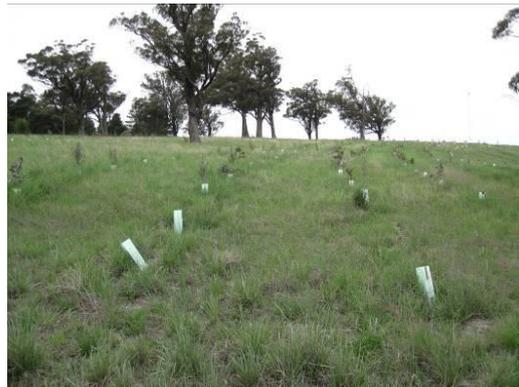
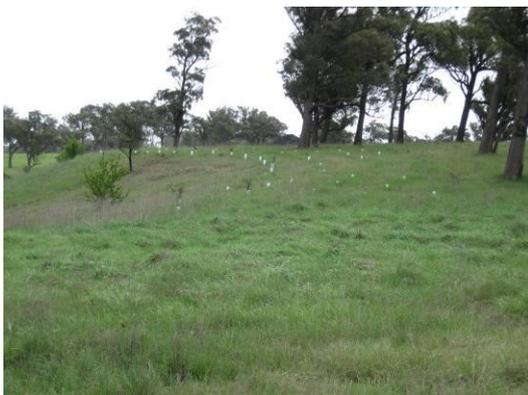
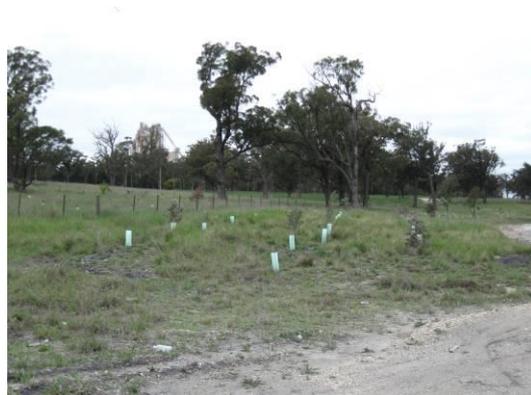
**Plate 7 - Domain 4 Tree Planting**

Plate 7 below show examples of tree planting around the northern section of the quarry.

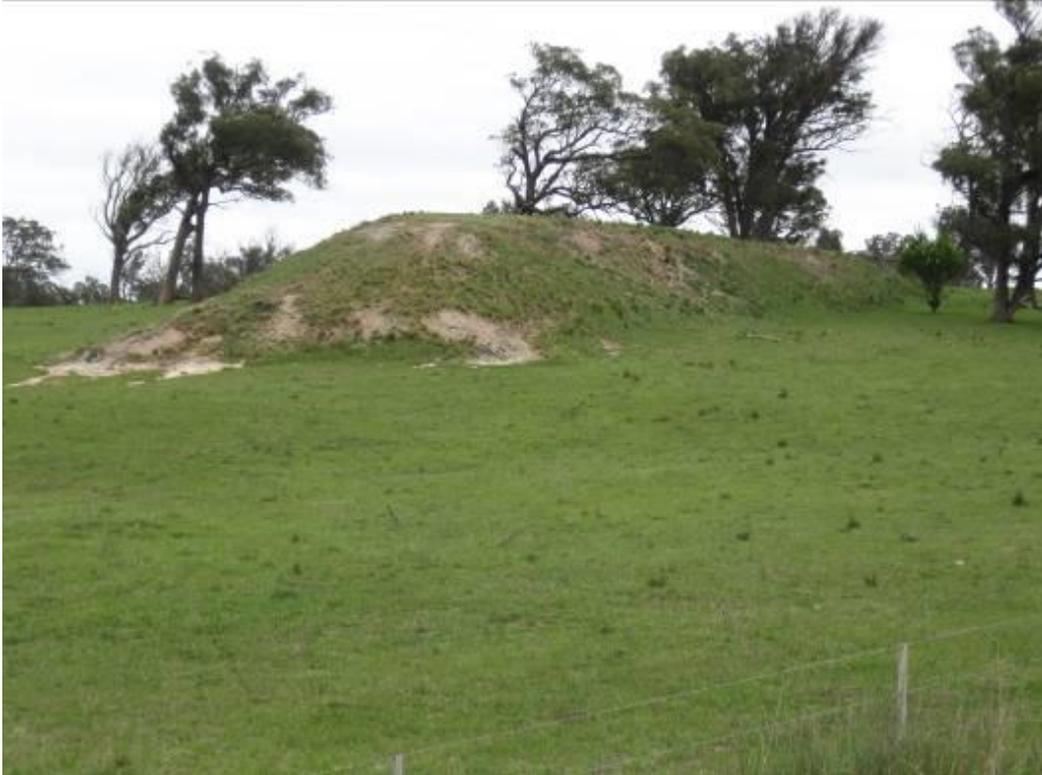
**Plate 8 - Transitional Rehabilitation**

Plate 8 below shows an area of transitional rehabilitation consisting of excess topsoil and subsoil generated during the original quarry development. The material has been emplaced in a long but relatively shallow emplacement located just outside the next extension of the quarry footprint. This material will not be required for several years but eventually will be used in the rehabilitation of finished berms.

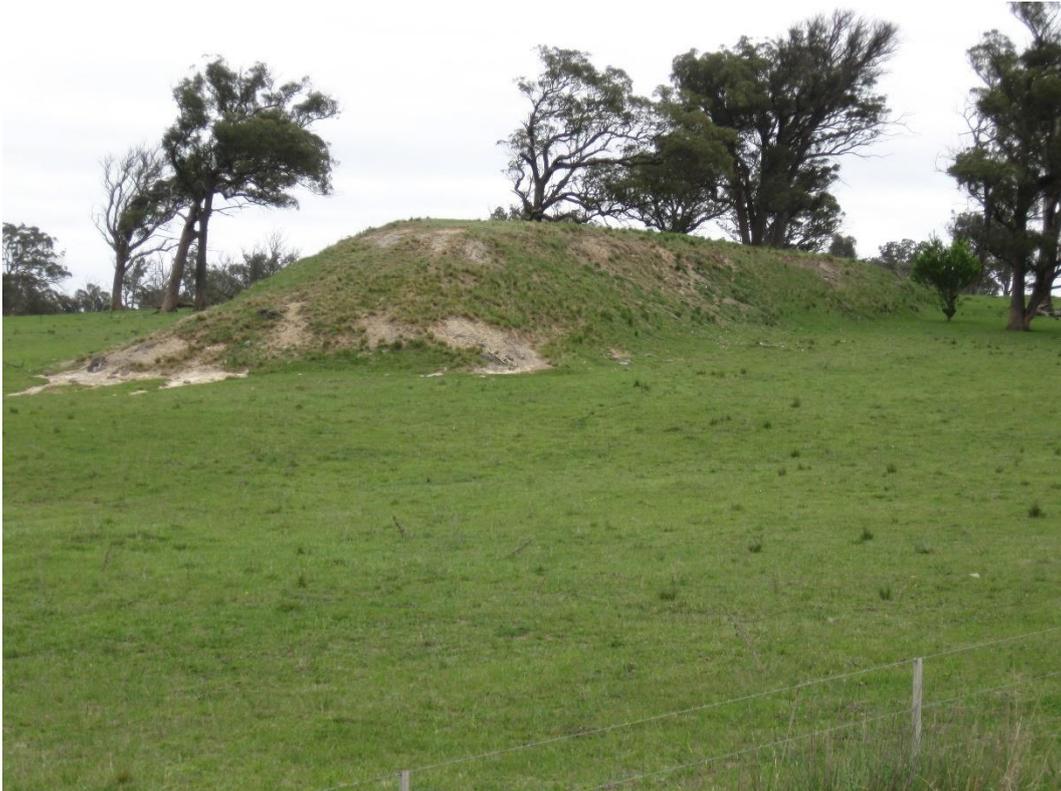
**Plate 1 – Existing Topsoil Stockpile**

The current topsoil stockpile, shown on Plate 1, has been in place for over 20 years and shows signs of deterioration. This stockpile area lies within the footprint of the future quarry footprint and will ultimately have to be relocated.
